AAIB Bulletin

7/2018

Published 12 July 2018

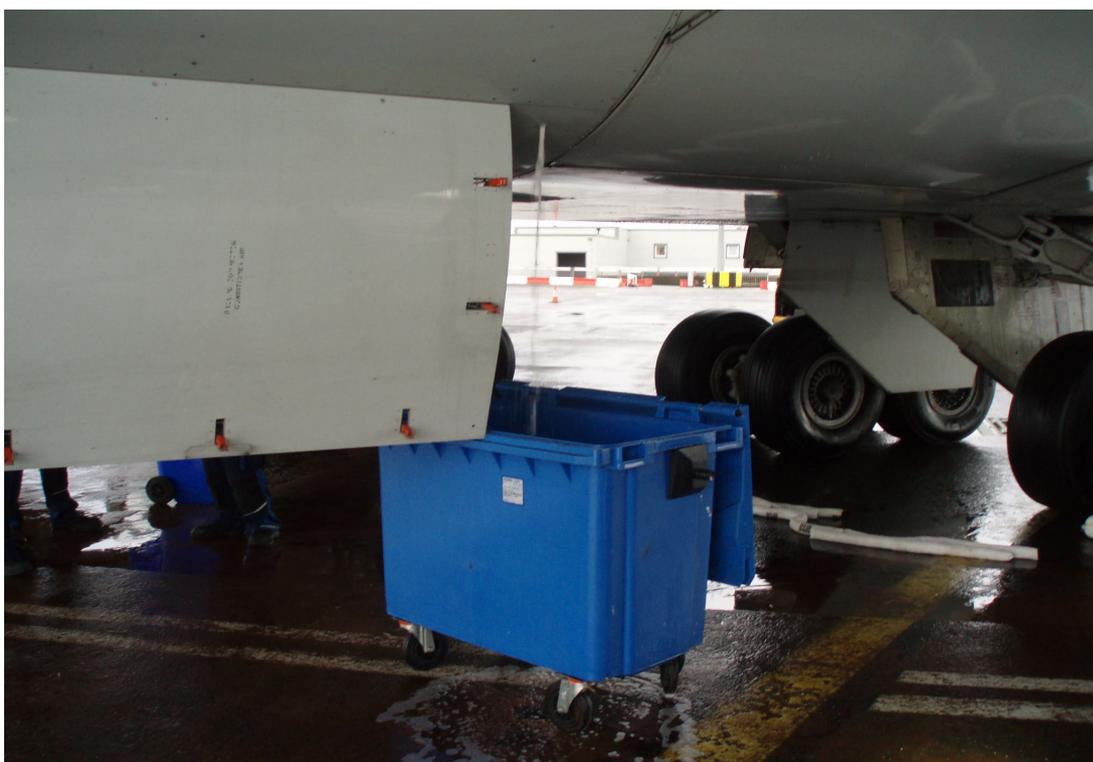
Figure 1

flight crew were shutting down the engines they smelled fuel. When the ground operations agent entered the aircraft via the main deck door to commence unloading operations, he too detected a strong smell of aviation fuel and heard the sound of running liquid. He identified the source as a Bell 412EP helicopter, which was being shipped as cargo on the main deck of the aircraft and noted that fuel appeared to be leaking from a vent on the forward right-hand side of the helicopter. The ground operations agent reported the situation to the flight crew. The Airport Authority and RFFS were notified and the airport emergency response plan was activated. The flight crew shut down the aircraft and opened the escape hatch and upper deck service door to ventilate the aircraft. Upon arrival at the aircraft the RFFS noted that fuel was coming out of the bottom of LX-VCF's fuselage, close to the left body landing gear, having leaked through the main deck, lower deck and avionics bay and was pooling on the apron beneath the aircraft (Figure 1). The aircraft was evacuated, electrically isolated and quarantined by the RFFS. The RFFS subsequently stated that the measured fuel vapour levels indicated a high risk of explosion and that the fuel flammability limits were potentially in range. After the aircraft had been made safe, all cargo, including the helicopter, was offloaded manually.

Fuel exiting lower fuselage of LX-VCF

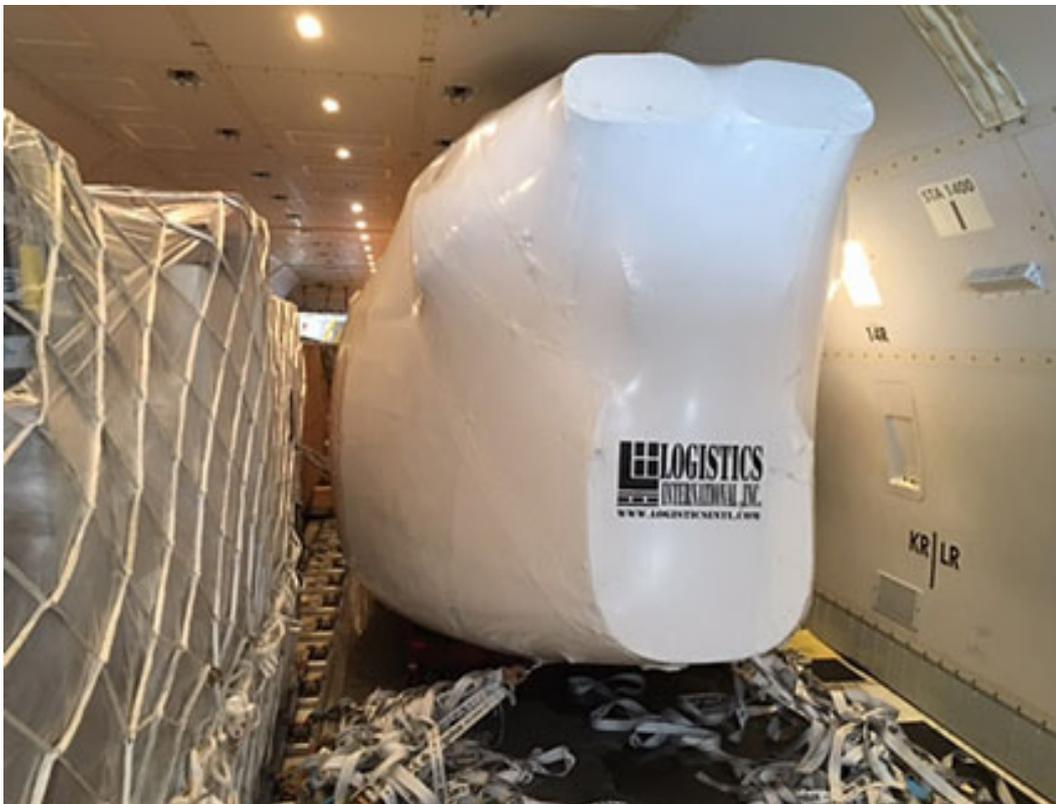
Figure 2

The helicopter was encased in strong white plastic shrink-wrap and had been secured to a cargo pallet for the flight, which occupied three loading positions on the right side of the aircraft's main cargo deck (Figure 2). During the aircraft examination, some fuel was present in the wells of the pallet and the securing straps were soaked with fuel.

Bell 412-EP fuselage, wrapped in shrink-wrap, on main deck of LX-VCF prior to being offloaded at Prestwick

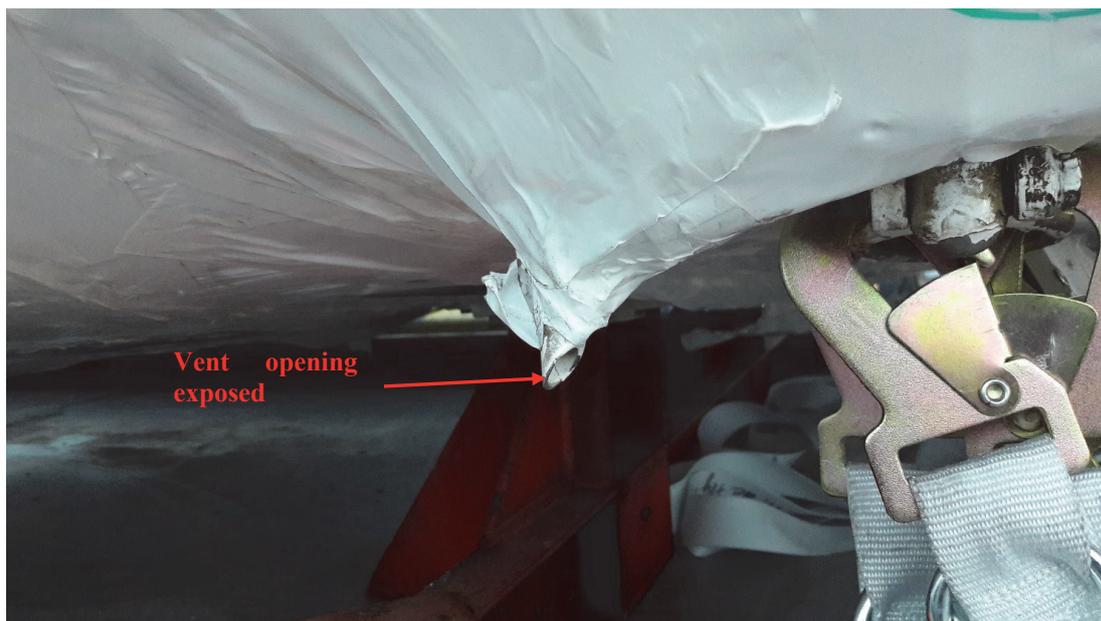
Fig 3

In the area of the helicopter's forward right-hand fuel vent, from which fuel was reported to have leaked, the shrink-wrap had been applied so that the opening of the vent was exposed (Figure 3). White tape had been applied on top of the shrink-wrap in the vicinity of the vent.

Forward right-hand fuel vent on Bell 412-EP helicopter

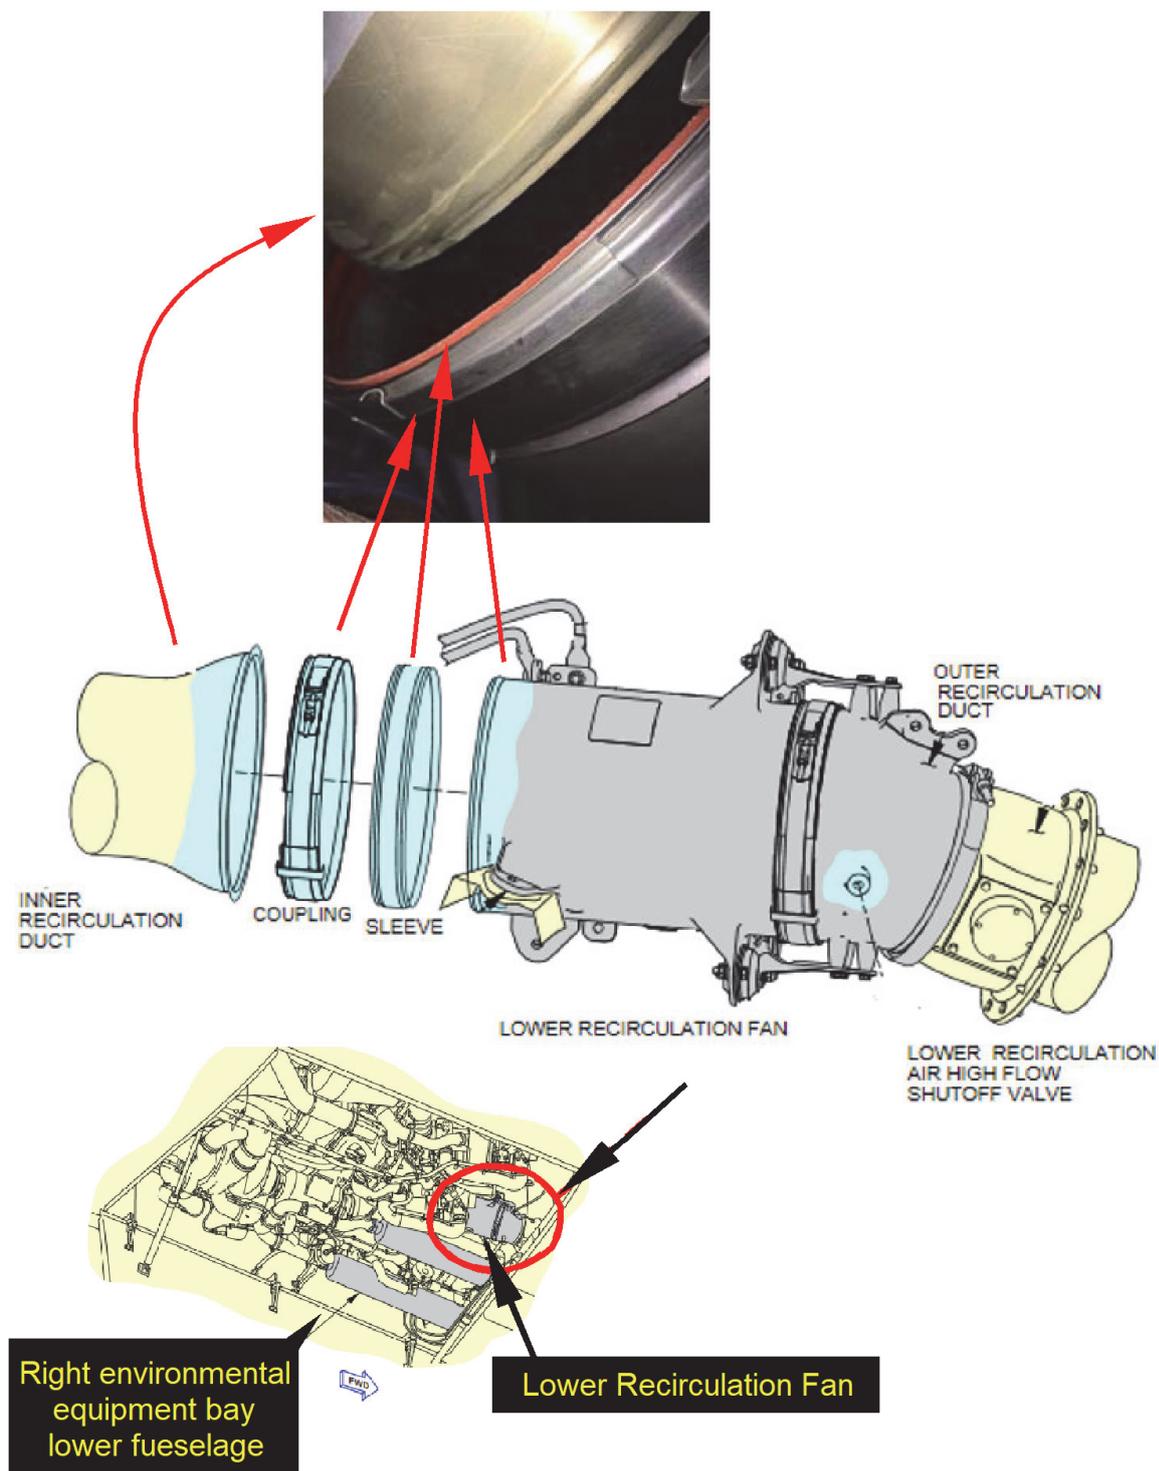
Following the return of the aircraft to Heathrow after the incident, an examination took place monitored by the AAIB. It was found that the right-hand inner recirculation duct was disconnected from the lower right-hand recirculation fan (Figure 3). Once the duct and fan unit were removed, there was evidence that the coupling and seal joining the two had been incorrectly aligned when last assembled. The V-band clamp joining the other end of the duct to the heat exchanger was correctly fitted.

Examination of the coupling system used to connect the recirculation fan to the inner duct showed that if the coupling were not installed correctly, there was less visible evidence and a reduced tactile feel compared to that of the V-band clamp used at the opposite end of the duct. The connection of the right-hand recirculation fan is located in a position that requires reaching through an extensive system of ducting and components to install it. Viewing of the connection between the duct and fan is also restricted. Figure 3 shows the relative position of the recirculation fan and the disconnected duct.

Position of Right Lower Recirculation Fan and photograph of disconnected duct

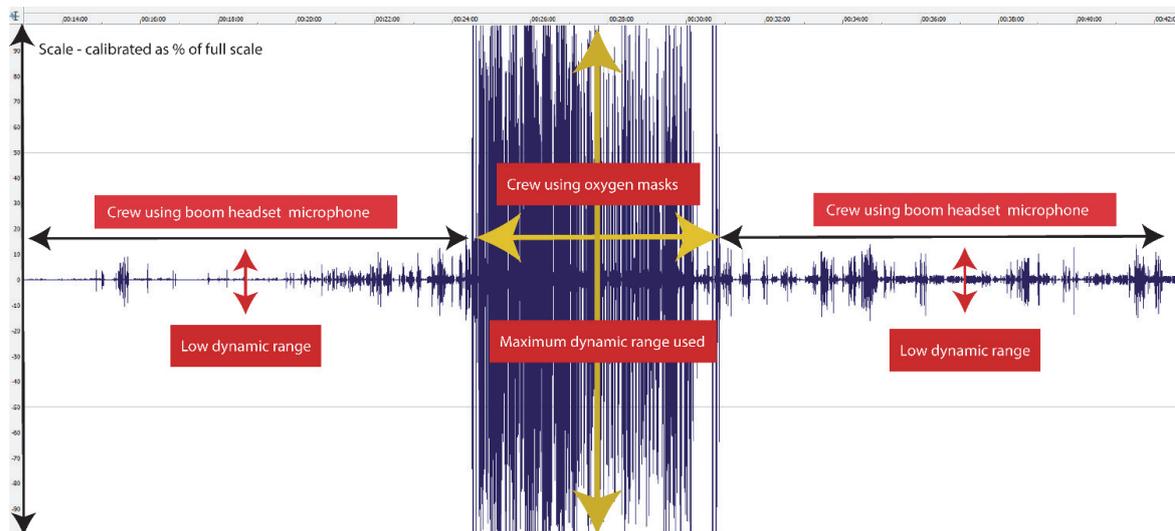
Further to the previous findings of the NTSB, the AAIB also identified that when the flight crew of G-ZBKF had used their oxygen masks, the full dynamic recording range of the crew CVR channels was used, with occasional clipping of the signal. Figure 4 reflects the difference in dynamic recording range when the flight crew used the headset and oxygen mask microphones.

G-ZBKF – CVR waveform of crew channel showing difference in use of available dynamic recording range between headset and oxygen mask microphone signals

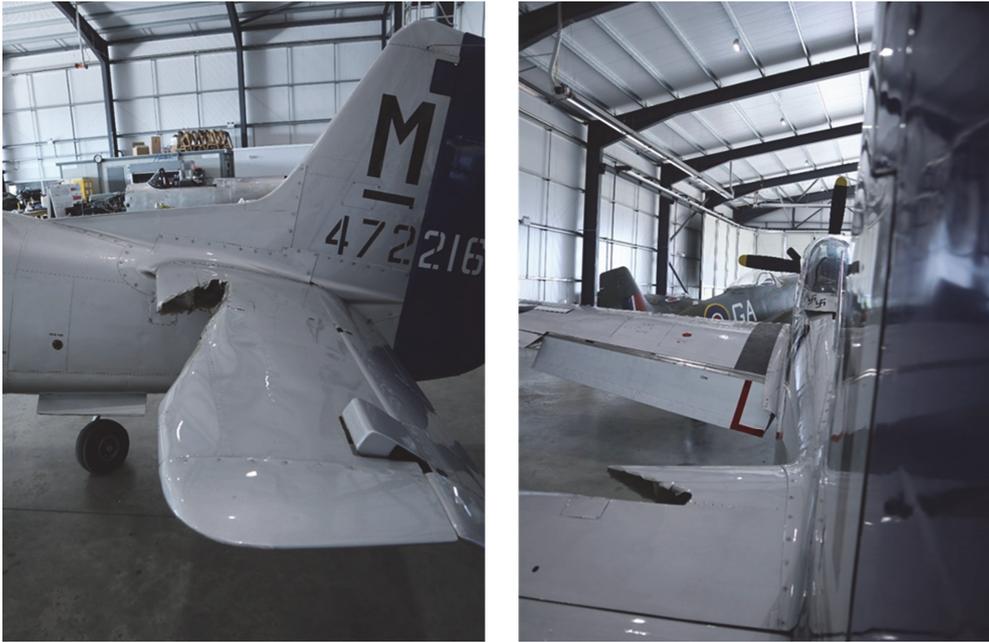
Figure 3

Damage was present on both aircraft from contact between the propeller blades of G-SHWN with the left horizontal stabiliser of G-BIXL (Figures 3 and 4). The blade strike on the horizontal stabiliser was within a few centimetres of the control cables for the elevator trim system, but resulted in structural damage only. The propeller blades all exhibited scuffing to the paint, but no visible structural damage.

Damage to horizontal stabiliser of G-BIXL

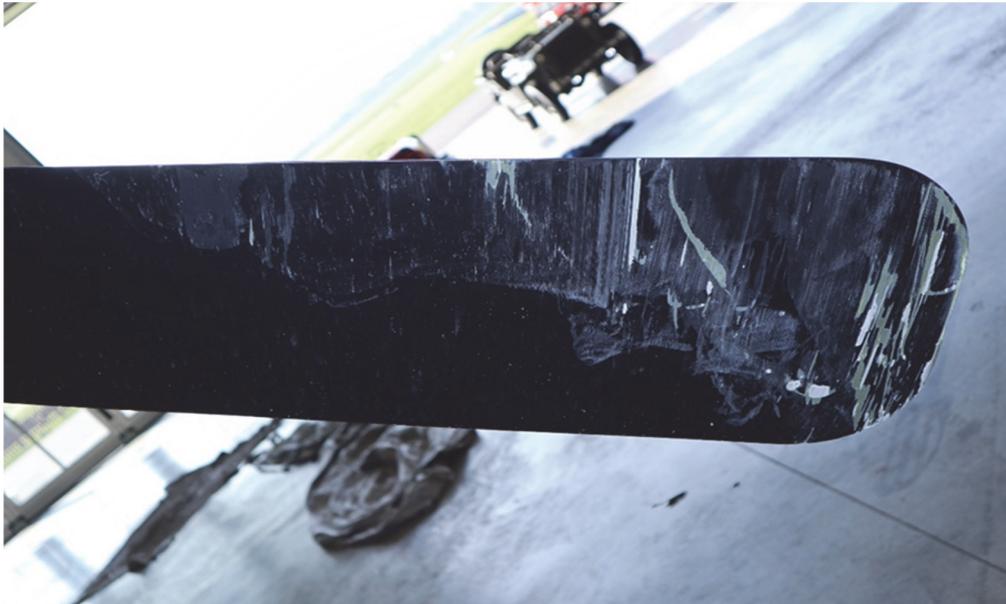
Figure 4

Damage to rear face of G-SHWN propeller blade

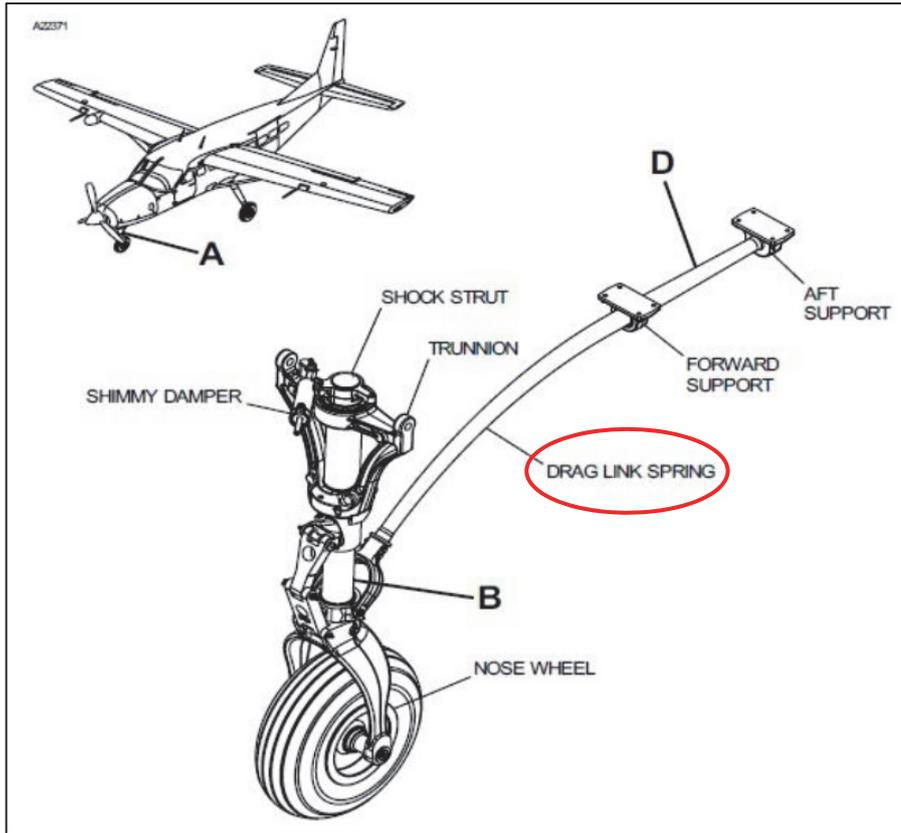
A detailed analysis of the failed part, carried out on behalf of the operator, indicated that the failure was most likely due to damage to the protective coating which had allowed the high-strength steel material to be exposed to moisture. A corrosion fatigue mechanism then led to the crack which resulted in the failure.

Figure 1
General arrangement of nose landing gear

The failure is being dealt with through normal continued airworthiness processes.

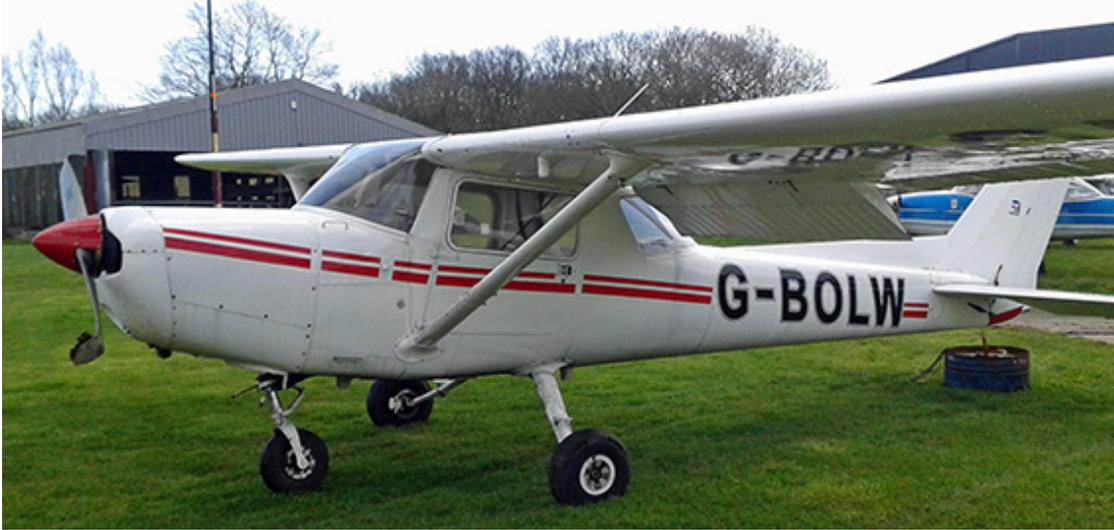
Figure 1

G-BOLW with the nose landing gear angled rearwards and the propeller tips bent

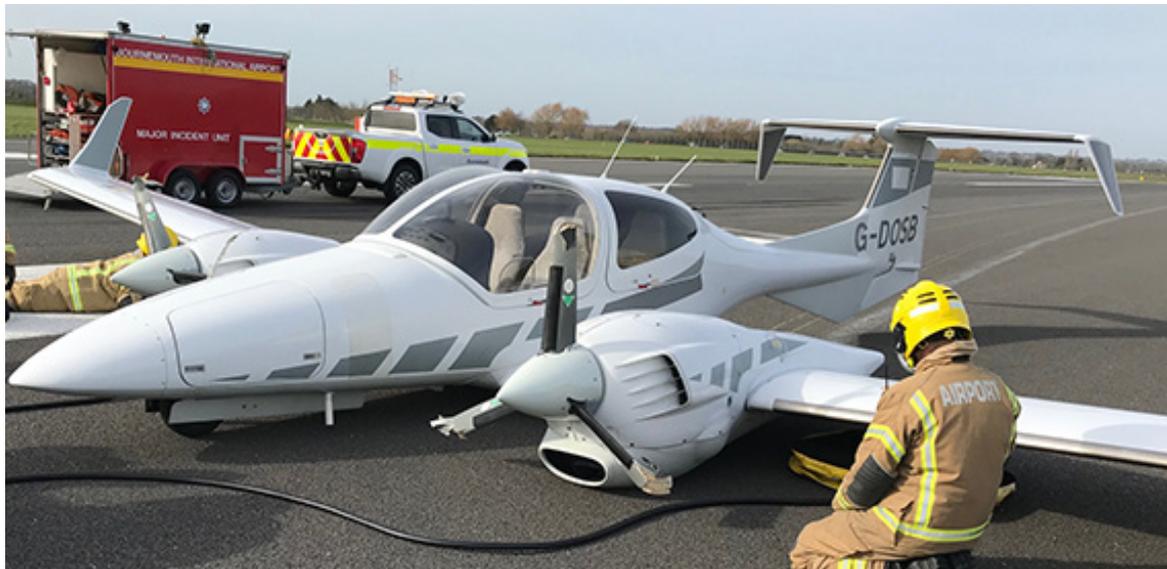
Figure 1

G-DOSB prior to an attempt to raise it using airbags.
The nose landing gear doors are open and the nosewheel appears to rest on the runway

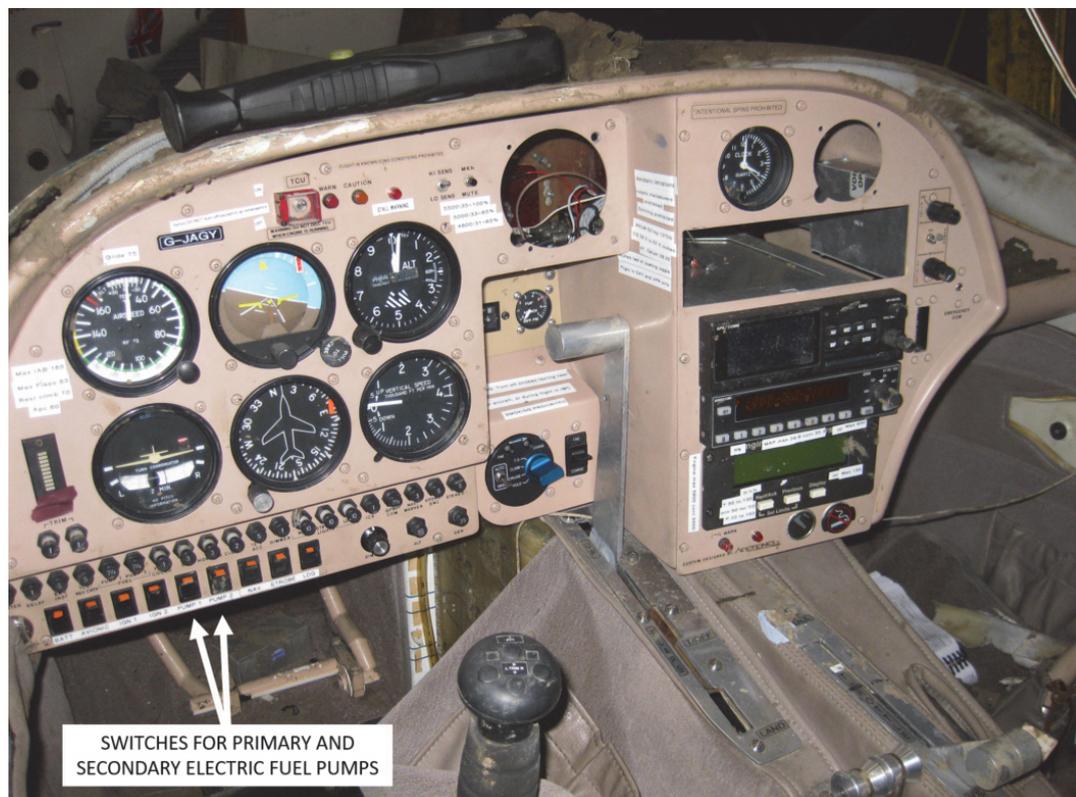
The LAA aircraft examination identified that the aircraft's instrument panel featured switches to control electrical power to each of the aircraft's electric fuel pumps (Figure 2).

Figure 2
Fuel pump switches

This arrangement is contrary to the Europa XS build manual, which requires that the primary electric fuel pump is powered directly from the engine's alternator with overload protection provided by a 5 amp circuit breaker. This design ensures that the primary fuel pump is powered whenever the engine is running.

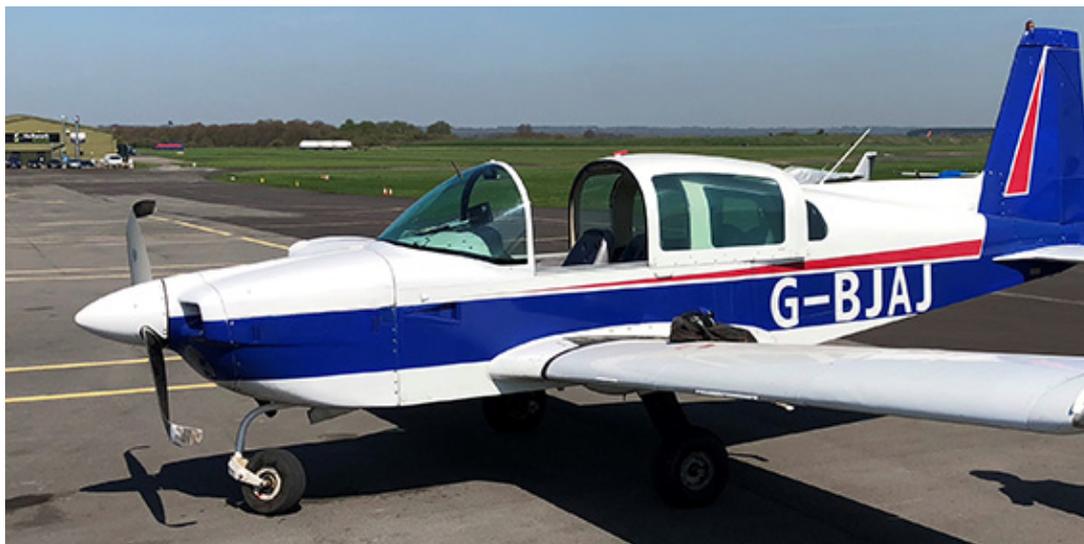
Figure 1

G-BJAJ with damage to the propeller and the nose leg

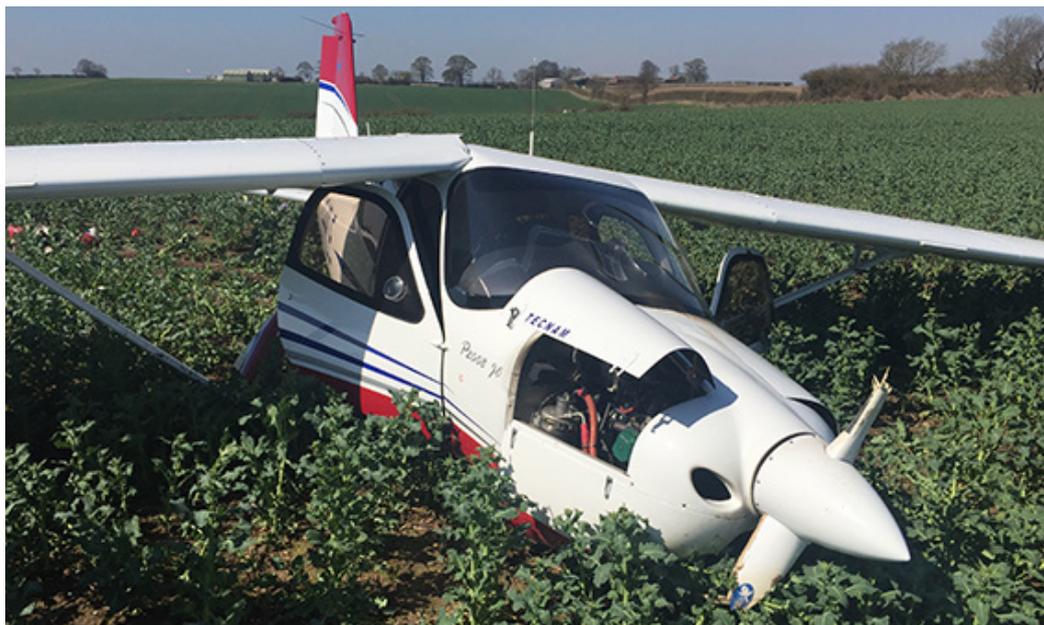
Figure 1

G-HRLE after the accident, with the airfield background left

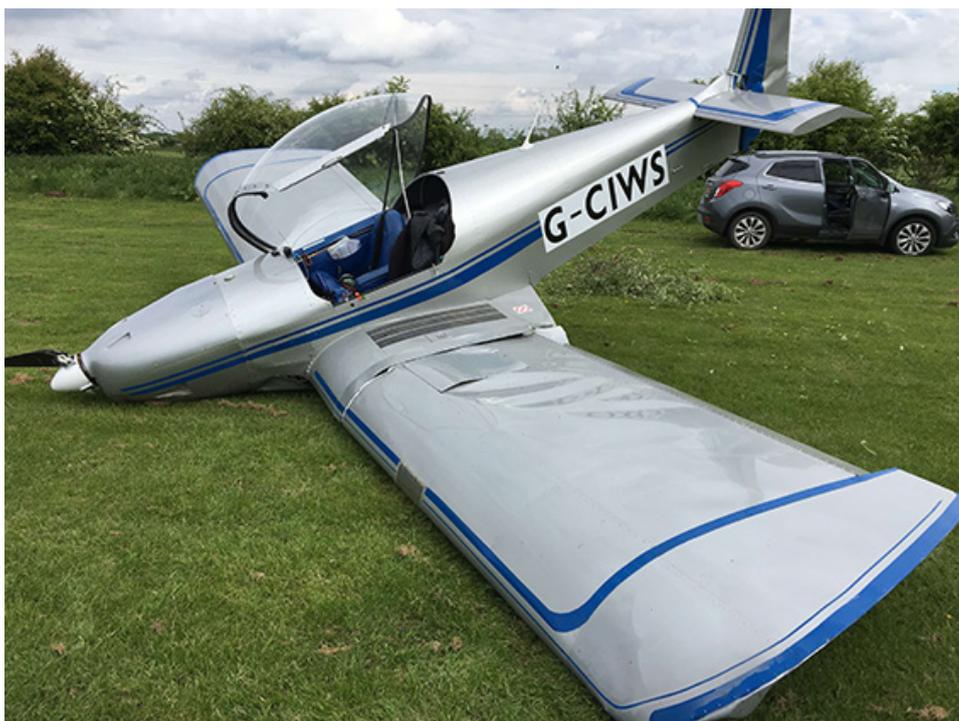
Figure 1

G-CIWS near the vehicle that it missed and with the hedge visible behind
