**PART 1.4 – FINDINGS**

1.4.1 The XZ210 Service Inquiry (SI) was convened on 5 Dec 11 to investigate the circumstances surrounding the loss of a Gütersloh based Army Lynx helicopter and to make recommendations in order to prevent recurrence and enhance air safety. While the main focus for the inquiry's determination of causal factors was on the technical aspects of the accident, a wide range of related issues were investigated to inform the Panel's findings set out in this part of the report. Although the SI Panel was dislocated from the country where the accident occurred throughout the majority of the inquiry, this did not prove a significant hurdle; particularly as the ac remains had been transported to UK for examination.

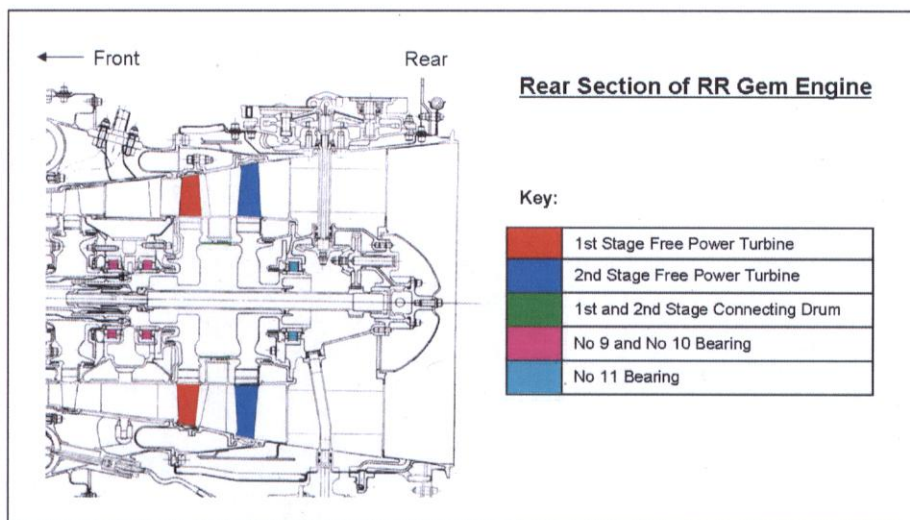
Fig 2 – Rear Section of Gem Engine

1.4.25 **Bang.** The first indication of any malfunction that the crew experienced was a loud bang emanating from above and behind them, on the starboard side of the ac. The preliminary conclusion of the subsequent engineering investigation was that the noise was the result of an FPT breakout from the No2 engine. There was a circular cut through almost the entire circumference of the Module 7 casing and the internal components were visible.

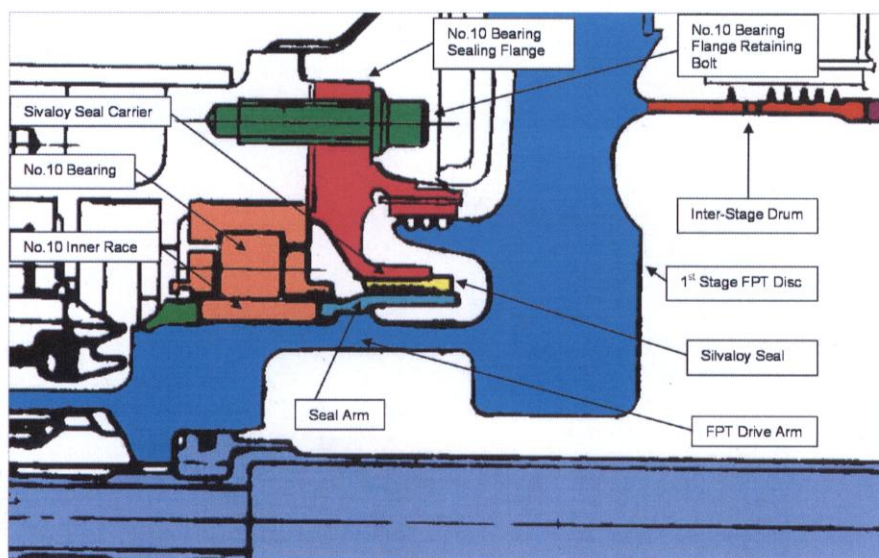
Fig 3 – Close-Up of No10 Bearing Area

1.4.26 Until the FPT failed there had been no indication of impending breakdown of the No2 engine during the sortie. However, the explosive disintegration of the FPT was the final event in the failure sequence which may have started a relatively short time before, perhaps mins or secs. After discounting the possibility of engine control, lubrication system, foreign object damage, Module 1, bearings forward of Module 7 and drive shaft failures as catalysts for the start of the failure sequence, the Module 7 was examined more closely.

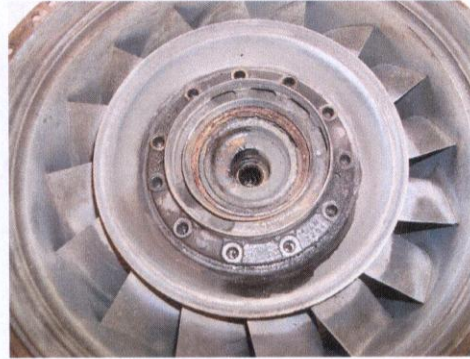
Fig 5 - No10 Bearing Flange (with Air Baffle removed)

- a. **No10 Bearing Sealing Flange Retaining Bolts.** The first part of the sequence initiated within the Module 7 whereby all 11 of the No10 bearing sealing flange retaining bolts had loosened over a long period of time (up to 1530 hrs). This allowed a micro-movement of the No10 bearing sealing flange causing a significant contact rub between the sivaloy seal and seal arm. The rub led to the subsequent mechanical failure of the sivaloy seal carrier location welds and an increased frictional distress in this area. This in turn generated significant heating which manifested itself at its most intense where the seal arm was attached to the FPT drive arm in the vicinity

of the No10 bearing inner race. As a result, the seal arm and No10 bearing inner race started to slip on the FPT drive arm, generating even more heat, leading to the eventual failure of the FPT drive arm under torsional load, disconnecting it from the Module 2 FPT shaft.

1.4.29 Subsequent action in Jul 12 by RR (under Service Engineering Instruction (SEI) Gem 0125) instigated a torque check of the eleven No10 bearing sealing flange retaining bolts and an inspection for any physical evidence of the silvaloy seal touching or rubbing before any work is carried out on a Module 7.

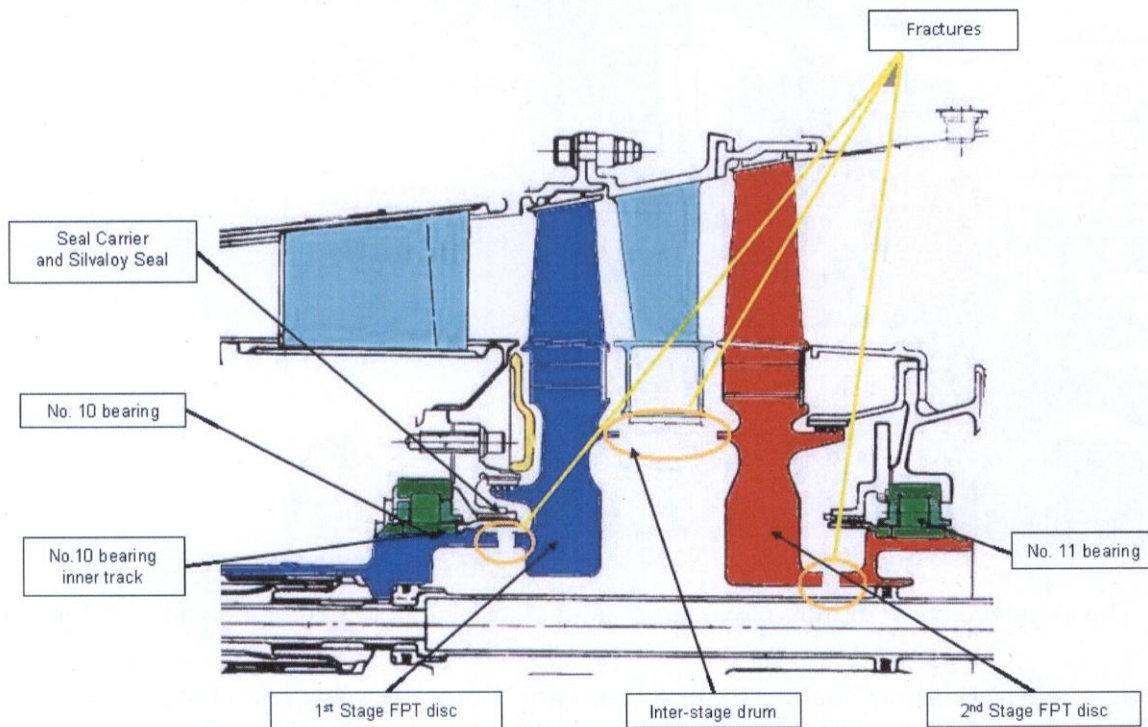
Fig 6 - Fractures within the XZ210 Module 7

b. **Drive Arm Failure.** The second part of the sequence started immediately after the drive arm failed allowing the now unloaded FPT to rapidly accelerate into an overspeed condition. The centrifugal load on the 2<sup>nd</sup> stage FPT blades was such that all of the blades failed in the aerofoil section above the fir tree root. They were then released radially outwards with enough explosive energy to cut through the Module 7 casing and further damage components within their trajectory.

1.4.28 The Panel concluded that the bang was caused by the mechanical failure of the FPT assembly on the No2 (starboard) engine and the subsequent 'shedding' of the blades from the 2<sup>nd</sup> stage FPT disc due to an overspeed. The noise heard in the cabin and cockpit was the 2<sup>nd</sup> stage FPT aerofoil sections exiting through the circumference of the engine casing. However, this was a symptom of the initiating failure whose origin was traced to a gradual de-torque or loosening of the eleven No10 bearing sealing

flange retaining bolts over a period of up to 1530 flying hrs. The Panel found that the loosening of the retaining bolts on the No10 bearing sealing flange which resulted in the failure of the FPT drive arm and subsequent FPT overspeed was the **cause**.
