**RANGE ADVICE NOTE 2/09**

Date: Jan 09

**AKAMAS CONTROL MEASURES.**

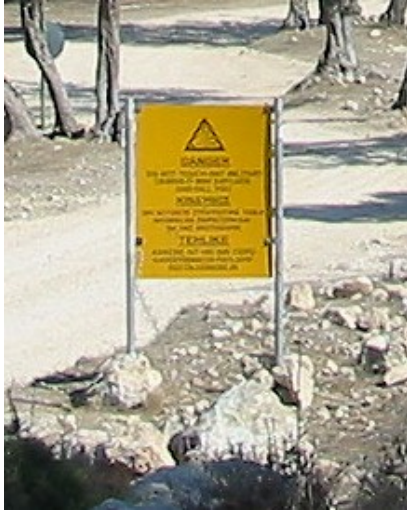
### Suggested RDA boundary warning sign in line with JSP 403 Vol.2

(Safety Symbols are regulated by the European Safety signs Directive 92/58/EEC.)

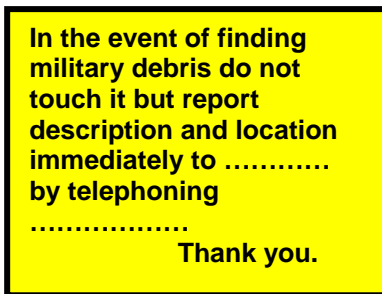
a. **Warning signs.** The current signs provide effective warning but do not conform entirely to current EU Safety signs as set out in JSP 403. See attached clarification relating to the prominence of the Safety Symbol. The size and number of signs / notices will be a matter of balance between the predicted hazard (J3 Trg. based on frequency and density of any UXO finds) and the wishes of those who manage the country park. Local DE can assist with the liaison in this area. As a minimum, all main entry points onto the area F3 should be signed. There is no contact information displayed for the public who might find UXO. HQ BFC should maintain a central reporting point where locating and clearing UXO can be effectively implemented. All finds should be plotted on a master map to assist in determining potential “hot spots” for further clearance work.

Existing signs on Akamas.

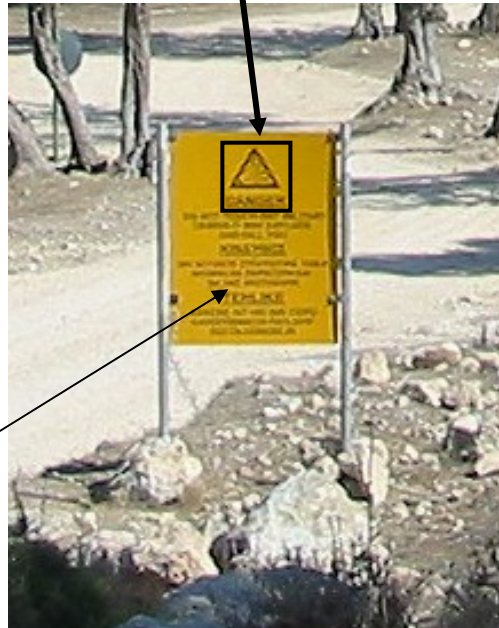
Safety Signs with the symbol representing 50% or more of the sign.

Suggested modified sign with box around the Symbol and "DANGER".
