Marine Management Organisation

Under 10 metre remote electronic monitoring technical trial

June 2013

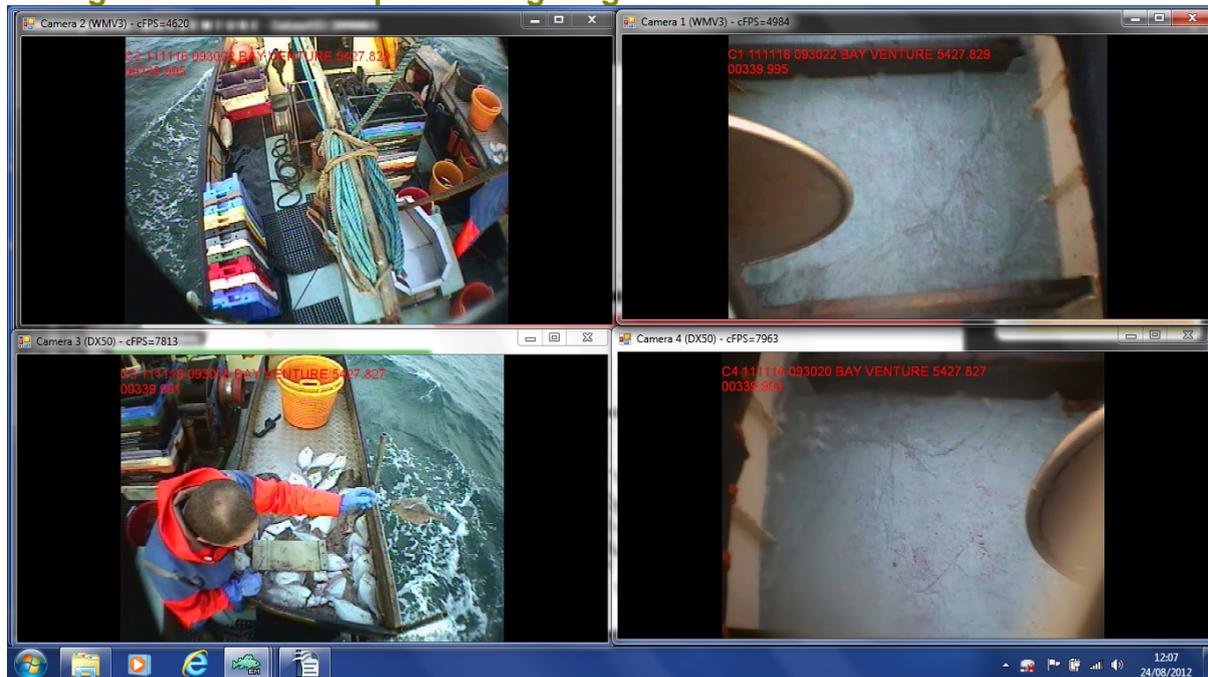
Figure 3 shows the camera views for all four cameras installed on the Bay Venture and the image for C3 clearly shows a crewman discarding a plaice during the gutting process. Figure 4 shows the difference between the catch compositions of the two different codends being trialled by Cefas.

Figure 3: The camera views for the Bay Venture with imagery of discarding during the retained fish processing stage

- Camera 1 (C1) was set up to view the port side pound in the stern of the vessel.
- Camera 2 (C2) shows an overview of the starboard side of the vessel to look down inside the baskets of retained fish.
- Camera 3 (C3) shows the port side of the vessel and the metal table where the retained fish are gutted.
- Camera 4 (C4) shows the starboard side of the pound at the stern of the vessel.

The two stern cameras (C1 and C4) provide a good view of the pounds and how it is divided in two. They also provide a good view of the net drums and can easily discern when the nets are stored on board on the drum. This provides good information on whether the vessel is fishing or not. When the vessel has hauled the nets on board, the codends can be seen being emptied into the pounds.

Viewing the processing of the retained fish is excellent and C3 can provide an opportunity for a full individual count of fish during the gutting process. This same camera provides an excellent view of any discarding of undersize or damaged fish identified by the crew at the gutting stage. However, when the retained fish are thrown into baskets it is difficult to get a volume estimate of partially filled baskets or the total baskets of retained catch for the trip.

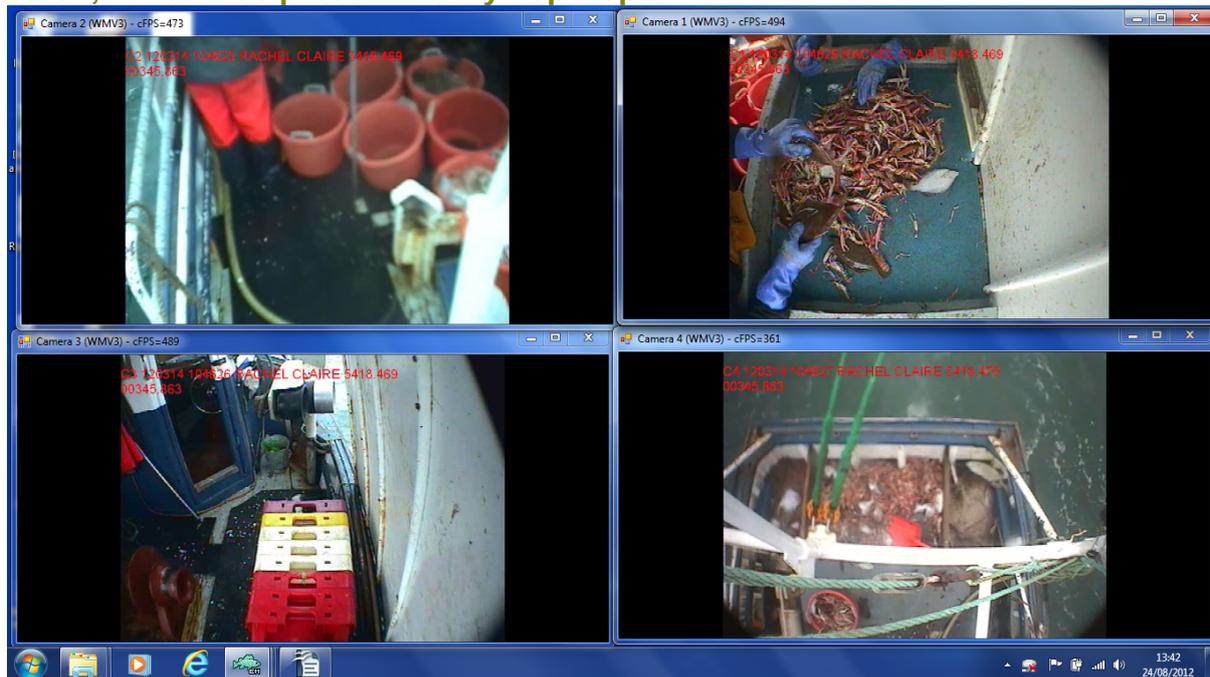
Figure 5 shows the camera views for all four cameras as displayed by EMI Pro software and the crew can be seen tailing nephrops on a sorting table, with catch in the fish pound at the stern of the vessel. The crew also select out fish for retaining at this stage and discard nephrops heads and small unwanted finfish straight through a scupper in the shelter deck at table level.

Figure 5: Rachel Claire camera views with imagery of the crew processing the catch, which was predominantly nephrops

C4 gives an excellent view of the stern of the vessel and all trawl activity can be clearly viewed, especially the trawl doors coming in and out. It also affords a clear view of the codends being emptied on board the vessel. A total bulk estimate could be made if required. The crew can clearly be seen shovelling the catch into baskets for processing on the sorting table or removing larger fish into separate baskets. Any discarding by hand can be observed at this stage but speciation would be difficult at this stage except for very large individual fish.

When the basketed catch is sorted on the table all species can clearly be identified and a good count of discarded and retained fish can be made at this stage. During gutting all species can be counted and identified. However, obtaining a volume of discarded and retained fish is not as easy. C2 does give an overview of where the retained catch is stored but it is difficult to see into part filled baskets to obtain volume or weight estimates, unless the baskets are almost full.

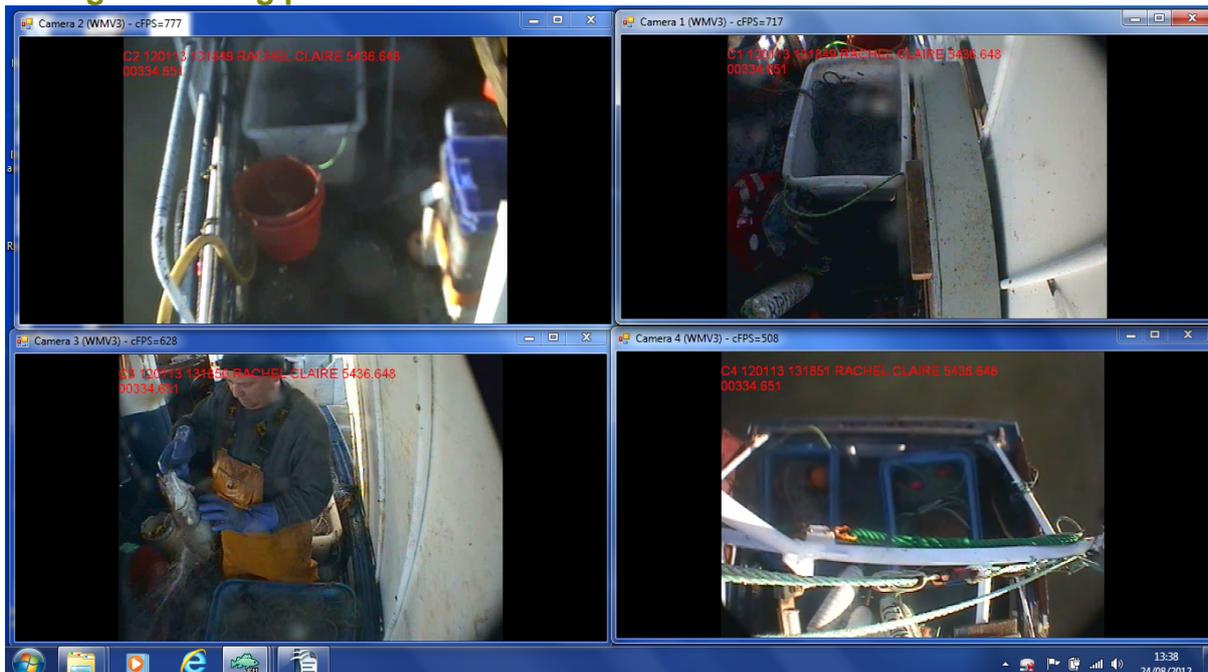
During the gill netting process the net is flaked between two large containers and this is when the crew usually extract the fish from the net, by hand. C1 and C3 allow this process to be observed, as shown in Figure 7. It is possible to see most of the fish being removed from the nets but again this could be improved with some minor camera adjustments.

Figure 7: The crew extracting a cod from a gill net on board the Rachel Claire, during the flaking process

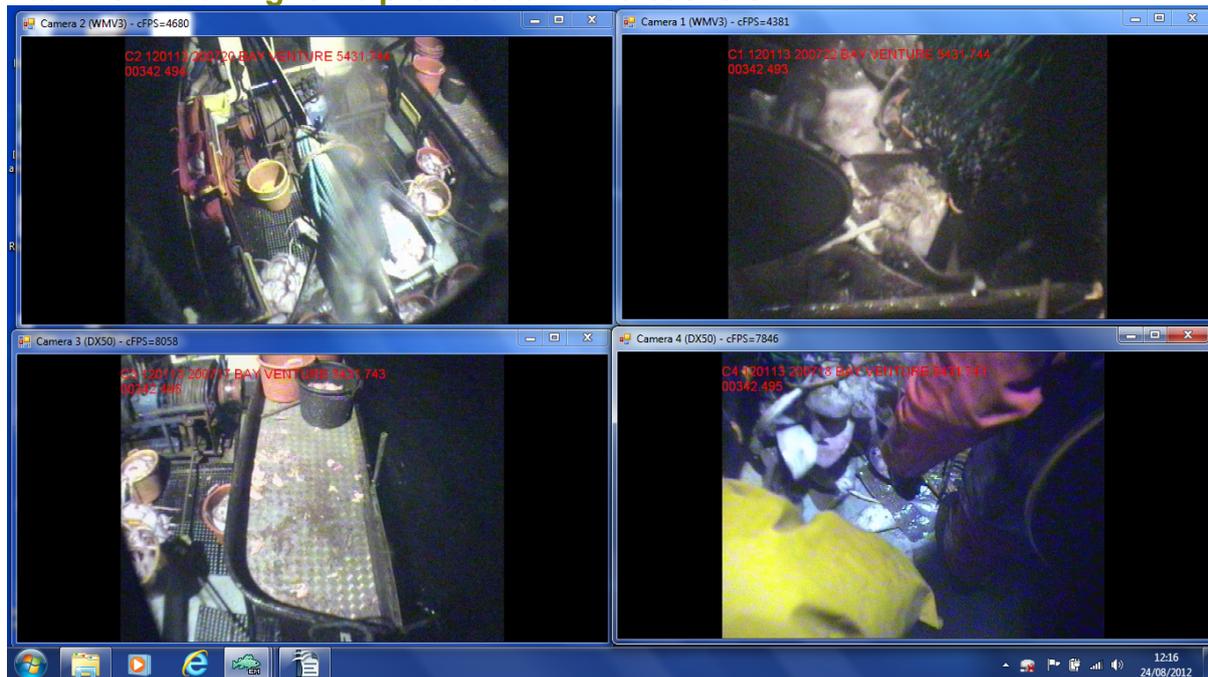
It is interesting to note that the skipper's estimate for rays, 274.4 kg of retained mixed ray, was almost identical to the analyst's estimate of 275 kg, despite the large quantity caught and the difficulties associated with the two hauls being handled together. The skipper split this almost equally across both hauls whereas the analyst had to process the hauls together because of the way the crew handled the catch – there were a lot of rays caught on haul 4 and these had not been completely processed before more rays from haul 5 were retained and mixed together with those from haul 4. This can be seen in Figure 8. It was observed from the video footage that the rays were not caught in equal weights for each haul and most were retained on the haul 4.

Figure 8: Additional rays being caught on haul 5 with the retained rays from haul 4 still waiting to be processed in the baskets
