## Appraisal of river restoration effectiveness: Seven Hatches case study

Report – SC070024/a

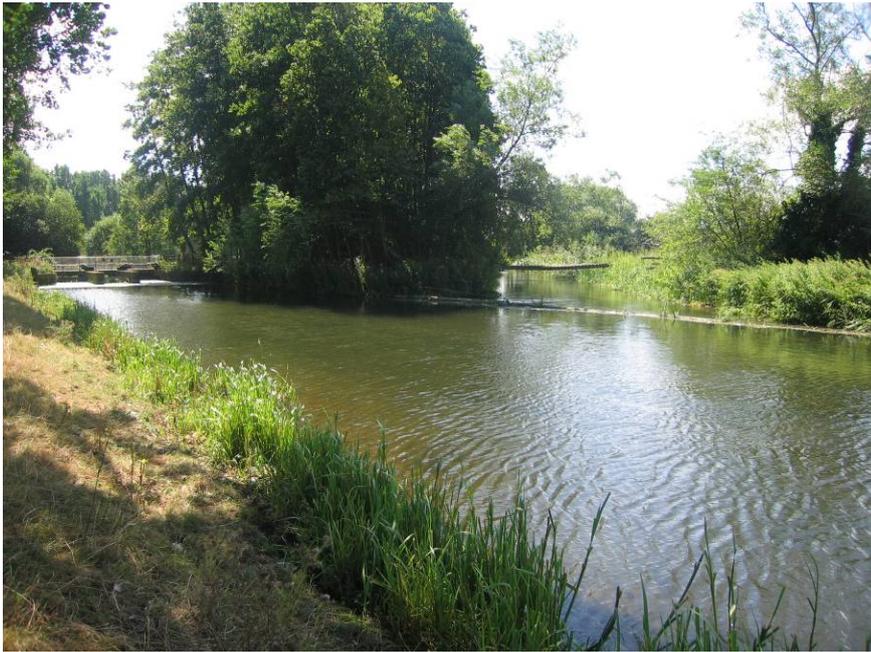
**Figure 2.3 Impoundment upstream of Seven Hatches**

local name are impounding upstream water levels with associated deposition of fine sediments (Figure 2.3).

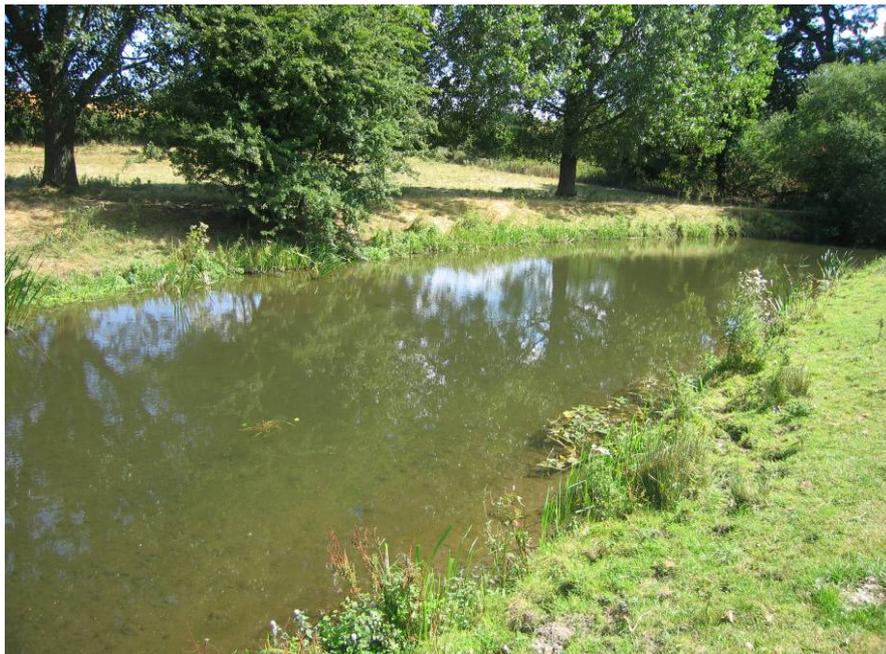
**Figure 2.4 Slow uniform flow conditions due to historical modifications**

The slower flows (Figure 2.4) and resulting siltation from the impoundment and historical land drainage had damaged favourable status for the *Ranunculus* macrophyte community and resulted in the absence of salmon spawning (RRC 2009).

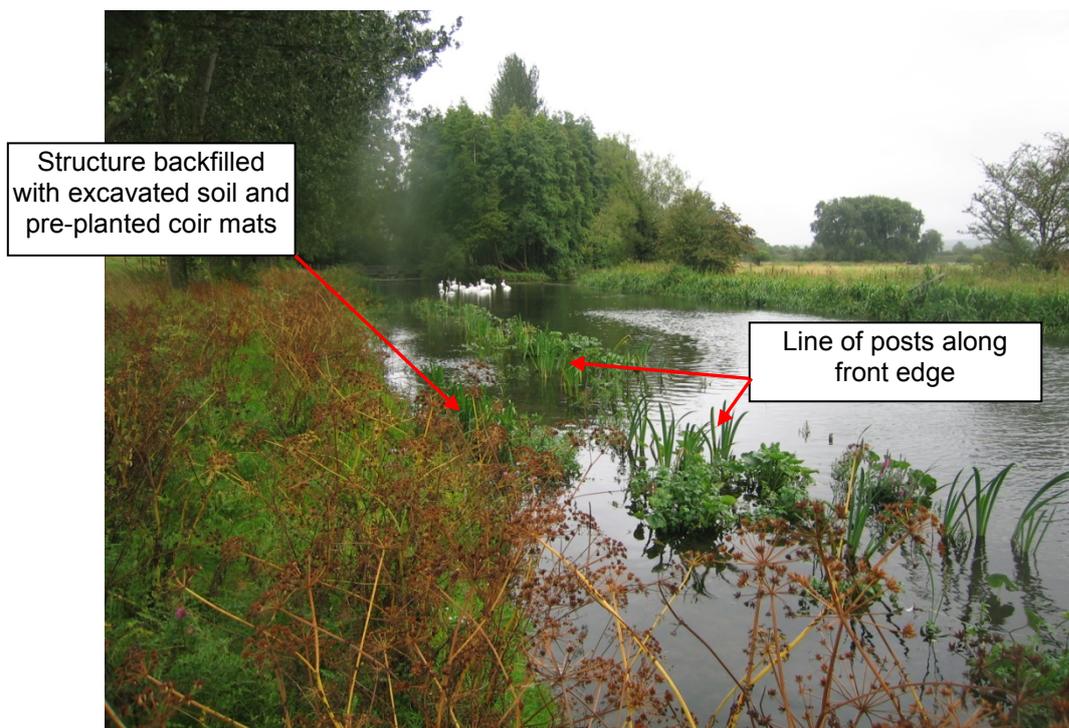
**Figure 3.1 Channel narrowing berm in 2008 (one year after installation)**

structure and soil was used to backfill the structure. The brushwood and soil were then topped off with pre-planted coir mats and the whole structure was cross-wired together. The coir mats had been planted with reed canary grass, water mint, yellow flag, water parsnip and marsh marigold. The deflectors narrowed the channel by 3–3.5m.

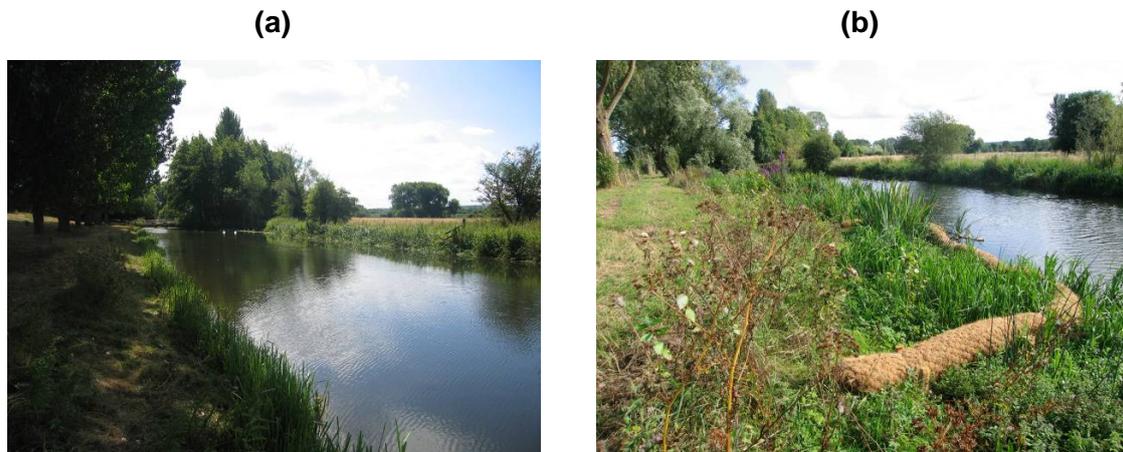
The photographs in Figure 3.2 were taken upstream of Seven Hatches and show the berm constructed to narrow the channel. The berm has become colonised by emergent vegetation and is likely to be increasing flow velocities in this section of the reach.

**Figure 3.2 Upstream of Seven Hatches (a) before (2006) and (b) after (2009) construction of beam to narrow the channel**

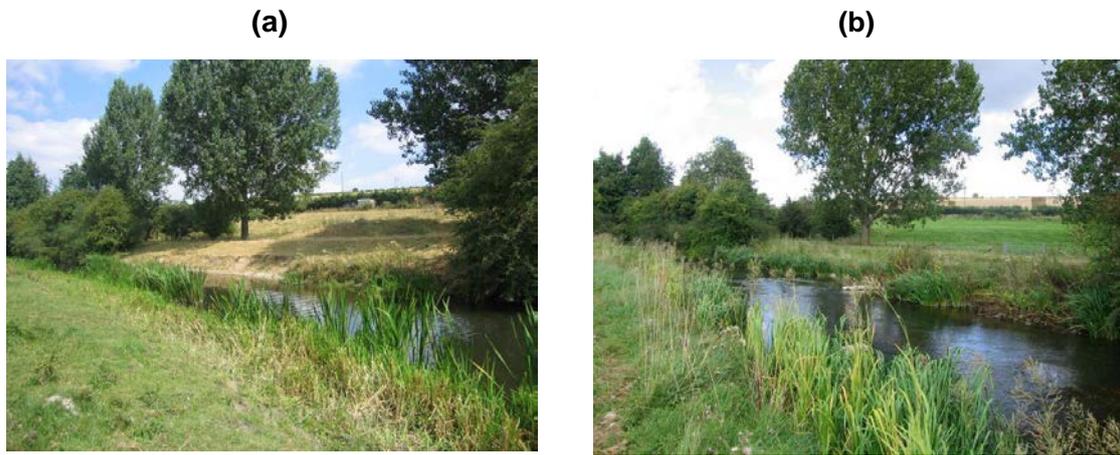
The photographs in Figure 3.3 show a section of the reach where a gravel riffle has been constructed. The flow was slow and uniform pre-restoration (Figure 3.3a), but post-restoration, flow depth has decreased and localised velocities have increased, creating more diverse morphological conditions (Figure 3.3b).

**Figure 3.3 Downstream of Seven Hatches (a) before (2006) and (b) after (2009) construction of a gravel riffle**

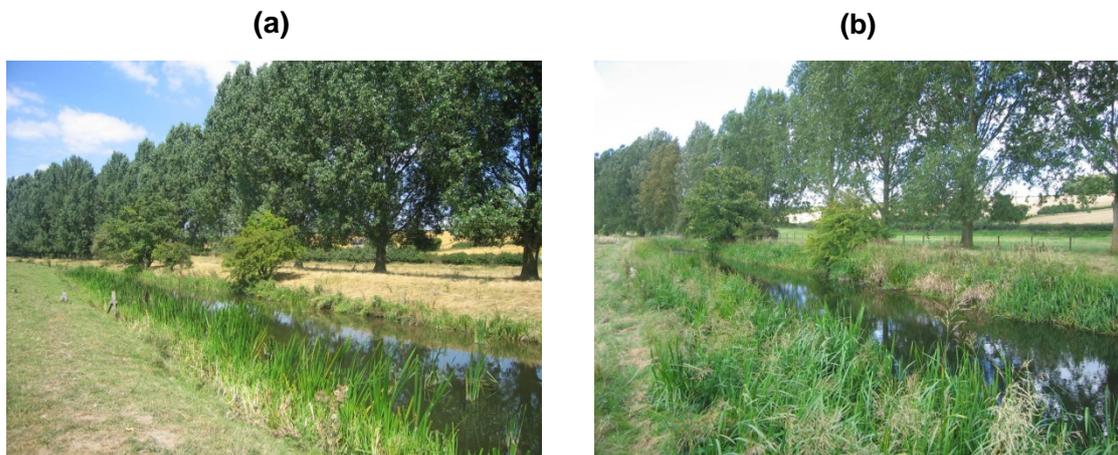
Figure 3.4 shows the increase in emergent vegetation at the channel margins between 2006 and 2009. There was also an increase during this period in the height of riparian vegetation in response to restricting livestock access.

**Figure 3.4 Extent of emergent vegetation at the channel margins downstream of Seven Hatches (a) before (2006) and (b) after restoration (2009)**
