Appraisal of river restoration effectiveness: Seven Hatches monitoring report

Report – SC070024/b

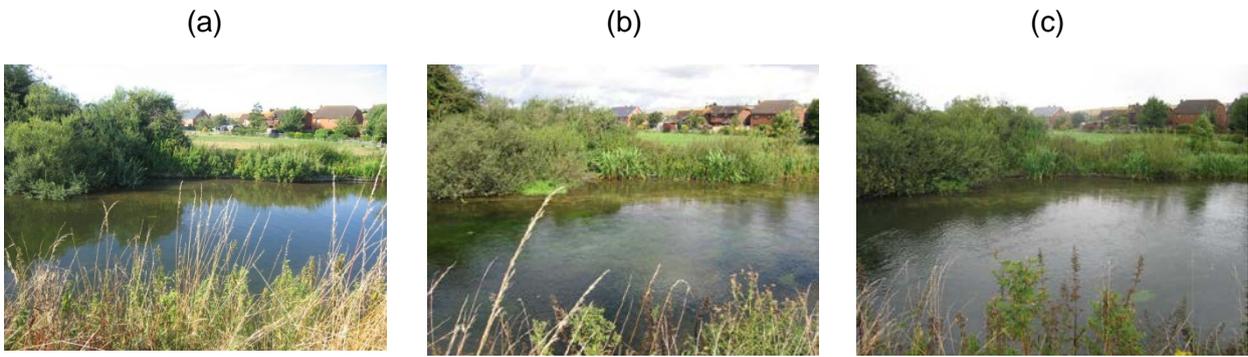
Figure 5.1 Control site in (a) 2006, (b) 2008 and (c) 2009

Comparison of the physical biotope mapping (Appendix B) confirms that the overall flow type remains the same, with much of the reach characterised as a glide with a riffle at the upstream end. Minor changes in flow velocities such as those evident from direct velocity measurements are not identifiable from these data. However, they are more evident in repeat photographs of the site as shown in Figure 5.1. These photographs show that the predominant glide flow type remains in each year. However, flow in 2008 and 2009 is rippled rather than of the uniform nature in 2006. A proportion of this increased surface rippling could be attributable to changes in localised weather conditions at the time of sampling (for example, increased wind shear on the water surface). However, this is also likely to indicate that flow velocity is higher, as shown by the velocity measurements, as a result of higher flow levels rather than because of changes in the channel form.

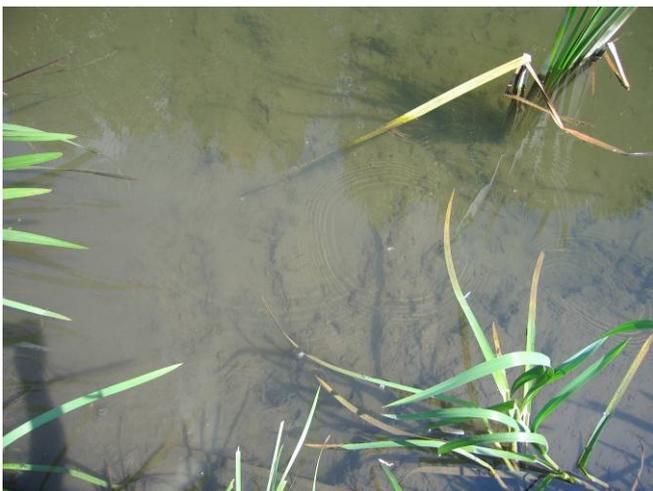
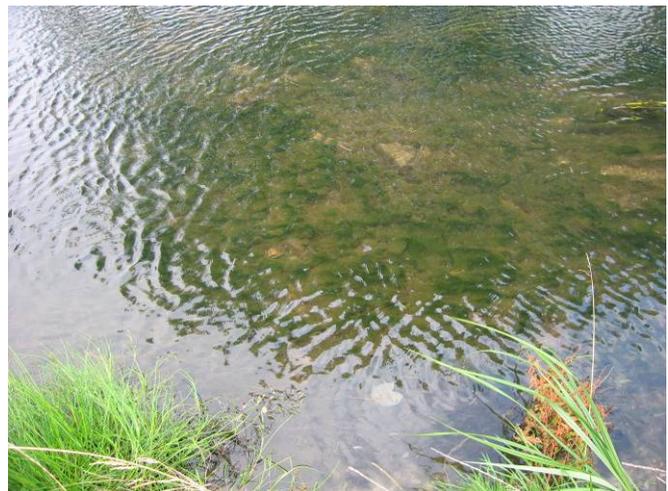
Figure 5.3 Channel margin at MS03 in (a) 2006 and (b) 2008

This may be related to increased transport of fine sediment as a result of higher discharge and flow velocities, as well as the restoration measures themselves. However, it is not possible to conclusively separate these influences with the data currently available. Flow data are limited to single sets of measurements for each year and as such are only representative of conditions at the time of sampling rather than longer term trends. Cobble substrate was noted within the riffle locations in 2008; this is likely to be large material imported during the restoration works that has become exposed as increased flow velocities have entrained the overlying gravel material.

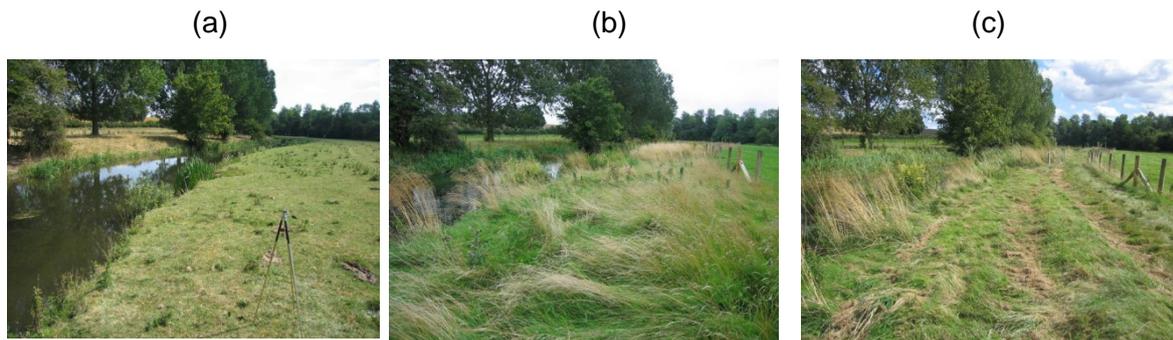
Figure 5.5 Riparian vegetation in (a) 2006, (b) 2008 and (c) 2009

increased coverage and indicate that there is a general increase in the height of the riparian vegetation, particularly of the nettles on the right hand bank. This increase is likely to be a result of natural vegetation growth in the period between surveys which has potentially been enhanced by the spread of fertiliser from the adjacent agricultural land use.

At the restoration site, overall riparian vegetation cover is less than at the control site, but does show an increase between 2006 and 2009. The species present in 2009 consist only of grasses, with some planted willow saplings. The reason for the lower overall coverage in 2006 is that, unlike at the control site, the floodplain in the restoration reach was used for agricultural grazing and livestock had unrestricted access to the bank top and water's edge. This grazing resulted in a lack of cover and low diversity of species. One element of the restoration work was to install a fence approximately 10 m from the bank top to prevent livestock access and to create a buffer strip where riparian vegetation could become established. This accounts for the increase in overall vegetation cover in 2008 and 2009. The increase in overall coverage is relatively modest as a result of the timescales over which monitoring was undertaken. Continued increase in vegetation coverage would be expected in the future as vegetation becomes more established and widespread. Repeat photography of the buffer strip is shown in Figure 5.5. The 2008 photograph clearly shows that the height and coverage of vegetation has increased significantly as a result of these works. The photograph from 2009 shows that the buffer strip had recently been mown as part of ongoing maintenance. The height and coverage of vegetation has therefore temporarily decreased but overtime will quickly return to the extent seen in 2008.

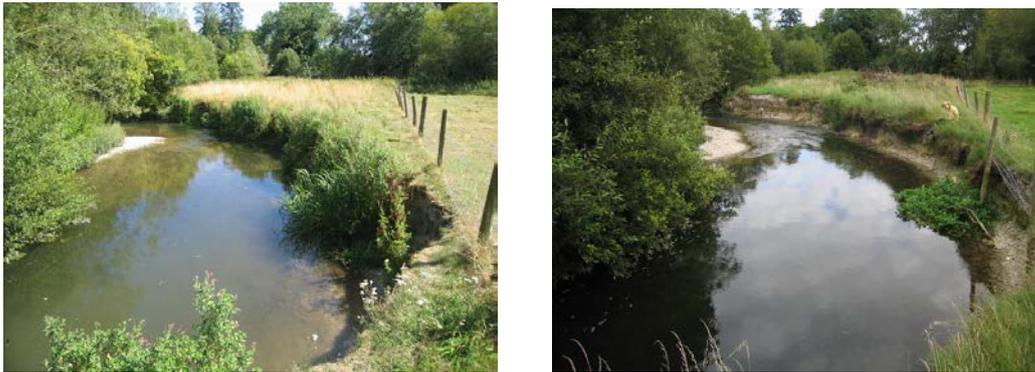
Figure 5.7 Bank retreat in the restoration reach in (a) 2006 and (b) 2009

At the restoration site, analysis of physical biotope mapping shows that several in-channel features were present pre-restoration, primarily downstream of the railway bridge. This included two gravel bars on the left hand bank immediately downstream of the railway bridge, silt deposition further downstream, and bank erosion and scour in localised areas. All these features remain in the subsequent surveys in 2008 and 2009, with the exception of one of the gravel bars. It is likely that this was washed away during high flows. No additional in-channel features were recorded in 2008 or 2009. Erosion and scour has continued and the bank has retreated since 2006, as shown in Figure 5.7.

In the upstream section of the reach, no in-channel features were recorded pre-restoration. In-channel features were created during the restoration work through the introduction of gravel, but no additional features were recorded in the areas between the riffles.
