## Appraisal of river restoration effectiveness: Shopham Loop case study

Report – SC070024/c

The case study featured Shopham Loop on the River Rother in West Sussex which was restored in 2004. Historical modification of the River Rother for navigational purposes resulted in the creation of a canal cut at Shopham. Over the years, the former course of the river, a large meander loop, has become cut off and the canal cut has become the preferential course of the river. The restoration scheme involved:

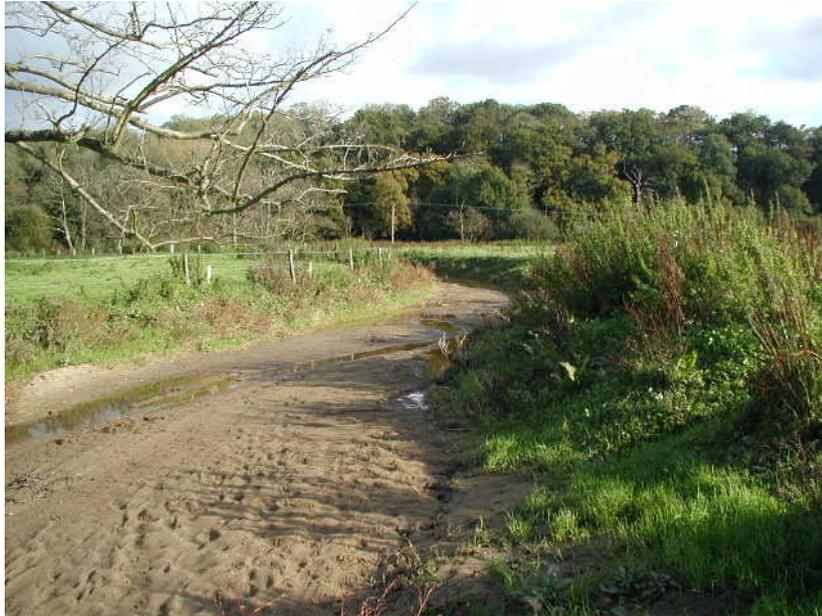
from the canal cut due to large deposits of sand and silt that were derived from the occasional flood flows (Figure 2.3).

**Figure 2.3 Sand deposited in the upstream end of the meander loop**

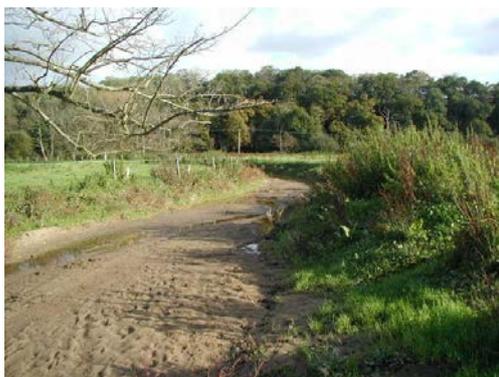
Figure 3.4 shows the upstream end of the meander loop before restoration and indicates the extent to which sand deposition had cut off the meander. The riffle created at the upstream end of the meander, which is acting as a bed control to prevent headward recession, is shown in Figure 3.5.

**Figure 3.4 Upstream end of meander loop showing sand deposition and lack of flow pre-restoration**

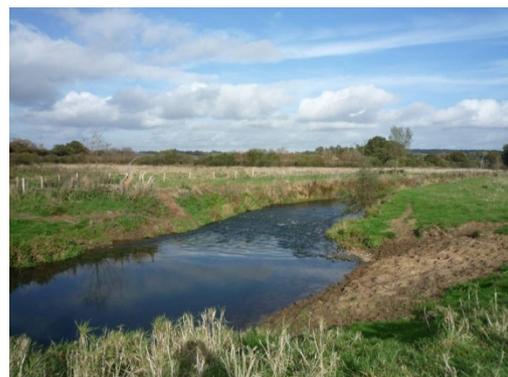
**Figure 3.5 Riffle/ford at upstream end of the meander loop post-restoration**

- **Increased variability in velocity and diversity of flow types.** The installation of bed controls at the upstream and downstream ends of the loop has created gravel riffles which display fast, shallow flow – conditions that were not present in the loop pre-restoration.

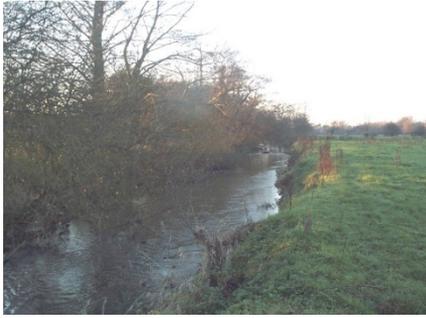
Figures 3.6, 3.7 and 3.8 show the canal cut pre-restoration, during construction of the bund and post-restoration respectively. The bund was constructed just upstream of the old lock and consists of sand and clay excavated from the meander loop and the Haslingbourne Stream.

**Figure 3.6 Canal cut pre-restoration**

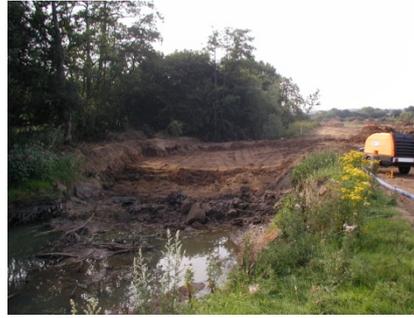
**Figure 3.7 Construction of bund in canal cut**

The earth bund was constructed to a height that prevents overtopping in flood events. The existing earth embankment was also increased to the same height. The rationale for this was that water levels in the canal would rise rather than flow, causing silt deposition in the cut rather than in the downstream catchment. In addition, degradation of the existing embankment would have continued due to scour when floodwaters overtop. The bund and the embankment were constructed to 8 m above ordnance datum (AOD) to prevent frequent overtopping.

The clay, silt and sand acquired during works to the meander loop and the diversion of Haslingbourne Stream were used to construct the bund and to raise the embankment. This reuse of material was considered very beneficial and it is recommended that a similar policy is adopted for future schemes. Importation of materials was minimised and no material was transported offsite for disposal.

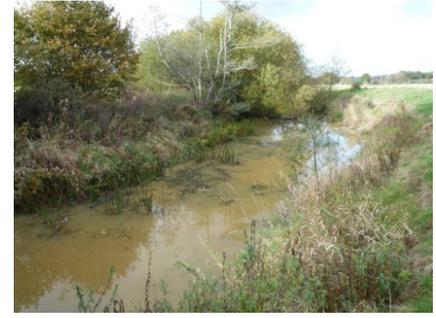
**Figure 3.8 Canal cut acting as a backwater (post-restoration)**

The canal cut is providing suitable habitat for a range of fish species including perch, rudd, tench, pike, eel and bream. A large number of roach fry were netted at the upstream end of the canal cut, which is a positive indication given that observed roach catches are consistently less than expected in the catchment.
