BRE Report

In-situ measurements of wall U-values in English housing

Prepared for: Alex Boss, DECC

Output Number: 290-102

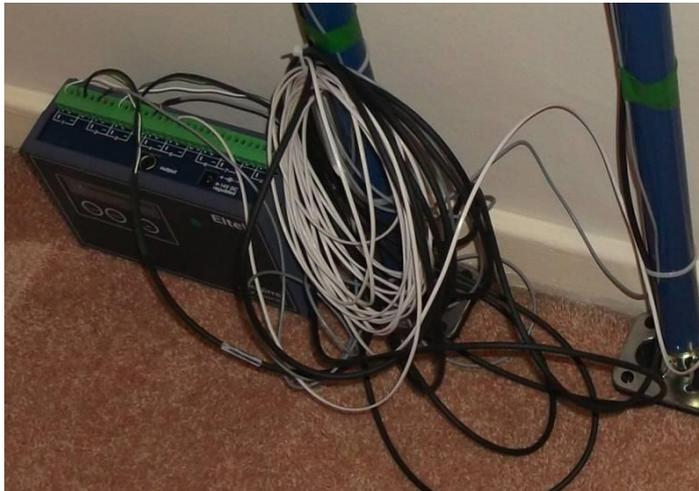
Figure 3 - An Eltek 851L datalogger, recording EMF and thermistor readings from the sensing equipment

Data from the HFPs and the thermistors were recorded using an 8-channel Eltek 851L logger. This is shown in Figure 3.

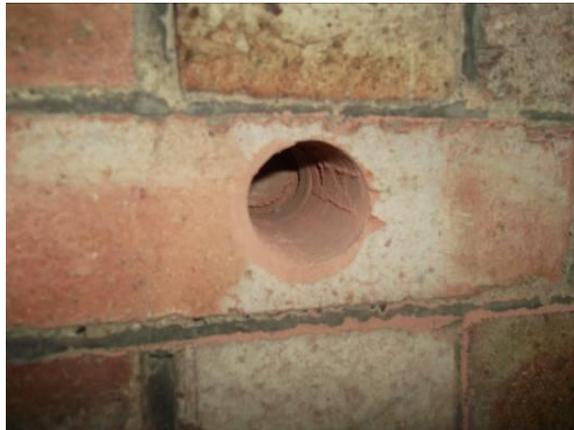
Figure 5: An area where a core sample was taken. The gap between the inner and outer stretchers is just discernible as a shadow at the back of the bore hole.

The core samples were removed from outer stretchers, and taken to laboratories at BRE to be measured and weighed to determine the brick density. They were subsequently replaced in the walls and damage to the wall repaired. The removal of brick cores also allowed the examination of the interface between the outer stretchers and the corresponding inner stretchers. For each core sample, notes were taken regarding whether the space between the inner stretchers and outer stretchers was filled with air or with

mortar and the distance between the inner and outer stretchers was noted. An example of a wall which a core sample has been taken from is shown in Figure 5.
