RAIB Bulletin 05/2011

Passenger train collision with car on user worked crossing, Wensleydale Railway, 1 August 2011

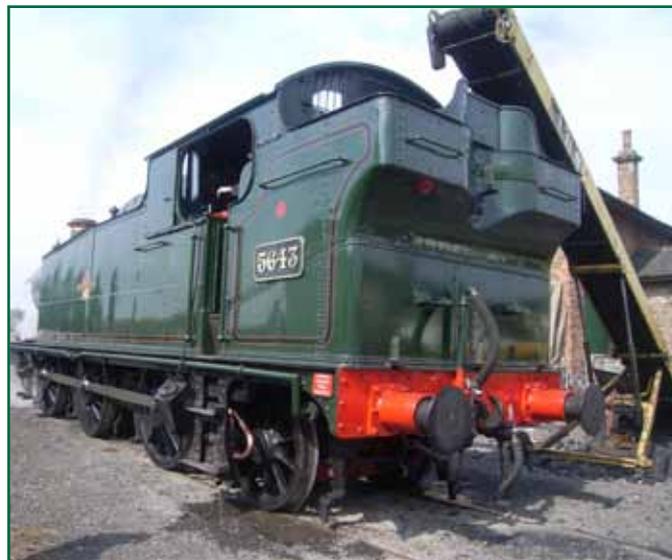
Figure 1: The locomotive involved in the collision

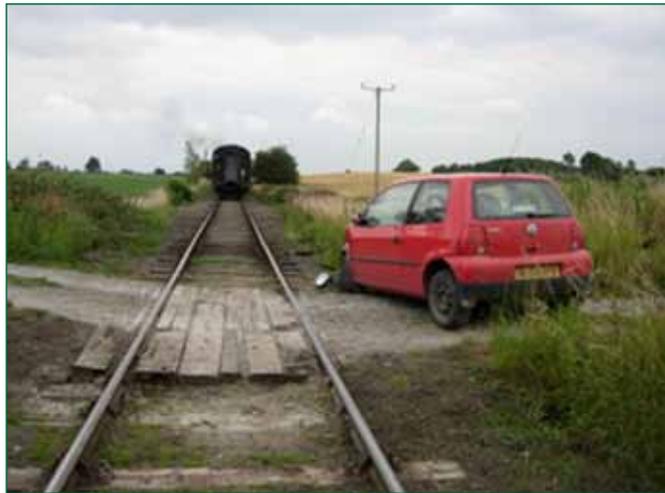
- 3 The car driver reported that he was edging out onto the crossing trying to see if the line was clear when the train appeared from behind the vegetation. The train struck the front of the car and the car was pulled to one side as it made further contact with the side of the locomotive and the first coach.

Figure 2: The accident site (photo courtesy of BTP)

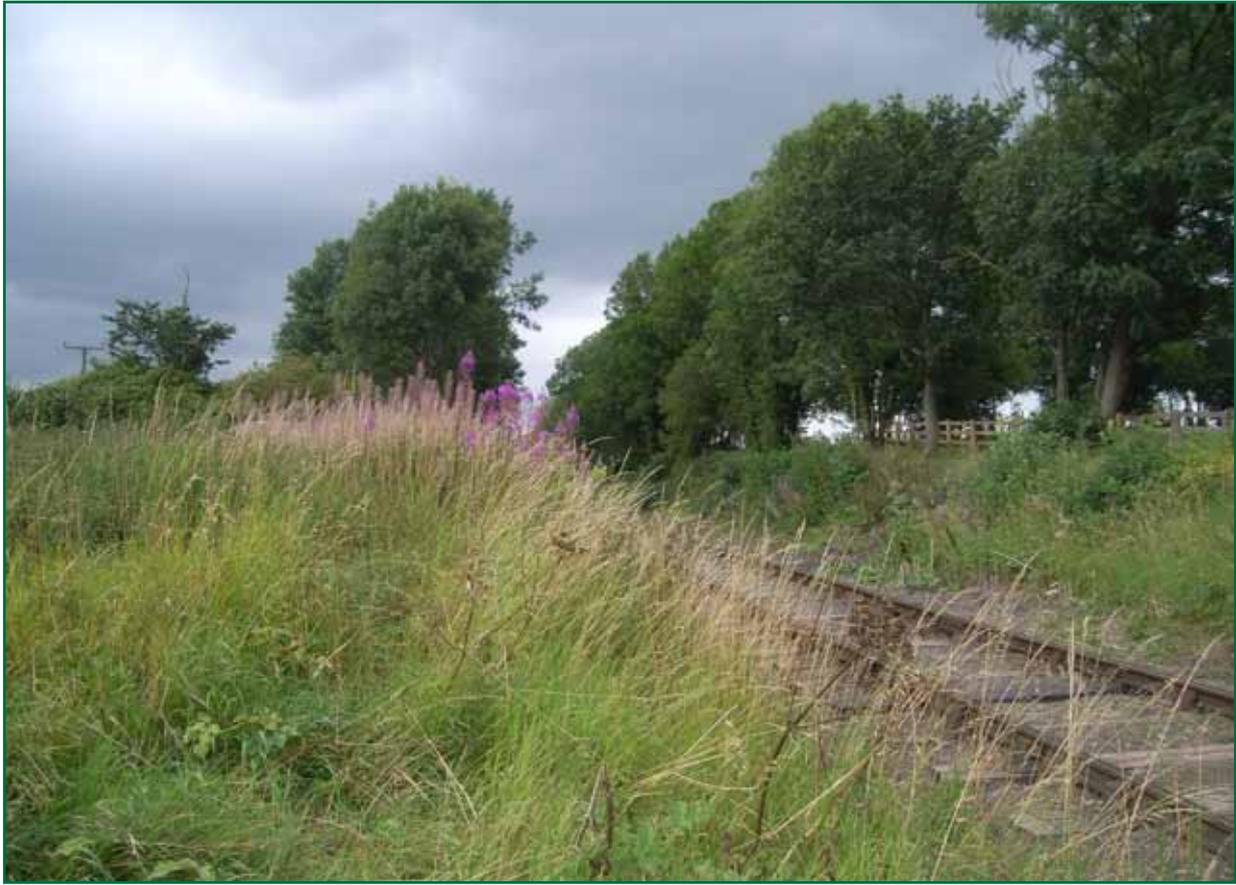
- 7 The visibility from the car as it approached the crossing towards the train was obscured by vegetation (figure 3). The gate at the side of the line that the car approached from was missing and the gate at the far side had been left open. Gates at user worked crossings are normally left closed across the road. The road user must stop and open both gates before crossing. Signs at the crossing remind users to close the gates behind them. If the gates are left open there is a risk of animals straying onto the line or of a road user driving onto the crossing without stopping to check that the line is clear. As there were no gates closed across the road, the car driver did not have to leave his vehicle to operate them. If he had done so, the train would have been visible from the far side of the line (figure 4). He would also have been more easily able to hear the train's warning whistle as it approached the crossing. Witnesses stated that the whistle was sounded.

Figure 3: View from the position of a car approaching the crossing, 3 metres back from the nearest rail, looking towards Redmire (ie looking in the direction that the train approached from)

- 9 The RAIB measured the distance along the line from the crossing to the first point at which the train would have been visible to the car driver. This distance was 39 metres (measured from a position 3 metres back from the nearest rail). Guidance published by the Office of Rail Regulation (ORR), 'Level crossings: A guide for managers, designers and operators, Railway Safety Publication 7'³ states that the decision point⁴ should be at least 3 metres back from the nearest rail for this type of crossing.

- 18 The Wensleydale Railway cut back the vegetation at Fox Park No.1 crossing during October 2010. No further clearance of the vegetation had taken place at the time of the accident. Figure 3 shows the view from the position of the car at the time of the accident looking towards the Redmire direction (the direction the train approached from).

- Ensure that actions derived from level crossing risk assessments are carried out, in particular routine vegetation clearance during the growing season to provide adequate sighting lines to ensure warning times are sufficient.

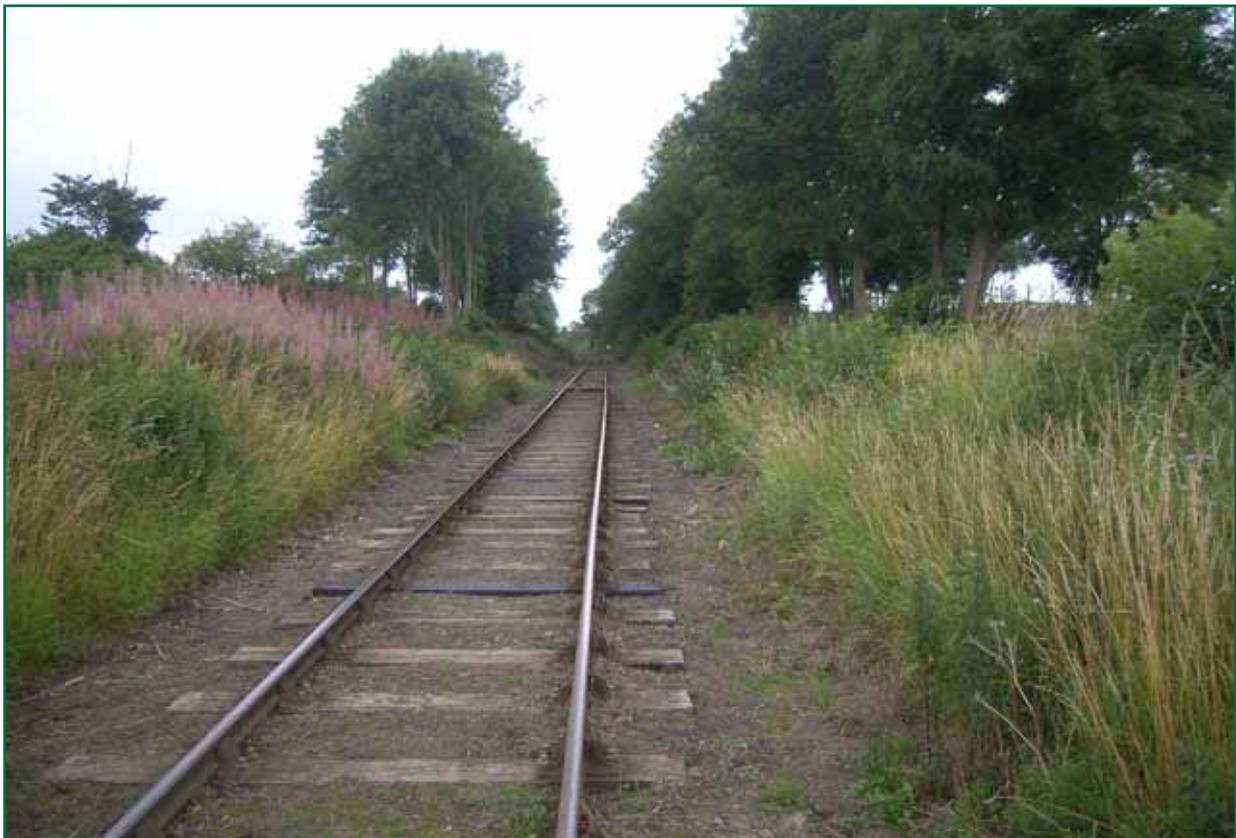
Figure 4: View towards Redmire from the far side of the line

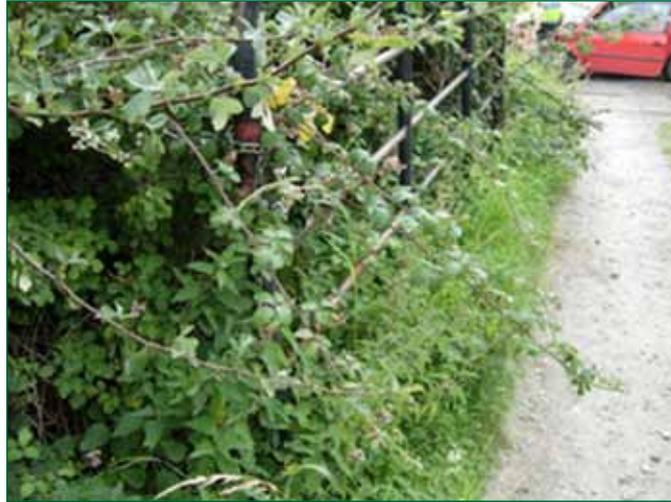
- 14 The other gate at Fox Park No.1 crossing was left open by the users of the crossing and had been left open for some time. Figure 5 shows the gate with vegetation growing through the bars. The Railway Clauses Consolidation Act 1845 makes it an offence for the user of this type of crossing to fail to close the gates after crossing the line. Signs on each side of the crossing state that the penalty for not closing and securing the gates is £1000. Failure to obey these signs is an offence under the Transport and Works Act 1992.

Figure 5: Gate on the farm side of the crossing (courtesy of BTP)

- Ensure that positive action is taken regarding users of user worked crossings where the gates are left open. The safety of user worked crossings is reliant on the gates being left closed.
