Rail Accident Investigation Branch

Rail Accident Report

**Child fell from train on the Nene Valley Railway
16 February 2008**

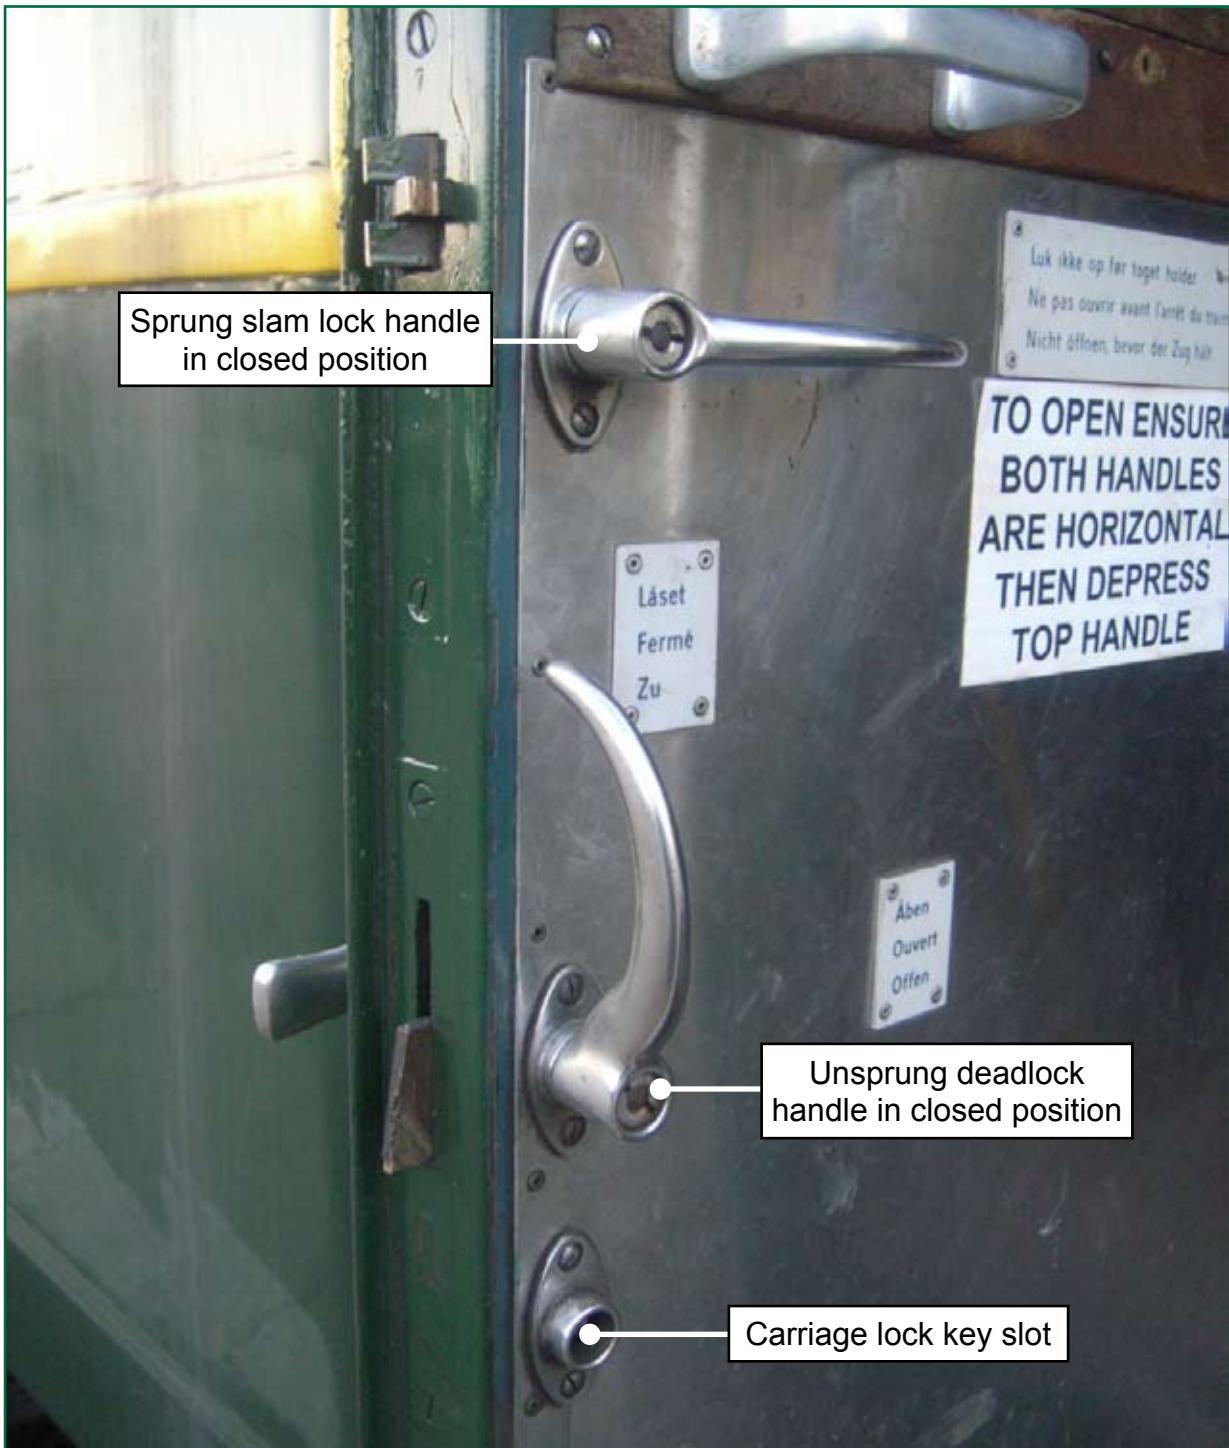
Figure 3: Incident door showing slam door and deadlock handles

- 9 Each external door is secured by two door locks and handles (Figure 3). The upper slam lock is sprung, and the handle inside the carriage is horizontal when the latch is engaged. The lower lock is not sprung, thus providing a deadlock, and the handle on the inside of the carriage should be vertical when the lock is engaged.
- 10 There are signs in Danish, French and German on the inside of the door stating that it should not be opened whilst the train is in motion; the only sign in English explains how the door handles should be worked to open the door.

- the deadlock handles have been turned through 90 degrees so that they are now horizontal and have to be lifted upwards to unlock;
- half the doors on each coach (the outer doors of each door pair) have been permanently locked out of use; and
- guards and travelling ticket inspectors have been briefed to be vigilant if young children are close to the handles of the external doors in the vestibule area.

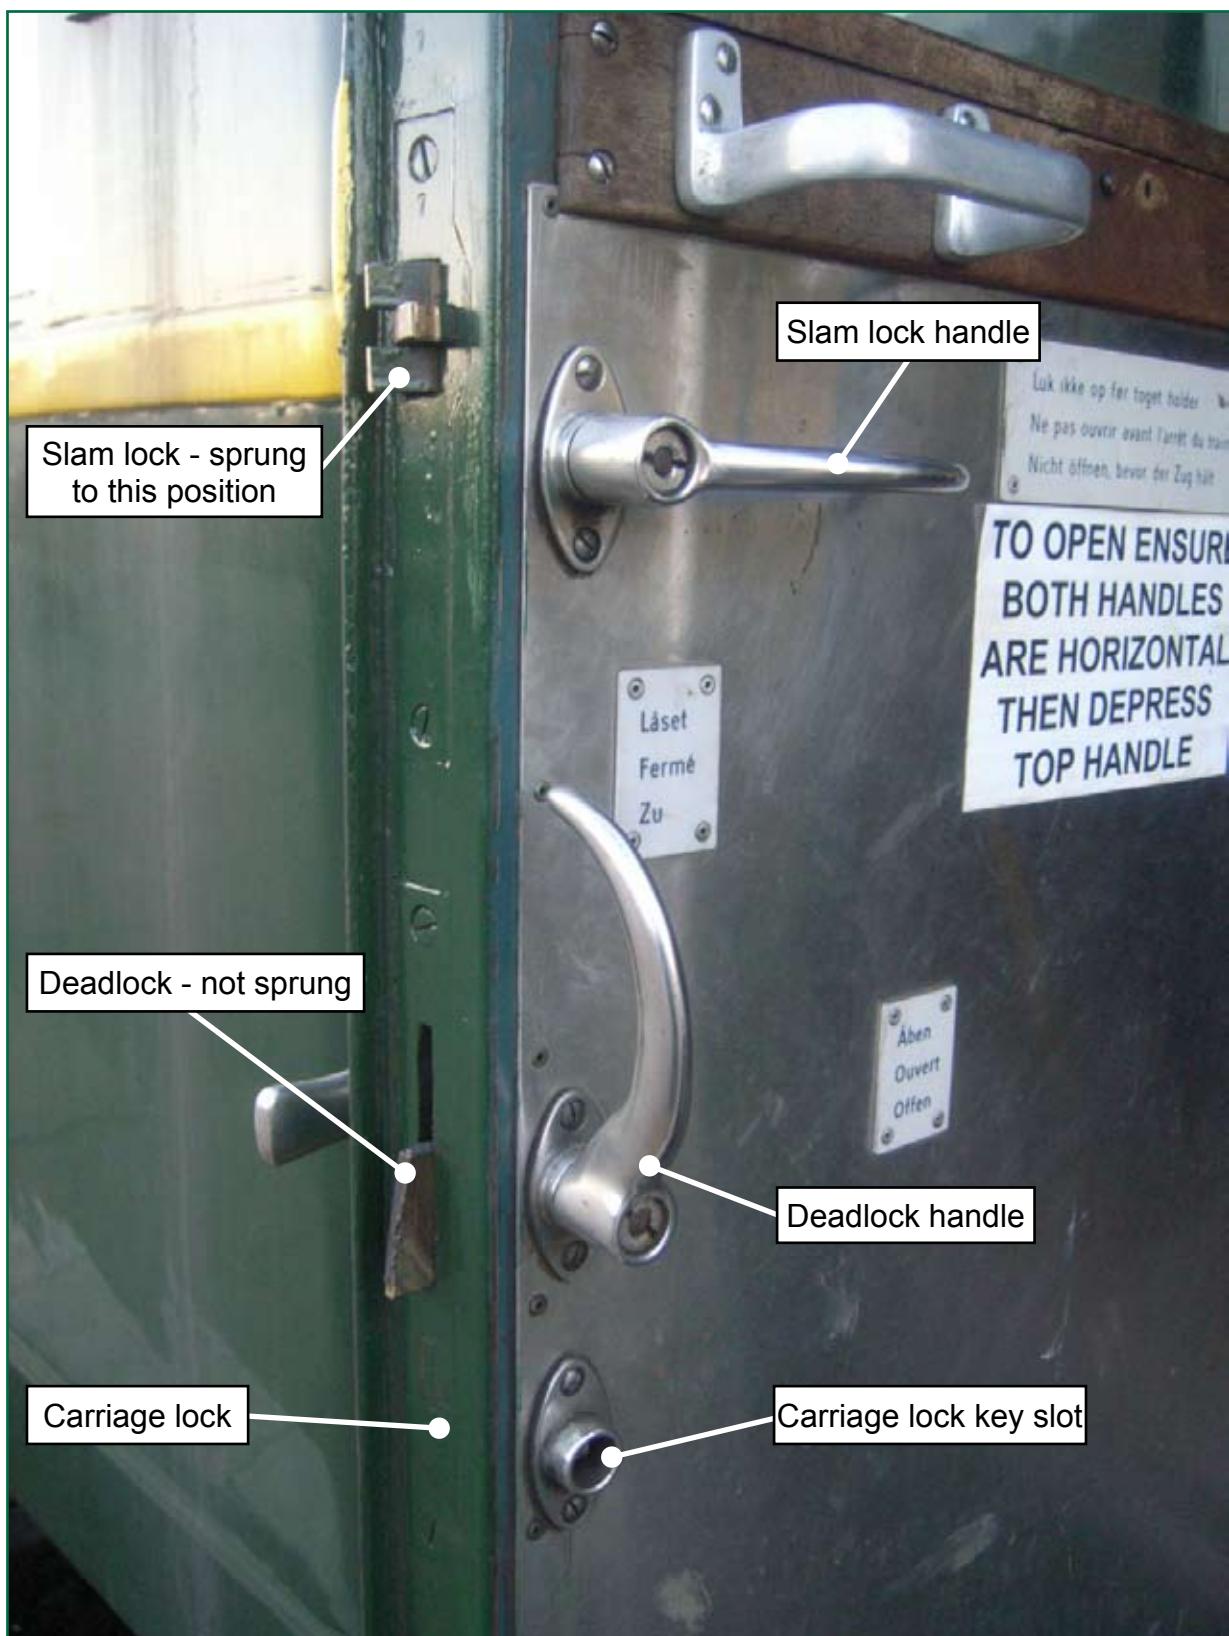
1. INCIDENT DESCRIPTION			
LEAD / INSPECTOR		CONTACT TEL. NO.	
INCIDENT REPORT No	0268	DATE OF INCIDENT	16/2/08
INCIDENT NAME	Wansford, Nene Valley Railway		
TYPE OF INCIDENT	Child fell from train travelling at approx 20 mph		
INCIDENT DESCRIPTION	A vestibule door on former Danske Statsbaner (Danish Railways) carriage 1478 came open whilst the train was running from Wansford to Peterborough, allowing a young child to fall onto the railway track.		
SUPPORTING REFERENCES	See attached photograph for details of the door handle arrangements

2. URGENT SAFETY ADVICE	
USA DATE:	18/02/08
TITLE:	Door locking arrangement on former Danske Statsbaner carriages
SYSTEM / EQUIPMENT:	Nene Valley Railway
SAFETY ISSUE DESCRIPTION:	The former Danske Statsbaner carriages used on the NVR have vestibule doors with two interior handles, a lower one to deadlock the door and an upper one to open the slam lock. The lower lock is not sprung; the upper lock is.
CIRCUMSTANCES:	Initial RAIB tests indicate that only a small force is necessary to open both interior door handles—estimated at about 2 kilos applied at the end of the door handles. If the lower lock is moved to the open position and the upper lock is then turned the door is free to open, allowing egress from the train. The forces to turn the handles are such that they can be applied by a small child.
CONSEQUENCES	Risk of fall from train.
REASONS FOR ISSUE:	The Nene Valley Railway should investigate and urgently implement one or more measures to reduce the risk of people being able to open the doors of carriage 1478, and any other carriages on the railway employing the same door lock arrangement. This advice is also sent to the Heritage Railway Association in case any other railway has a similar arrangement, and to the European Rail Agency, in case the door arrangement is still in use in Denmark, or on heritage railways in Europe.
