## FLYER TO THE FISHING INDUSTRY

### *Ronan Orla*: accident leading to a fatality on 30 March 2014

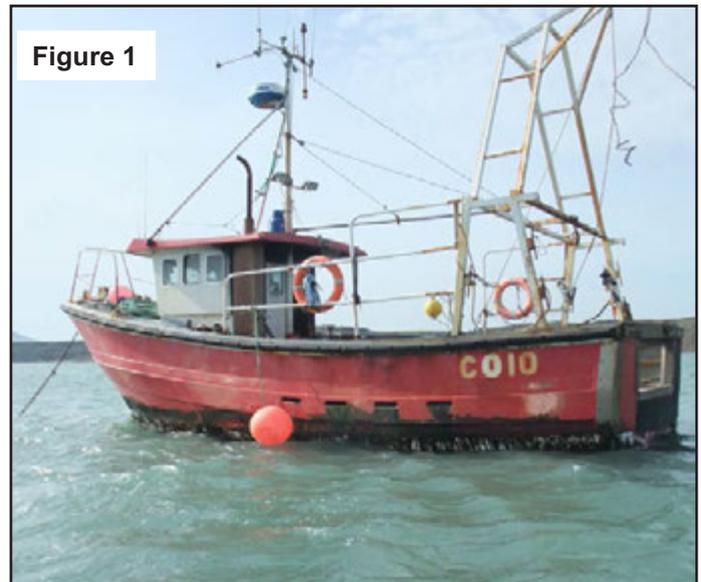
At about 1100 on 30 March 2014, the owner/skipper of the 9.98m scallop dredger *Ronan Orla* (**Figure 1**) was fatally injured when he became entangled on the starboard warping drum of the vessel's winch. The skipper was operating the vessel single-handedly and was attempting to recover his dredge gear on board when the accident happened (**Figure 2**). About 4 hours later, the crew of another scallop dredger noticed that *Ronan Orla* appeared to be in trouble. They came alongside *Ronan Orla* and a crewman climbed on board and stopped the winch. It was apparent that *Ronan Orla*'s skipper was deceased.

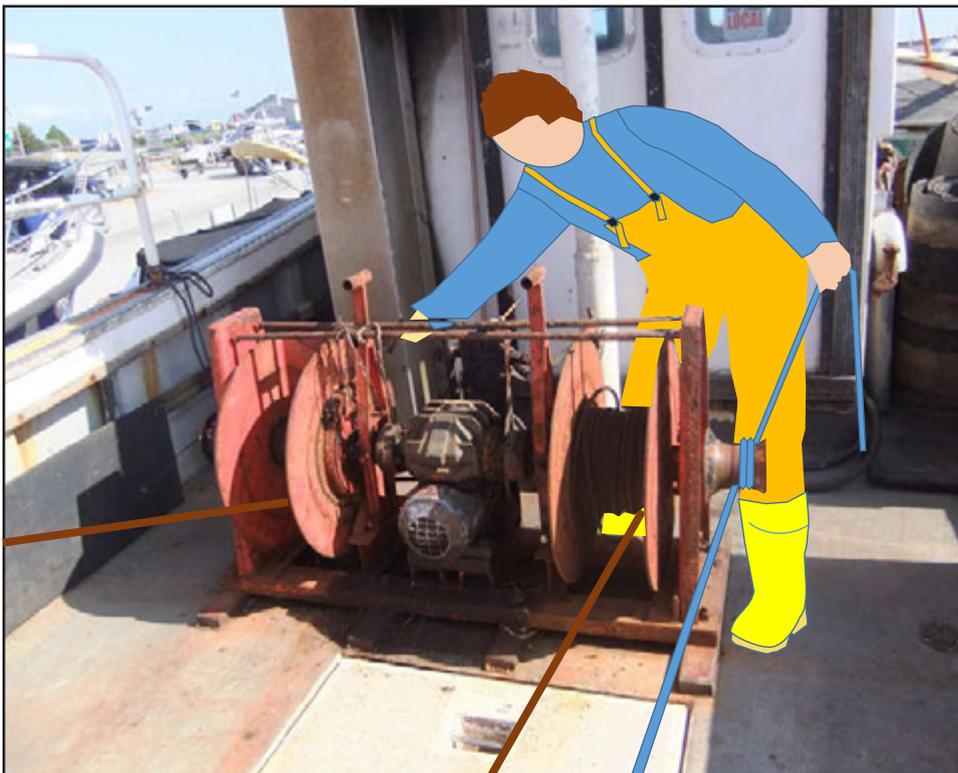
**Figure 2**  
Simultaneous tensioning of pull-down rope and release of hoisting drum band brake

It is most likely that one of the shoulder straps on the skipper's bib-and-brace trousers became snagged/trapped by the rotating warping drum, and he was unable to free himself or stop the winch before succumbing to his injuries.

- Many hazards can be removed or reduced by engineered controls such as safety guards and emergency stops. Had an emergency stop been fitted to *Ronan Orla*'s winch, the skipper might have been able to stop it; had the winch control lever been designed to return to its stopped position when released, this tragic accident would have been prevented.

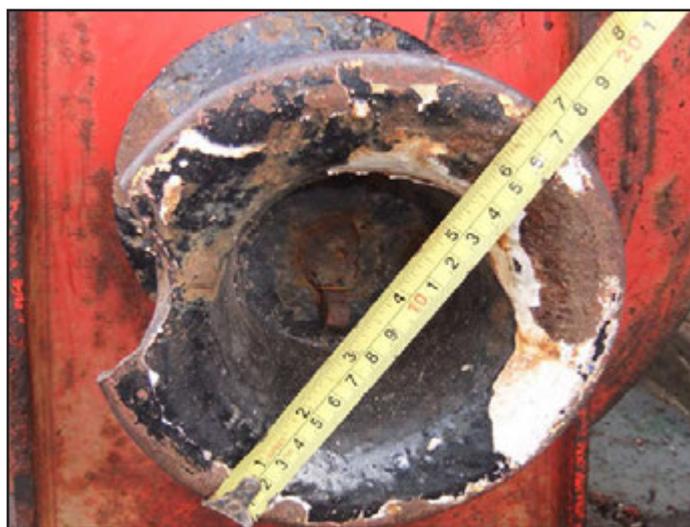
**Figure 3:** Chunk of cast steel broken from the rim of the starboard warping drum

- The material condition of the winch was probably a contributing factor in the accident. Equipment that is allowed to deteriorate becomes unreliable and difficult to use, and may fail when least expected and least wanted. Maintenance is an investment to ensure costly breakdowns are rare, but it also provides the crew with a safer working environment and will improve vessel safety overall.
