MARINE ACCIDENT INVESTIGATION BRANCH

SAFETY FLYER TO THE FISHING INDUSTRY

***Beryl*: fatal man overboard on 10 February 2015**

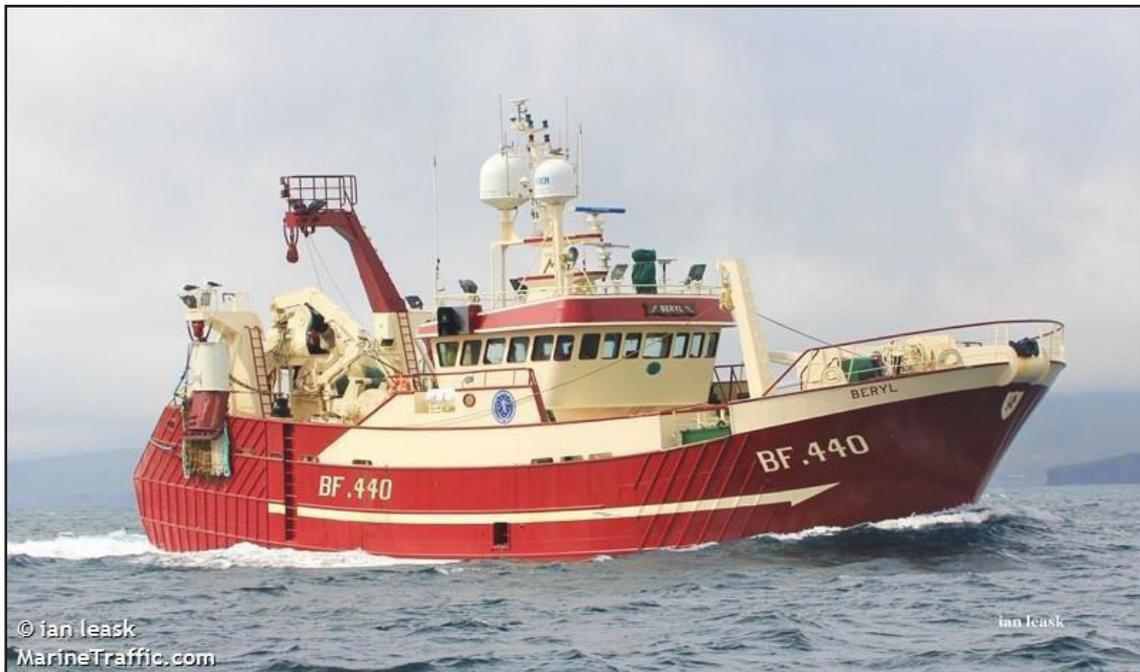
Beryl

At about 0910 on 10 February 2015, a deckhand on the 28m twin rig trawler *Beryl* was carried overboard by the vessel's port trawl net.

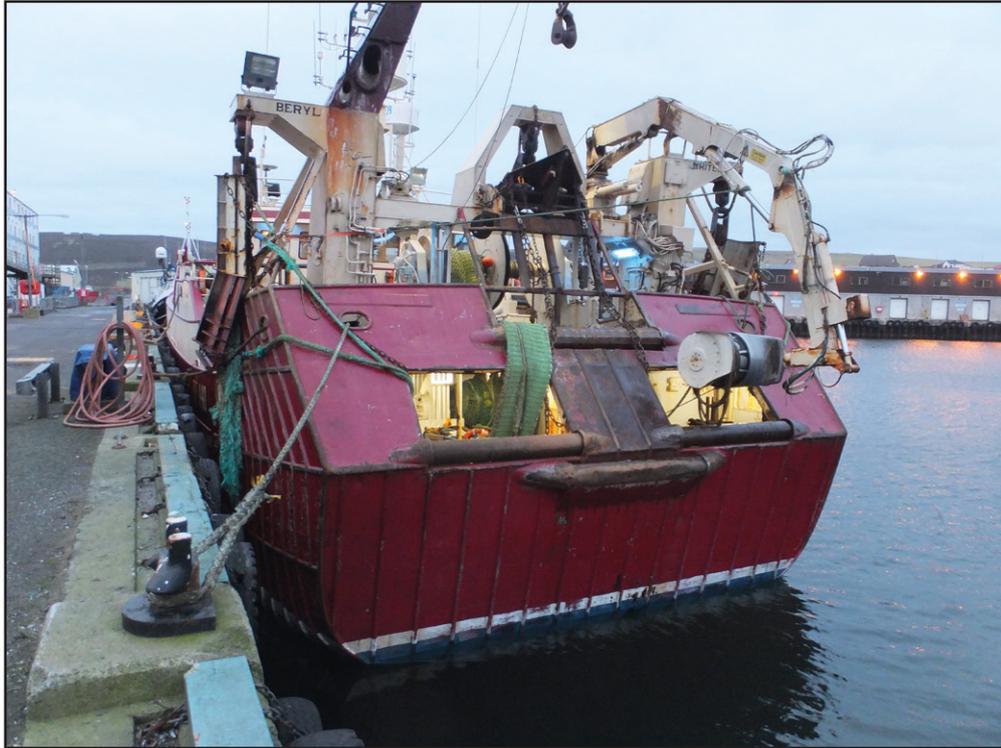
Shooting doors

The net was being shot away through the stern 'shooting doors' when it snagged. To free the net, the deckhand stood on the net to release a float caught on lashings inside the net track. The vessel was underway before rough seas and the net was under significant load.

Without warning, the net suddenly released and quickly streamed astern carrying the deckhand with it. The deckhand was carried through the port 'shooting door' and into the sea. He was conscious and managed to hold onto the net. The deckhand's lifejacket inflated and *Beryl's* crew spent almost 50 minutes trying to recover him back on board; they were unsuccessful. The crewman was eventually recovered by a rescue craft launched from an offshore support vessel. He was transferred to a rescue helicopter and flown to hospital but he did not survive.

- Initiatives such as the Scottish Fishermen's Federation 'onboard support scheme' and the 'Seafish safety folder' have helped to make risk assessments play an increasing role in the safety management of UK fishing vessels. However, risk assessments do not reduce the risk of accidents unless the control measures and safety precautions that they help to identify are implemented.

- It is easier to prevent crew from falling overboard than it is to recover them from the water.
- Work arrangements and practices require regular review to remove, as far as possible, the inherent risks in shooting and hauling operations. Brief 'toolbox talks' can be used to periodically remind crew of the procedures to be followed and the safety precautions to be taken.
