SAFETY FLYER TO FISHING INDUSTRY

Fishing vessel *Fredwood*, accident leading to flooding of a vessel at its berth, 6 April 2016

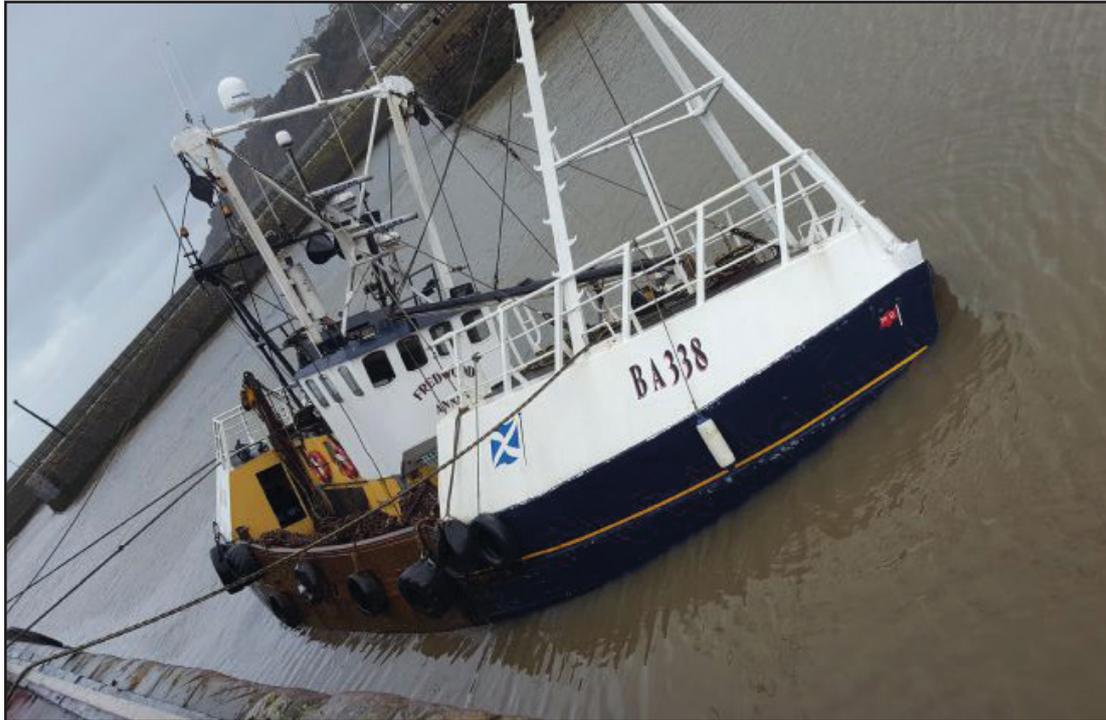
On 6 April 2016, the UK registered fishing vessel *Fredwood* flooded and sank on a drying berth in Maryport, England. When *Fredwood* took the ground, it listed away from the quay wall and the weight of the vessel came to rest on a sonar tube that protruded from the bottom of the hull. The tube was pushed upwards and the hull planking around it was damaged. This caused the vessel to flood on the rising tide. All of the crew were rescued by local fire service personnel and there were no injuries or pollution. However, the vessel was declared a constructive total loss.

Fishing vessel owners and skippers should always ensure that they have fully assessed the risks before taking the ground on drying berths. Procedures should be in place and actions taken to ensure that vessels remain upright or lean onto the quay wall when aground. In particular, the crew should:

- Consult with the harbour authority when assessing the suitability of the berth for taking the ground.
- Be aware of the type of seabed the vessel will rest on.
- Keep all watertight openings closed and monitor bilge levels and alarms.
- Tend the vessel's mooring lines and monitor its attitude and position as the tide falls to ensure the vessel lists towards the quay before taking the ground.
- Where necessary, rig extra lines or beaching legs, to ensure the vessel remains upright as the berth dries out.

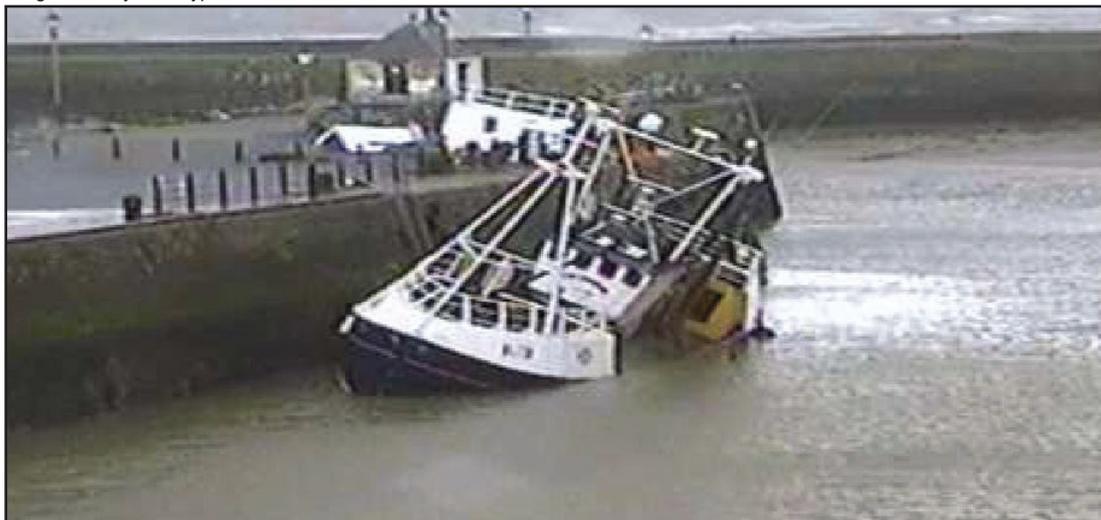
The resulting MAIB investigation found that the mooring arrangement, mooring line monitoring and emergency response on board *Fredwood* were inadequate.
