# Rail Accident Report

**Fatal accident at Grimston Lane footpath  
crossing, Suffolk  
23 February 2016**

Report 23/2016  
November 2016

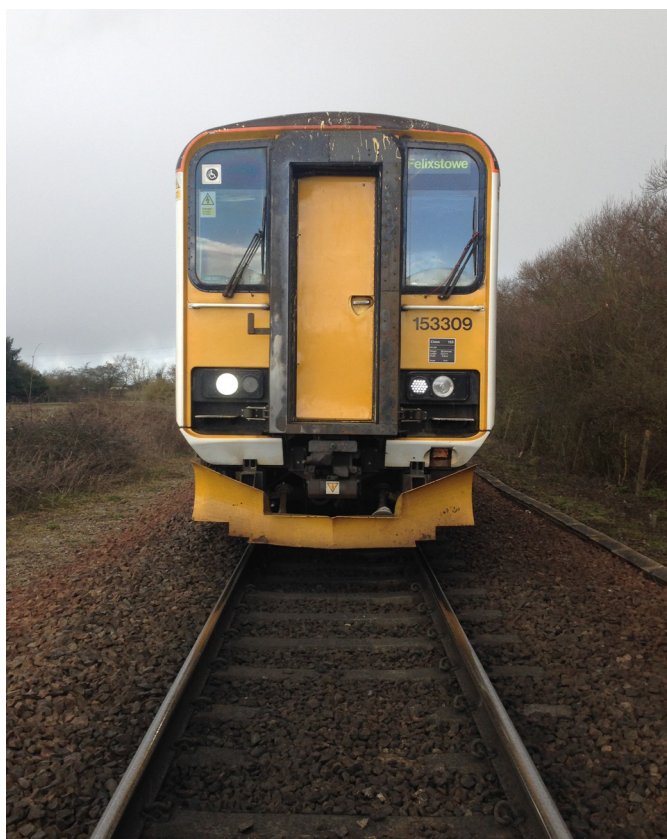
Figure 4: Photograph of train 2R14 taken at 13:49 hrs on 23 February 2016 (image courtesy of Network Rail)

- 13 Train 2R14 was formed of a single-car Class 153 *diesel multiple unit*, number 153309.
- 14 Photographs taken shortly after the accident show that, on the front of the train, the lights were working and there was no obvious degradation of the yellow-coloured areas provided to improve conspicuity (figure 4). Post-accident inspection and testing by Abellio Greater Anglia recorded nothing untoward with the brakes, warning horn operation, or the windscreen wiper and washer.
- 15 The RAIB found no evidence that the condition of the train, or the way it was driven, contributed to the cause of the accident.

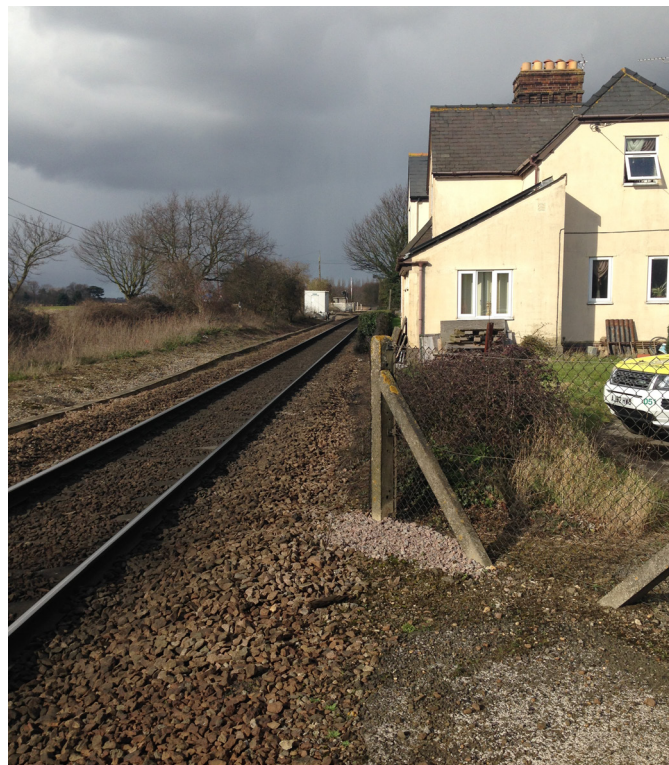
- 22 It was daylight at the time of the accident; the sun was close to due south (facing the approaching train) and almost at its maximum altitude, 27.98°. The weather recorded at Wattisham airfield, 28 km away, was partly cloudy. This is consistent with photographs taken at the crossing shortly after the accident (figure 7). There was no fog or mist.
- 23 A local weather station in Trimley St Martin recorded an air temperature of 9.4°C and a north-north-westerly wind of 15 km/h. There had been no precipitation over the previous 12 hours.
- 24 The RAIB found no evidence that the above environmental factors contributed to the cause of the accident.

*Figure 7: Photograph of the railway at Grimston Lane footpath crossing in the direction from which the train approached, taken at 13:36 hrs on 23 February 2016 (image courtesy of Network Rail)*

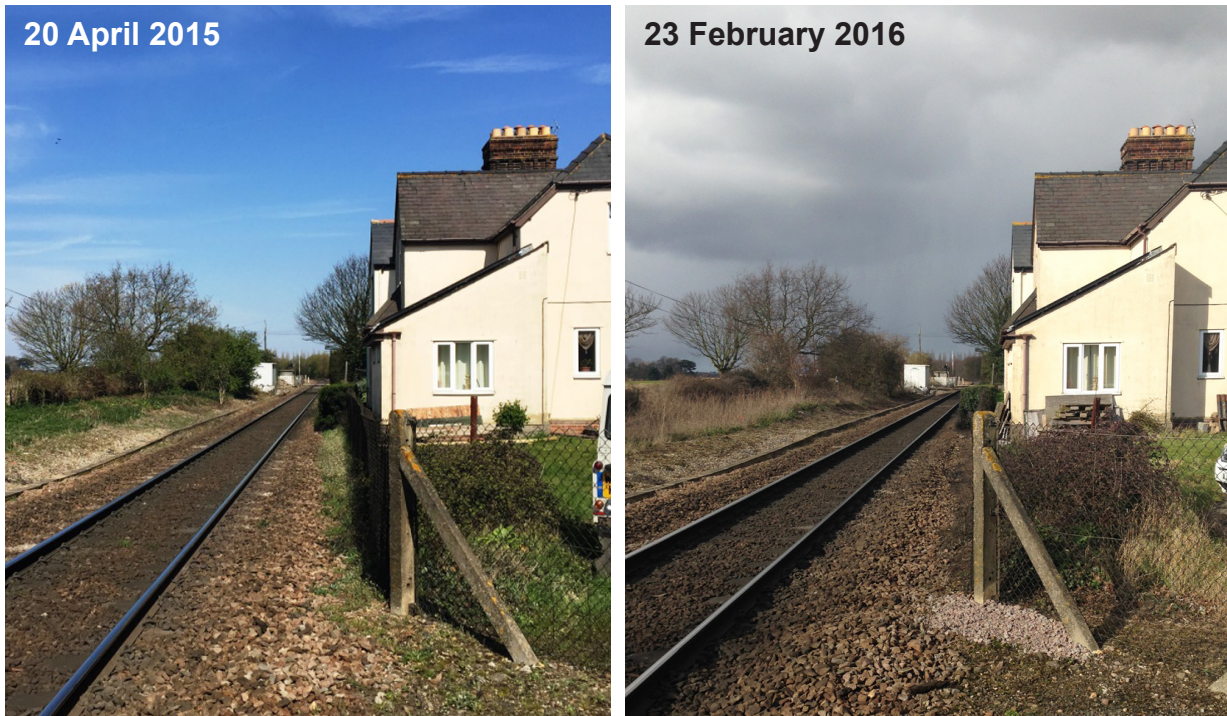
- Changes to the lineside equipment, structures or vegetation since the last risk assessment had not compromised the pedestrian's view of the approaching train. Figure 8 shows photographs of the view taken for the last risk assessment (on 20 April 2015) and the view after the accident (on 23 February 2016).

Figure 8: Photographs taken from the east side of the crossing, in the direction from which the train approached, on 20 April 2015, for the last level crossing risk assessment, and 23 February 2016, after the accident (images courtesy of Network Rail)

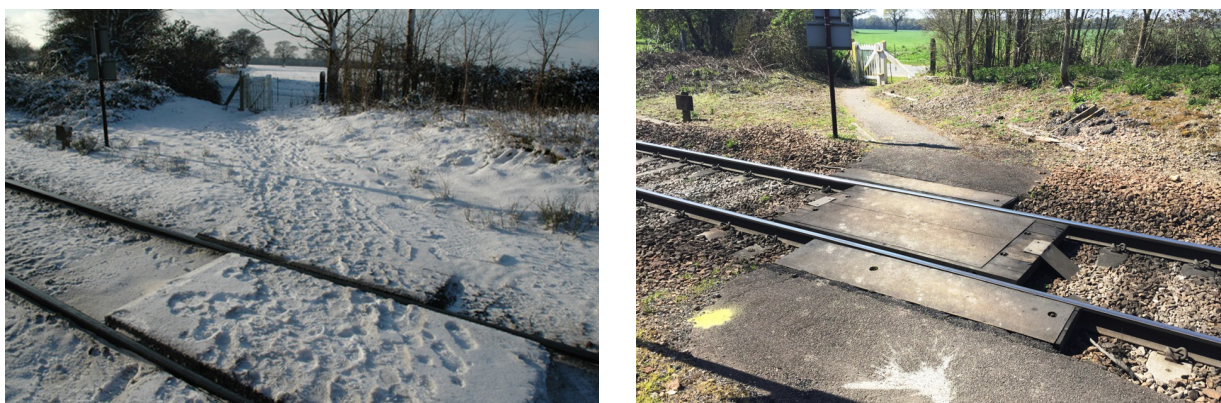
- 62 Photographs showing footprints and wear patterns on the crossing deck (figure 9) indicate that users routinely follow the general skewed alignment of the crossing deck (and the tarmac approach paths to and from it) and cross the railway on a diagonal path. The RAIB estimates that a typical path would be at 33° to the direction at right angles to the track, and orientated so that users crossing from the east side naturally tend to face away from trains approaching in the down direction.

Figure 9: Evidence of footprints and wear marks on the crossing deck (images courtesy of Network Rail)

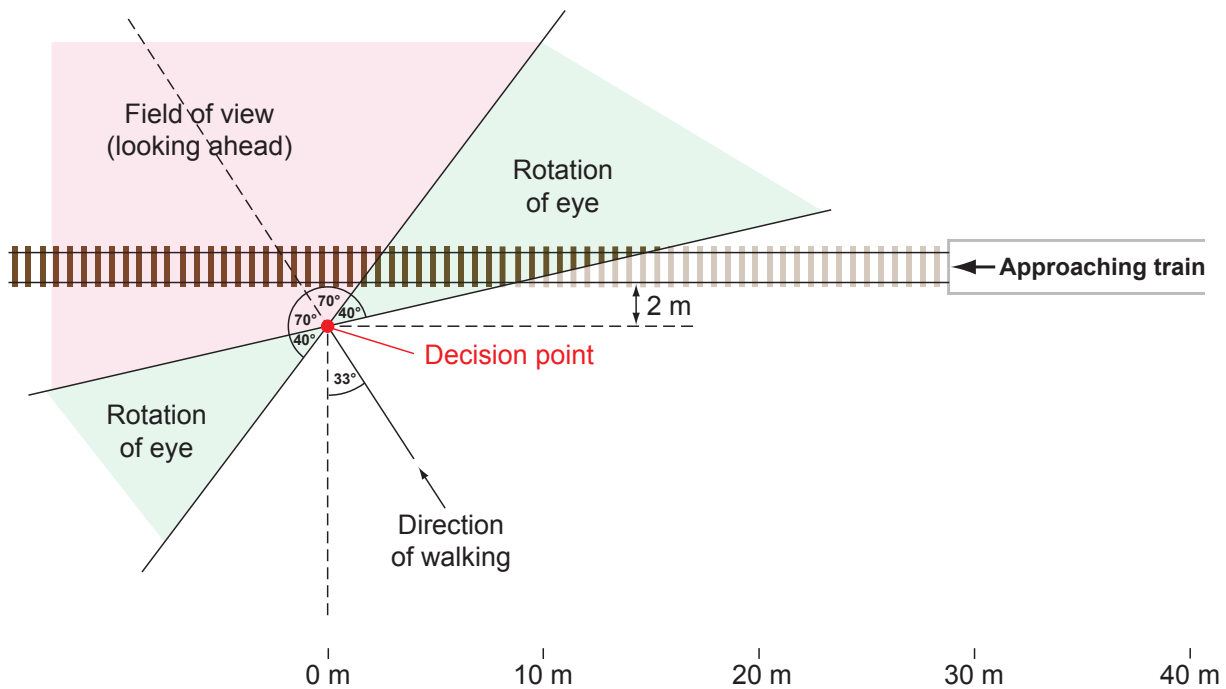
Figure 10: Estimated field of view at a decision point two metres from the track (paragraph 69) when crossing at a skew angle of 33° to the direction at right angles to the track

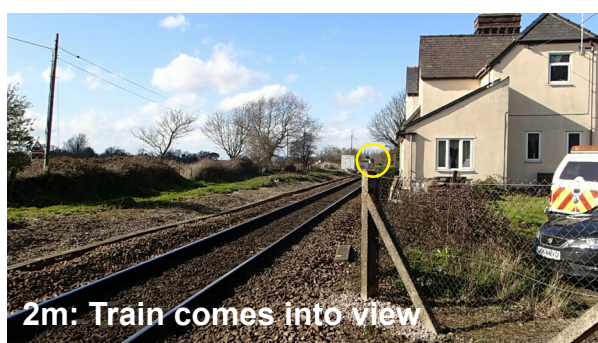
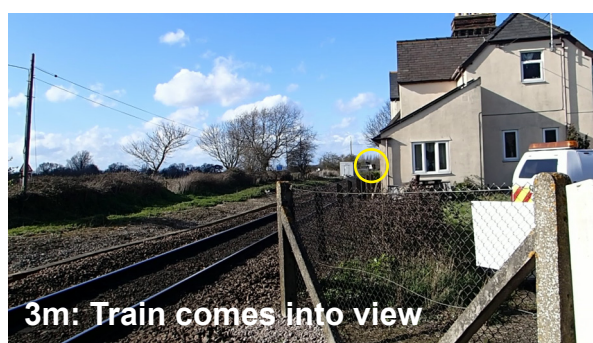
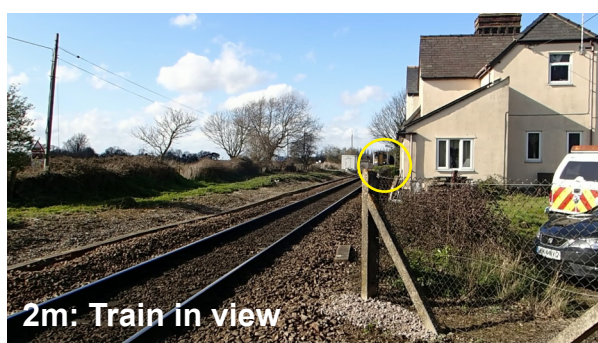
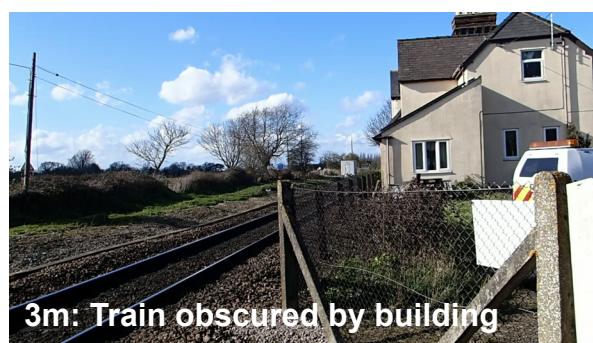
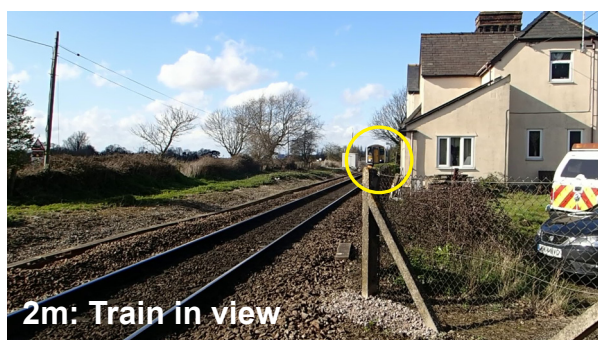
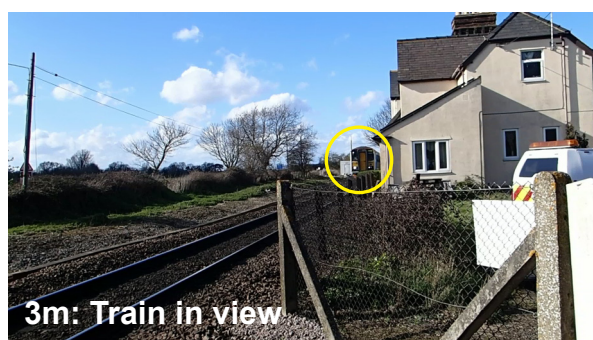
- 70 Trains approach Grimston Lane footpath crossing in the down direction on a right-hand curve (paragraph 26) and, on the east side of the crossing, nearby structures increasingly restrict a pedestrian's view of trains as the selected decision point moves further from the track. The RAIB made video recordings of down-direction trains approaching the crossing with cameras positioned at two metres (the decision point used in the last level crossing risk assessment) and three metres from the track. At two metres, close to the sign instructing users of the need to 'stop, look and listen' (paragraph 17), the train remains in view from when it appears, from behind level crossing equipment at Thorpe Lane, to when it reaches Grimston Lane. However, at three metres, it becomes obscured by a two-storey house shortly after appearing from behind the Thorpe Lane level crossing equipment; it only reappears when it is close to Grimston Lane footpath crossing (figure 11).

Figure 11: Video images of an approaching down-direction passenger train recorded at two metres and three metres from the track, on the east side of Grimston Lane footpath crossing

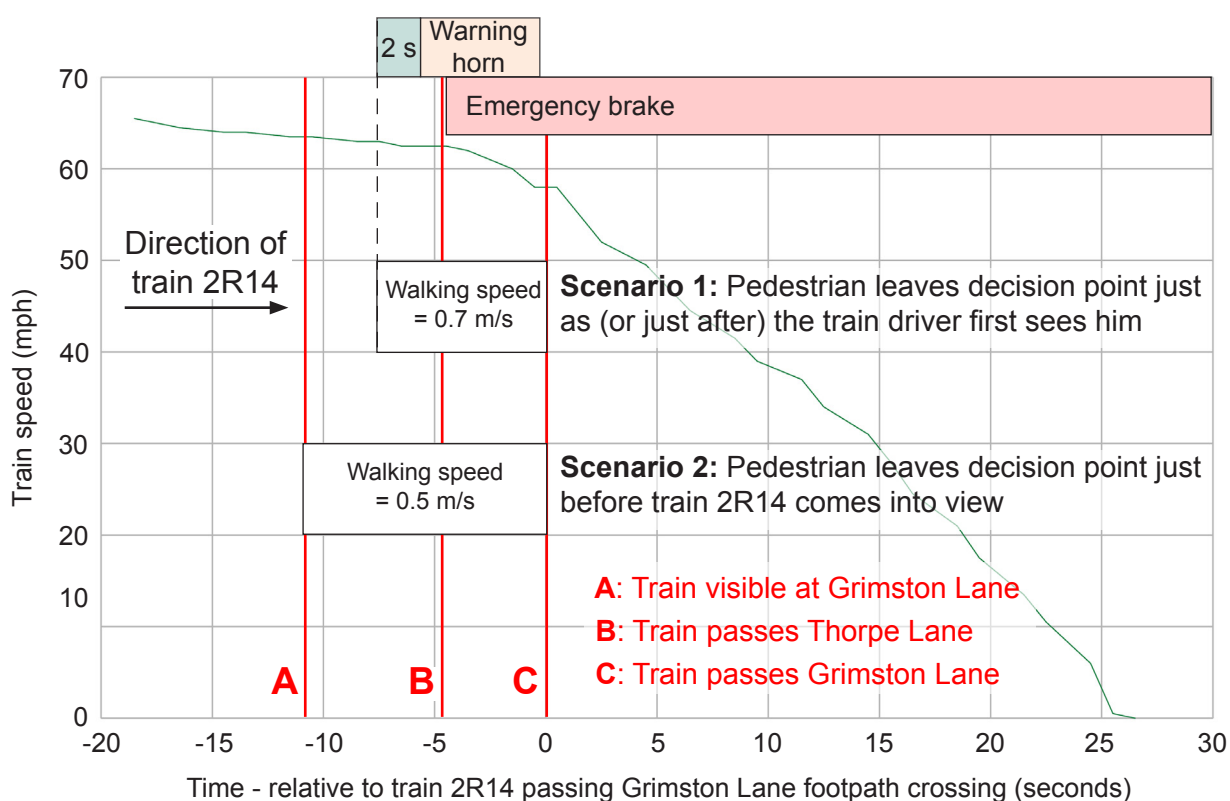
79 The RAIB analysed the information from the *on-train data recorder* (OTDR) to estimate the speed at which the pedestrian was crossing. With reference to figure 12, if the pedestrian had decided to cross just as (or just after) the driver had first seen him<sup>23</sup>, and was located at a decision point two metres from the railway (paragraph 70), he would have been walking at a speed of no more than 0.7 m/s (scenario 1). However, if the pedestrian had decided to cross earlier, when he would not have seen an approaching train, but when train 2R14 was about to come into view, he would have been walking much more slowly, probably around 0.5 m/s (scenario 2). A review of studies into road crossing behaviour has observed that older pedestrians may not fully compensate for the decline in their walking speed (paragraph 76).

Figure 12: OTDR analysis showing the possible range of speeds at which the pedestrian was walking. Both scenarios assume: a) the decision point was two metres from the track; and b) the traverse path was aligned at 33° to the direction at right angles with the track

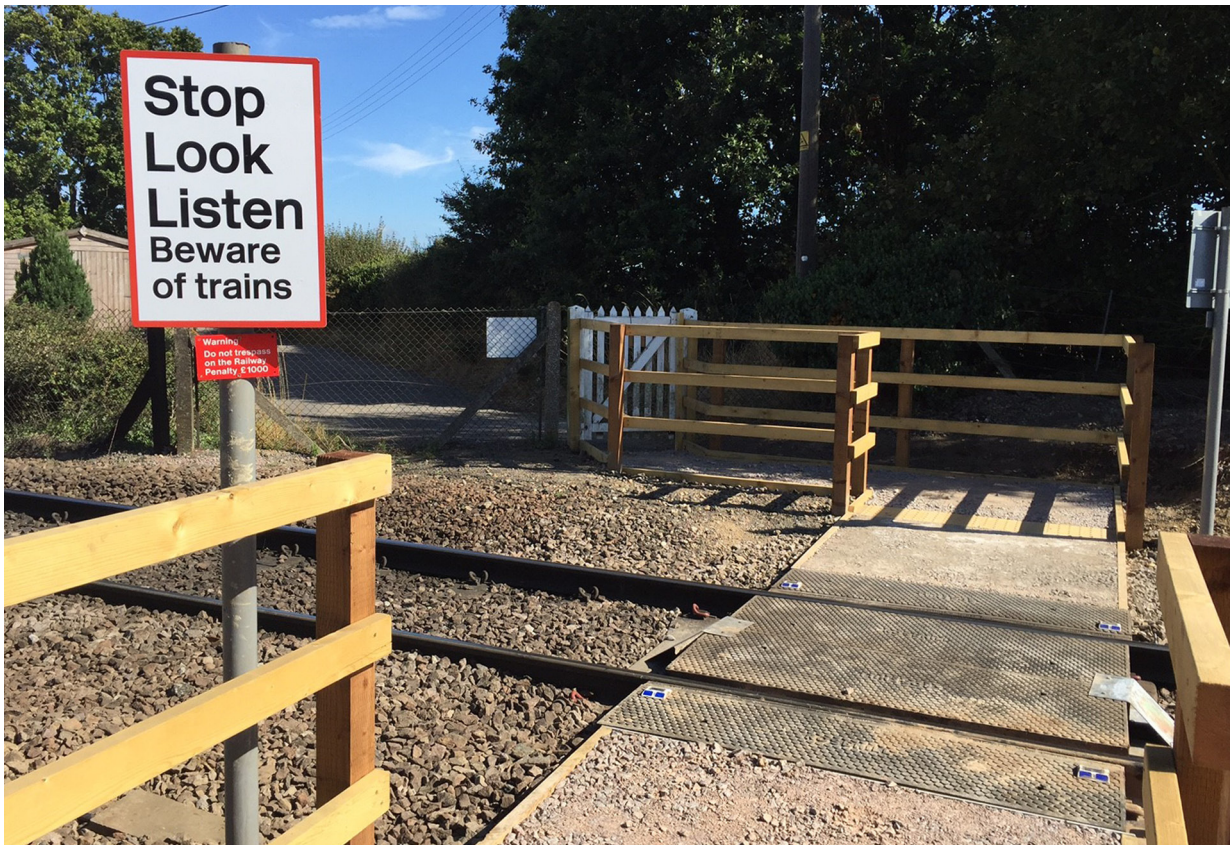
Figure 13: New crossing deck and fenced approach paths at Grimston Lane footpath crossing (image courtesy of Network Rail)

- 105 Network Rail has advised that it reviewed the sighting from Grimston Lane footpath crossing after the accident and removed vegetation and redundant lineside structures (in the vicinity of the nearby level crossing at Thorpe Lane) to improve the visibility of trains approaching in the down direction. It later advised that it has replaced the skewed timber crossing deck with a rubber crossing deck that is aligned perpendicular to the track, and has fenced the approach paths to it (figure 13).
