High Speed Two Phase 2a (West Midlands - Crewe)

CA1: Fradley to Colton

Cultural heritage survey reports (BID-CH-004-001)

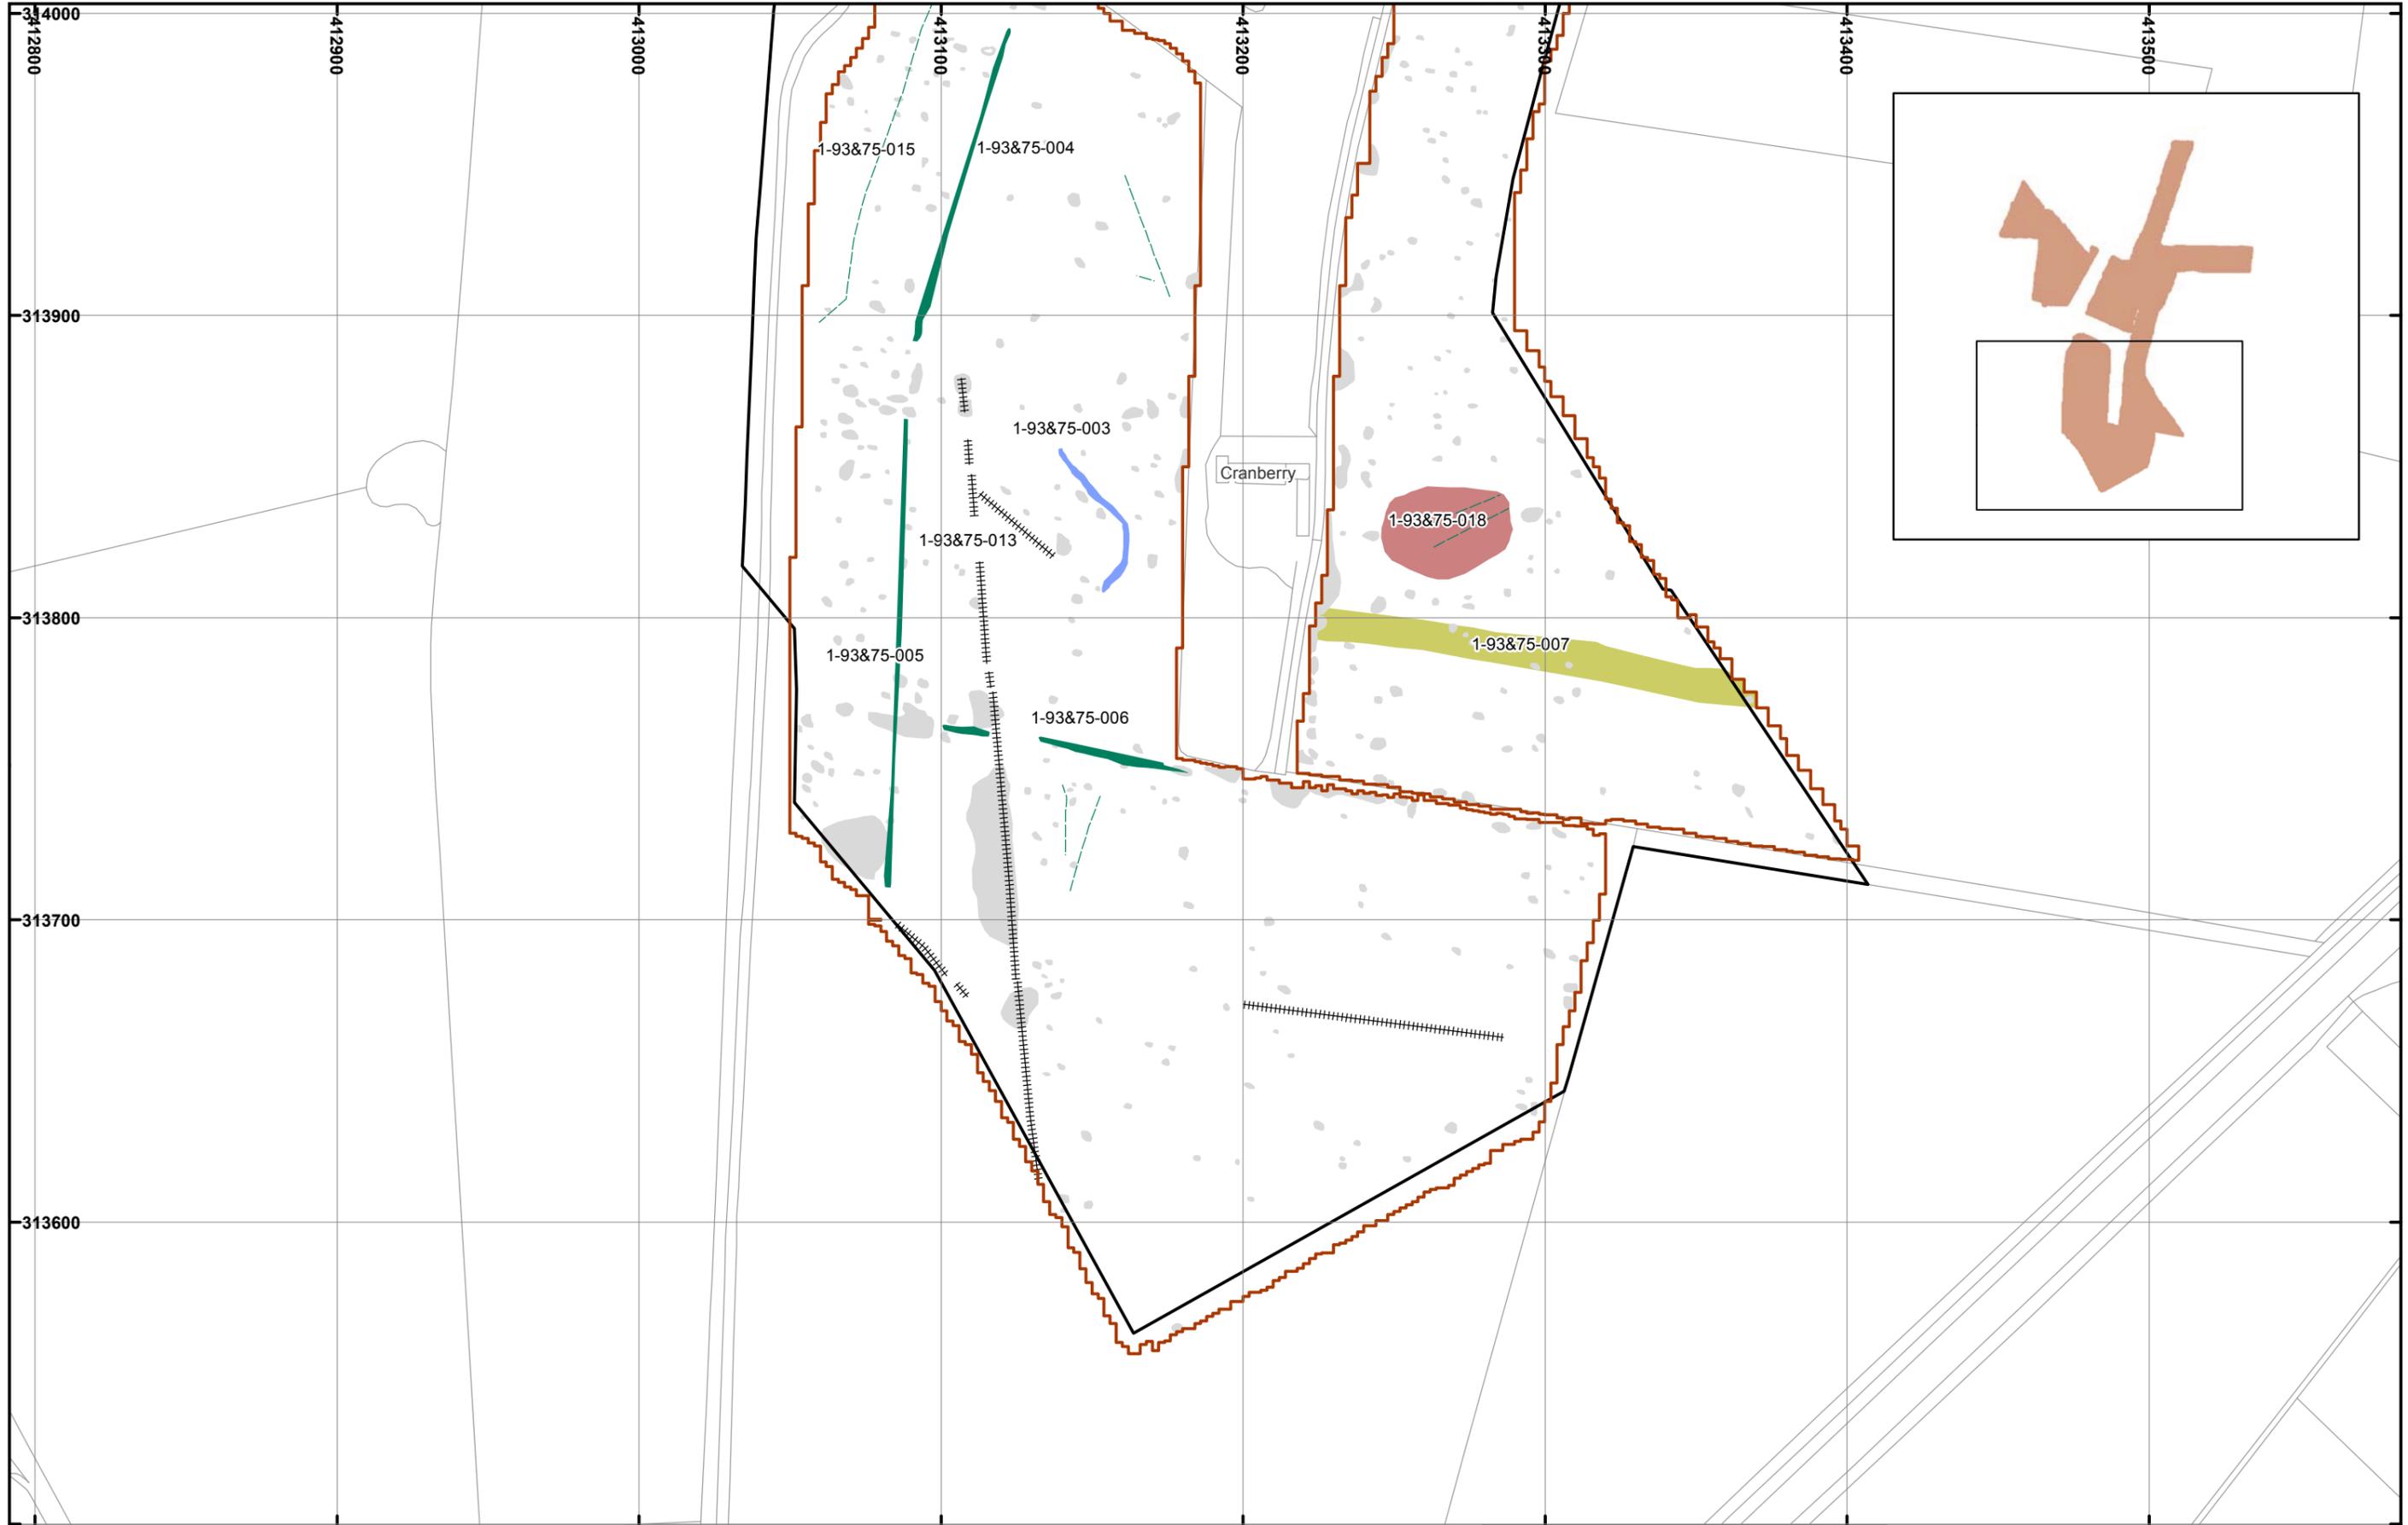
Map Number: Figure 11
 Map Name: CA1-93 & 75 Interpretation (south)
 Community Area: 1-93 & 75

- 2.4.9 The gradiometer survey carried out between 31 October – 8 November 2016 using hand-held systems has not identified any anomalies of definite archaeological interest. However, other possible anomalies can be seen. Areas of modern debris/burning, modern services, and ploughing have been detected, along with numerous trends.
- 2.4.10 Results are presented as a series of greyscale and XY plots, and archaeological interpretations, at a scale of 1:2000 (Figures 3 – 11). The interpretation of the datasets highlights the presence of potential archaeological anomalies, ferrous/burnt or fired objects, and magnetic trends (Figures 5, 8, and 11).

- 2.4.19 To the south-east of the survey area, a large area of increased magnetic response has been identified at 1-93 and 75-018. The anomaly does not correspond to any features of historic or modern mapping. However, it has two linear trends within it and may indicate an area of debris or modern burning.

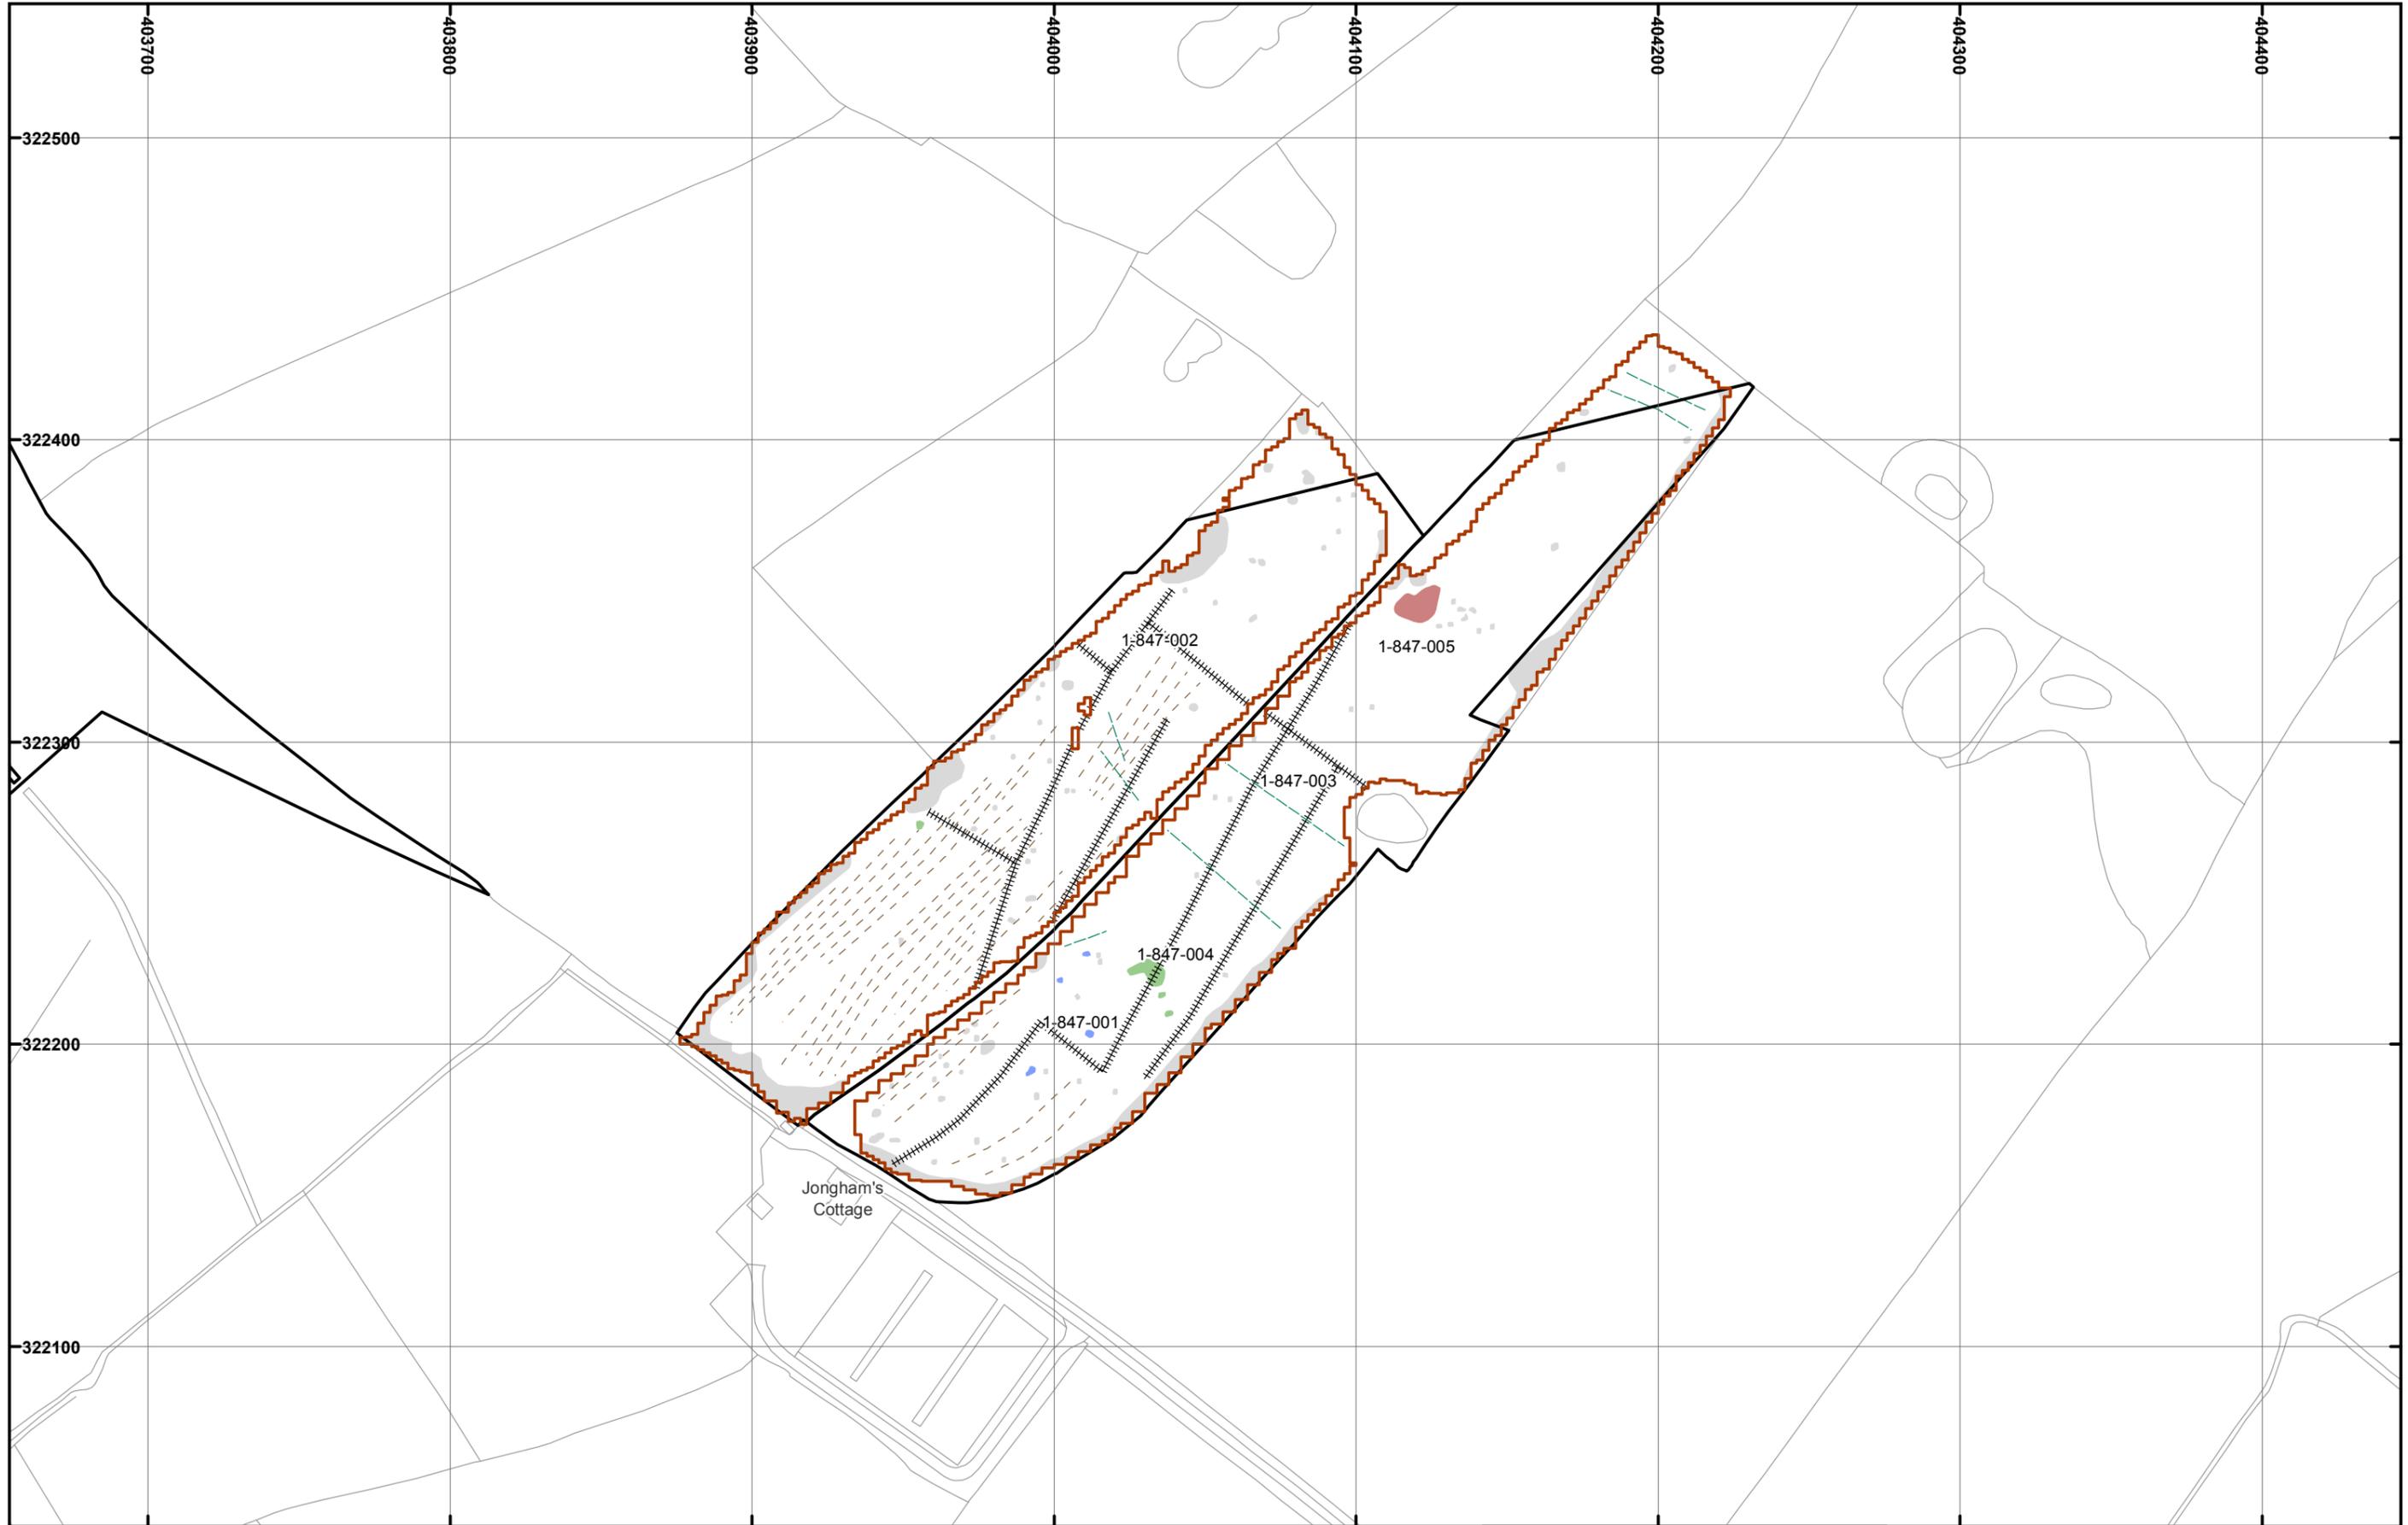
Map Number	Figure 37
Map Name	CA1-847 Interpretation
Community Area:	1-847

- 2.10.12 The gradiometer survey carried out on 2 – 3 August 2016 using hand-held systems has identified anomalies of possible archaeological origin, as well as those thought to relate to modern agricultural activity or natural variation, trends and ferrous responses.
- 2.10.13 Results are presented as a series of greyscale and XY plots, and archaeological interpretations, at a scale of 1:2000 (Figures 35 – 37). The interpretation of the datasets highlights the presence of potential archaeological anomalies, ferrous/burnt or fired objects, and magnetic trends (Figure 37).

- 2.10.19 As well as the aforementioned ferrous anomalies present throughout the dataset, there is an area of moderately strong (11 nT) positive anomalies with associated negative responses in the north of the area (1-847-005). The exact cause of this anomaly is not clear. However, its strength suggests it is likely related to a modern cut feature, such as a former pond.

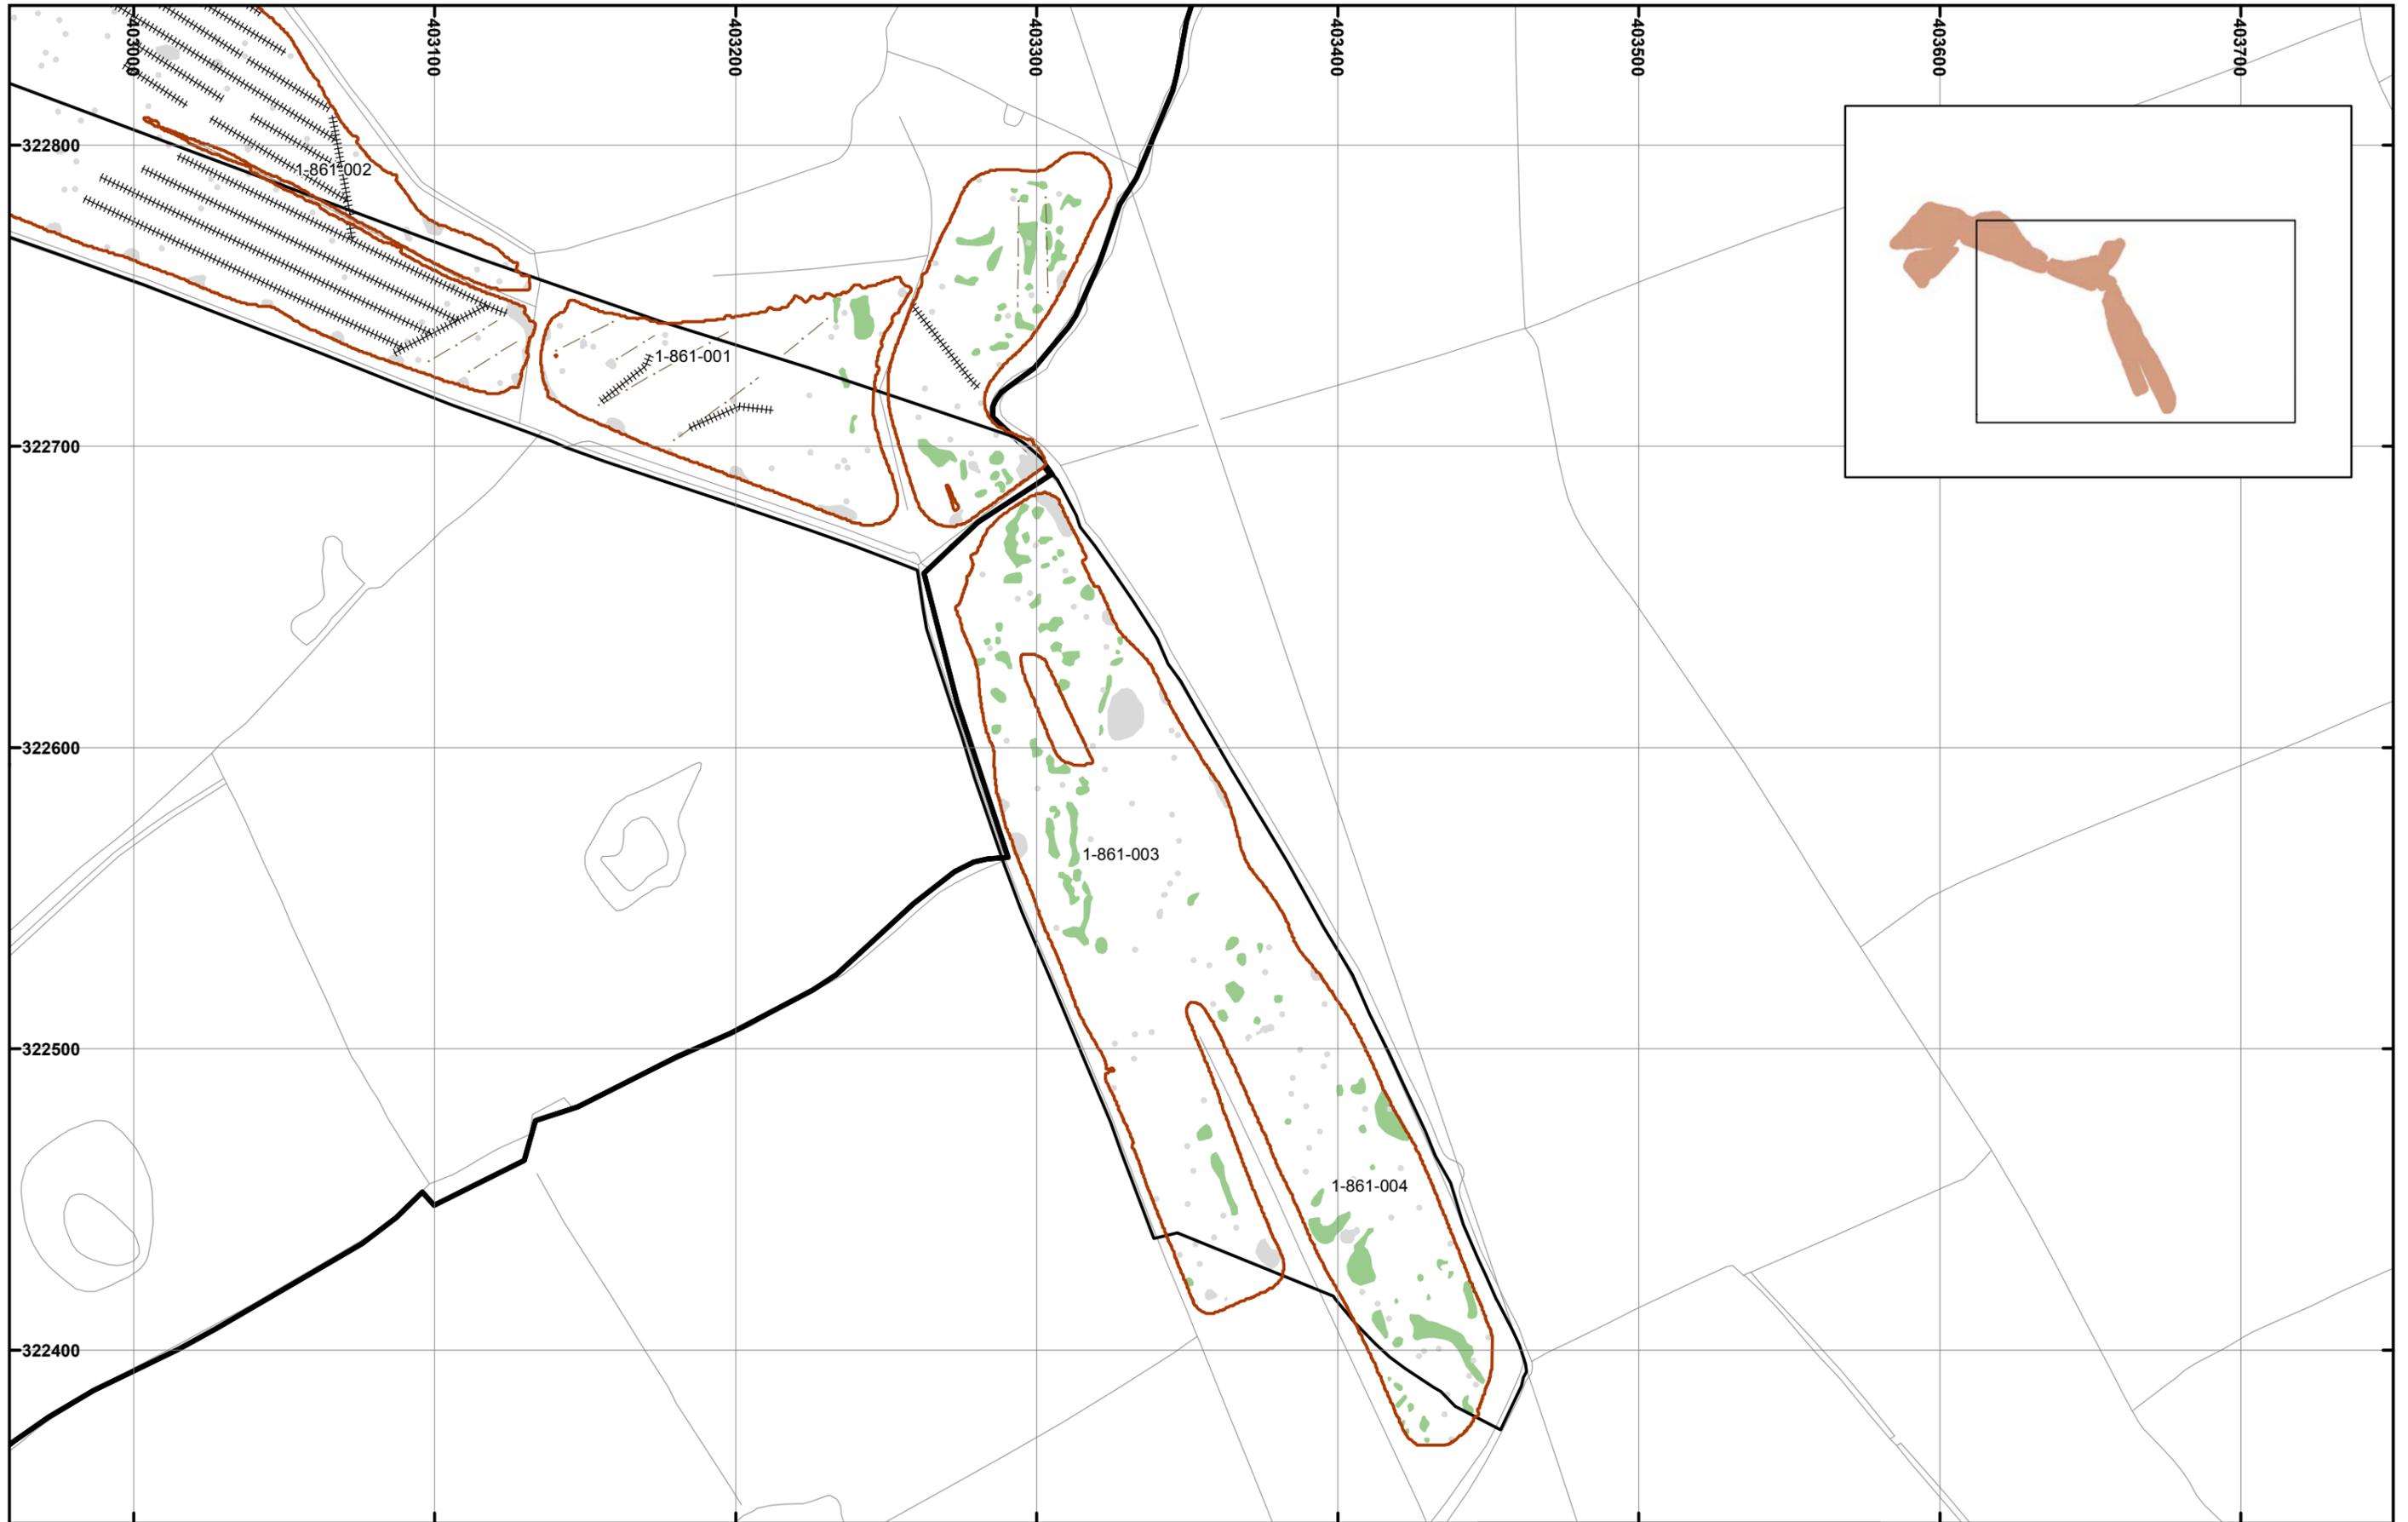
Map Number
Figure 50

- 2.13.11 The gradiometer survey, carried out between 26 – 27 September 2016 using a cart system, identified an area of ridge and furrow, anomalies likely of agricultural and geological origin, along with some trends and numerous ferrous responses.
- 2.13.12 Results are presented as a series of greyscale and archaeological interpretations, at a scale of 1:2000 (Figures 47 – 50). The interpretation of the datasets highlights the presence of potential archaeological anomalies, ferrous/burnt or fired objects, and magnetic trends (Figure 48 and 50).
