Near miss at Magdalen Road level crossing, 9 August 2017

2. Summary of the incident

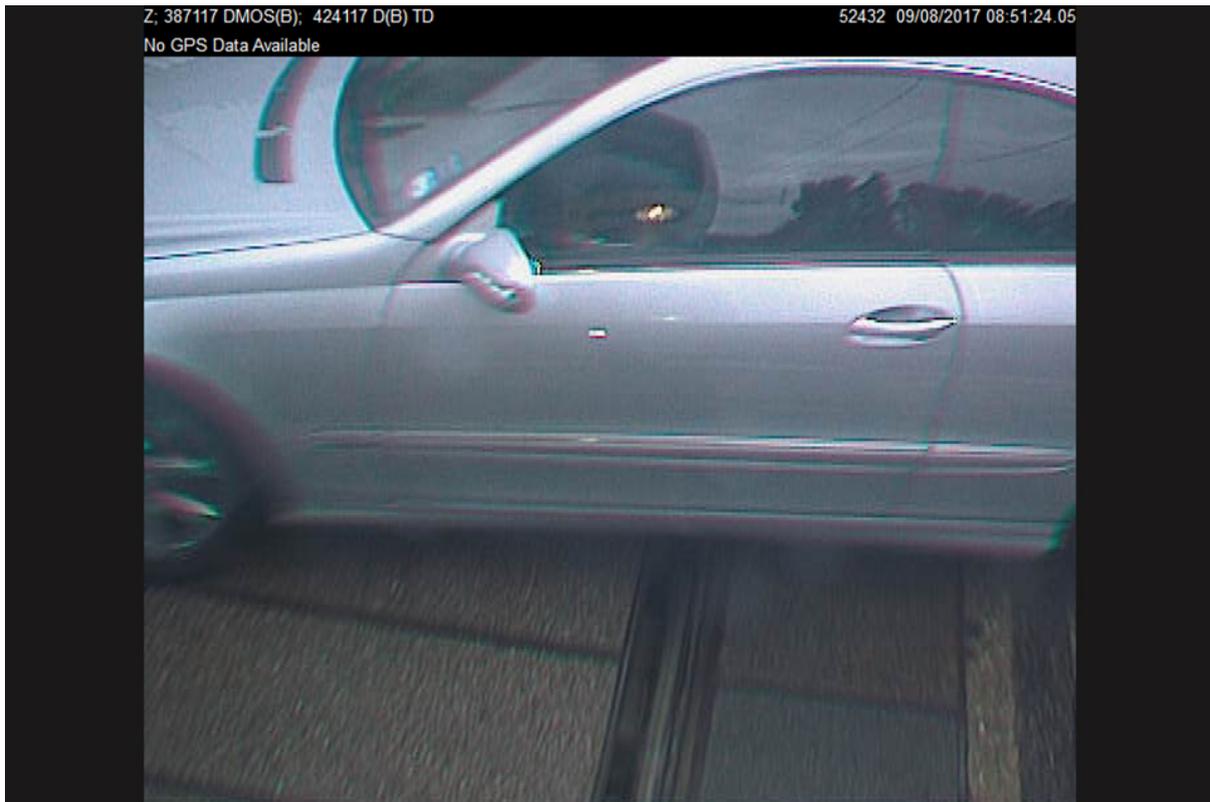
At 08:51 hrs on 9 August 2017, a car traversed Magdalen Road level crossing at Watlington station immediately in front of a train, narrowly avoiding a collision. The crossing, controlled from the adjacent signal box, was open to road traffic at the time of the incident. The train, the 07:54 Kings Lynn to King's Cross service operated by Govia Thameslink Railway, was travelling at low speed as it had just departed from Watlington station.

CCTV footage (courtesy of Govia Thameslink Railway)

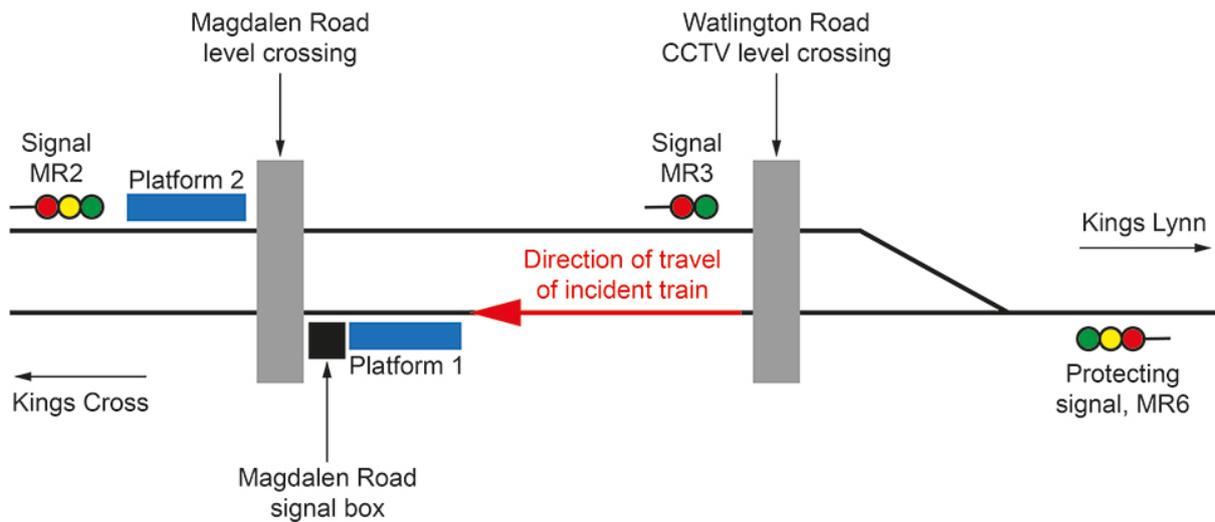
The signaller in Magdalen Road signal box is responsible for lowering the barriers at Magdalen Road level crossing and ensuring that the crossing is closed to road traffic during the passage of trains. When a train approaches from Kings Lynn, the signaller first closes both Magdalen Road and Watlington Road level crossings to road traffic. He then looks to check that both crossings are clear of any obstruction (he checks Watlington Road level crossing by means of a CCTV monitor). When he is satisfied that both crossings are free of obstruction, he clears protecting signal MR6 which authorises the train to pass over both crossings. Once the train has passed over each crossing it will re-open automatically. The exception to this, is when the signaller has placed the crossing into manual control. Then the crossing will remain closed until manually re-opened. The railway at this location is a two-track railway and the same principles apply for a train approaching from King's Cross.

Schematic diagram of area

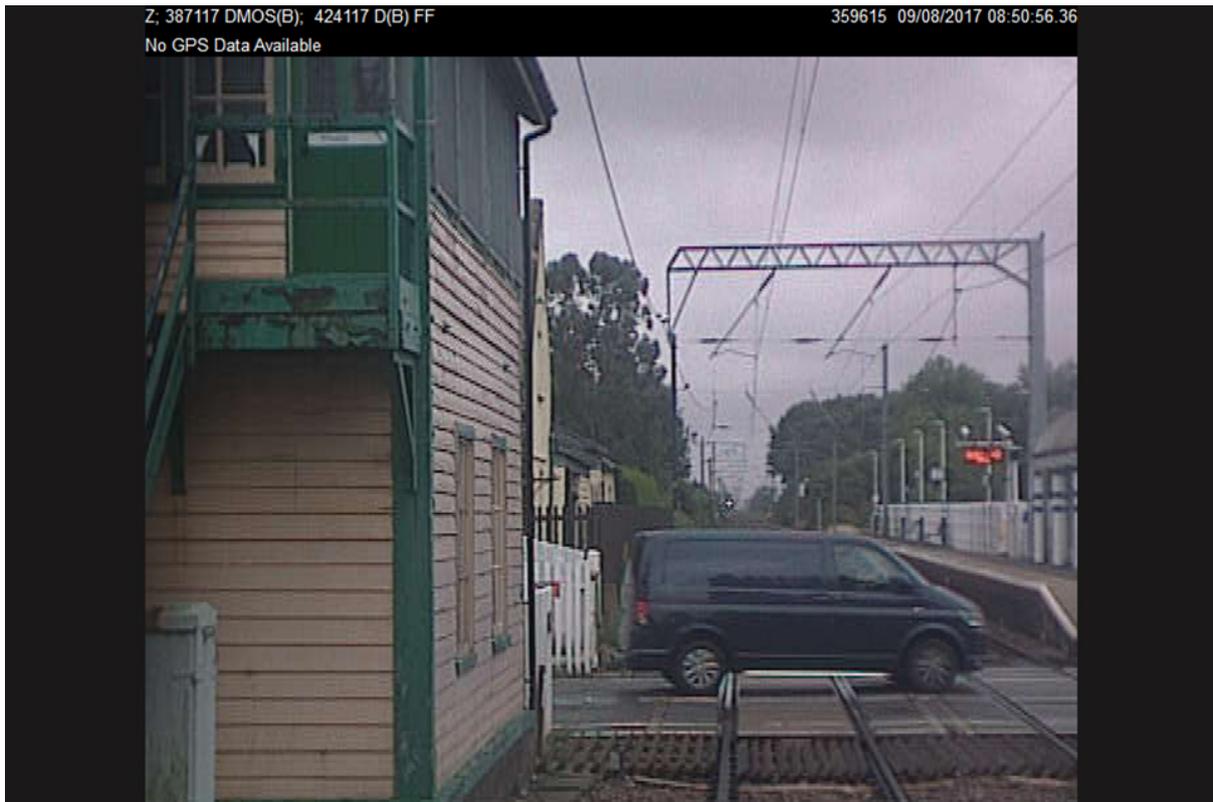
After being authorised to pass the signal at danger, the driver of the train from Kings Lynn proceeded towards the station. Witness evidence suggests that neither the driver nor the driving instructor saw any of the six cars that traversed Magdalen Road level crossing after the train passed over Watlington Road level crossing, or the two vans that crossed as the train was stationary at platform 1. The same evidence also suggests that they did not see that the barriers were raised. It is recognised that the driver and instructor were focused on the planned stop at Watlington station during this time. Nevertheless, the Rule Book states that, when authorised to pass a signal at danger, train drivers are to proceed at caution and to check that it is safe to proceed before passing over any crossing normally controlled by the signaller.

Neither the driver, nor the driving instructor, saw the vehicle that passed immediately in front of them. However, this is unsurprising as it can be difficult for drivers to see objects close to the front of trains due to their driving position.

CCTV footage – Van crossing as the train was waiting in platform (courtesy of Govia Thameslink Railway)
