# Dartford Housing Retrofit Project Evaluation Report

July 2017

Project	Dartford Housing Retrofit Project Evaluation
PRP Reference	AN6478
Studio	London
Client	The Secretary of State for Business, Energy and Industrial Strategy
Issue	Draft v2
Author	Jenny Ho and Sara Celentano
Checked by	Andrew Mellor
Date	July 2017

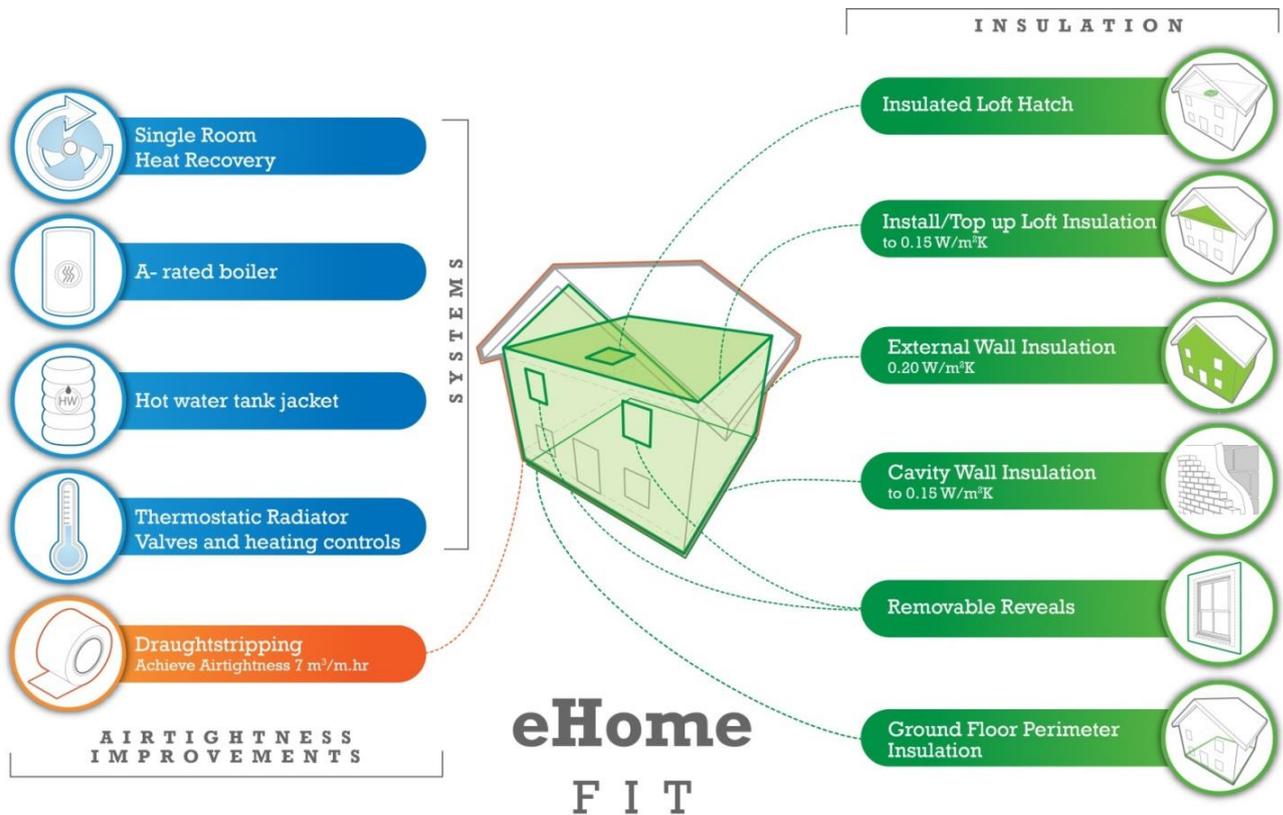
Figure 1: Infographic of the retrofit solution

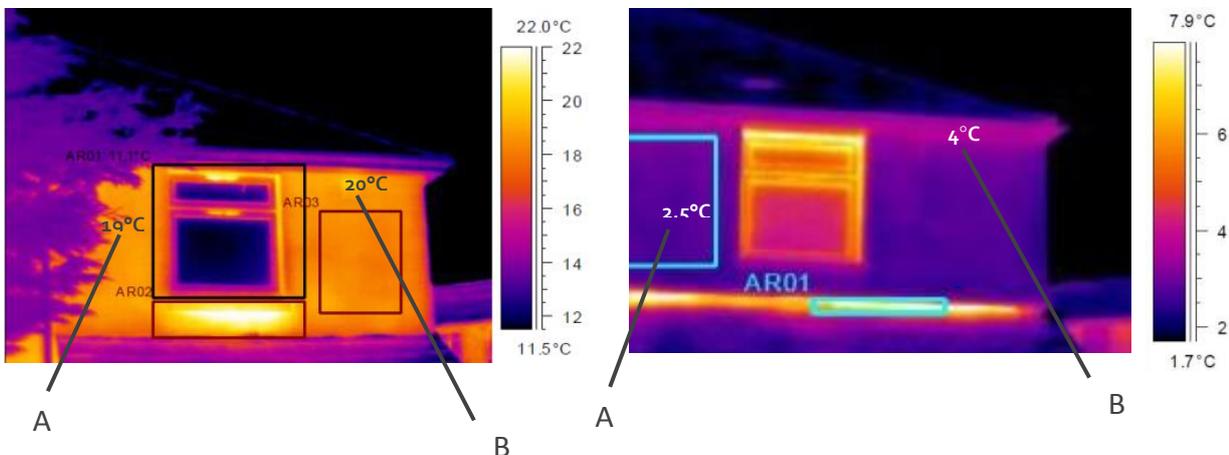
Figure 3: Thermal images of the front wall of D1 prior to retrofit (left) and post (right).

Figure 3 shows the exterior wall of D1, pre and post-retrofit. After 150mm of wall insulation was added to the first floor, the thermal performance was improved across the area. Specific areas highlighted a decrease in temperature loss; 16.5°C at point A and 16°C at point B, pre and post-retrofit. This equates to 87% and 80% of reduction in heat loss for points A and B respectively.

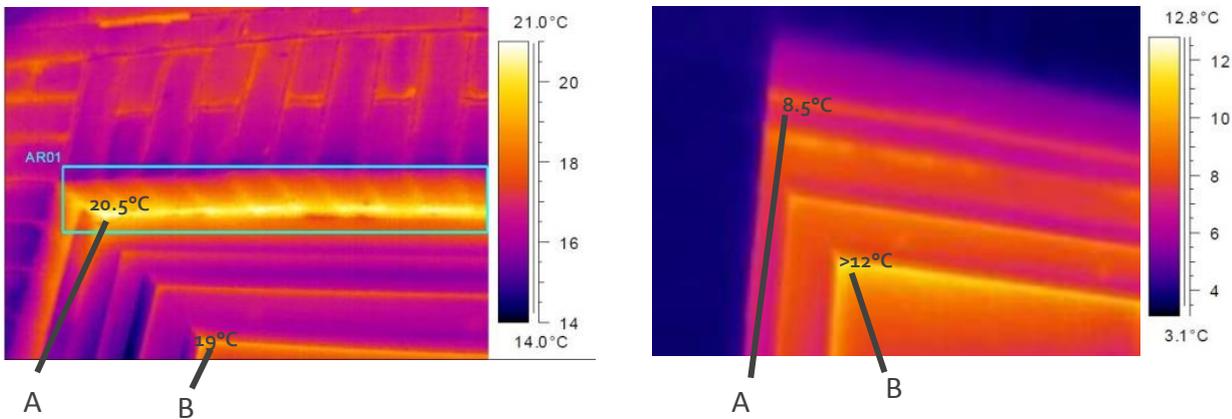
Figure 4: Thermal images of a door on D1 prior to retrofit (left) and post (right).

Figure 4 shows heat loss at the rear door of D1 that was insulated and draughtstripped as part of the project. A decrease in temperature loss was recorded, as shown in points A and B, with a difference of 12°C and 12.5°C pre and post-retrofit respectively.

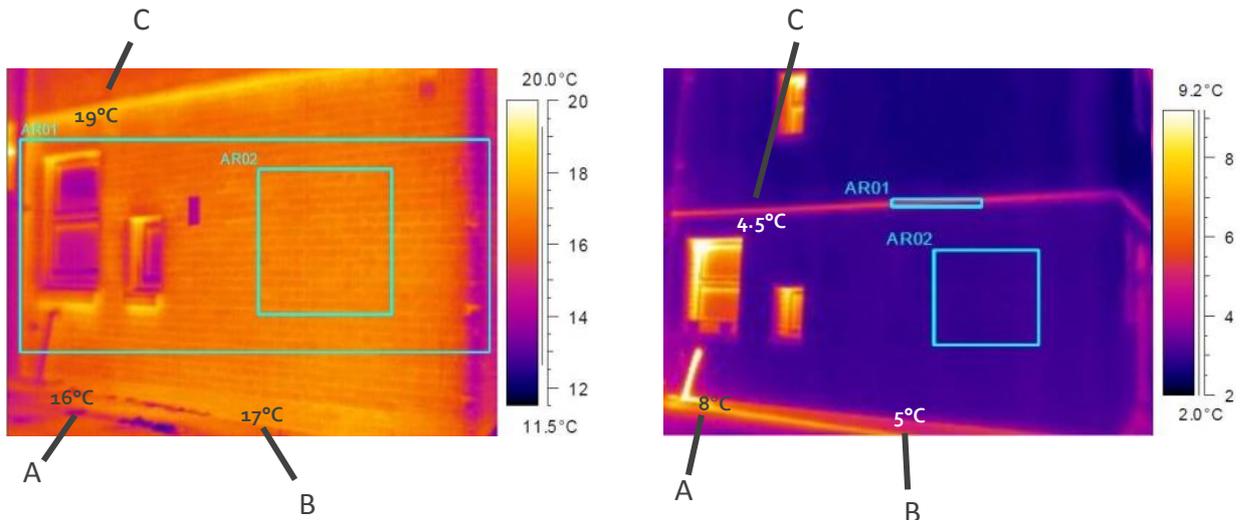
Figure 5: Thermal images the DPC on D1 prior to retrofit (left) and post (right).

Points A and B in Figure 5 both showed decreases in temperature loss around the below DPC area; 8°C and 12°C of difference pre and post-retrofit respectively. Point C showed the trim between the ground and first floor. Heat loss was reduced from 19°C to 4.5°C.

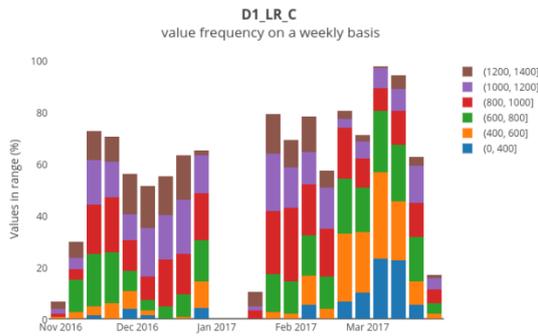
Figure 6 and Figure 7 below show the frequency of the CO<sub>2</sub> levels (measured in parts per million (ppm)) in the living room and the bedroom post-retrofit. Although there was very limited data available, it appears that the air exchange was considered generally acceptable at the property, and was only occasionally over the ASHRAE recommendations of 1,000ppm.

Figure 6: Frequency chart for CO<sub>2</sub> levels in D1's living room bedroom

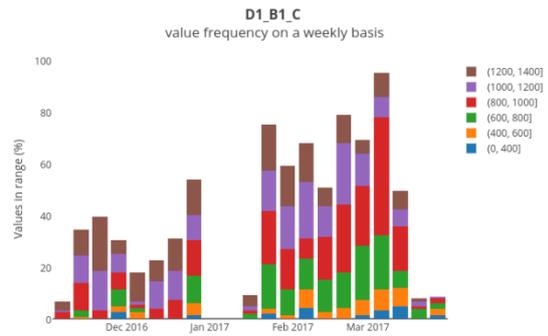
Figure 7: Frequency chart for CO<sub>2</sub> levels in D1's bedroom

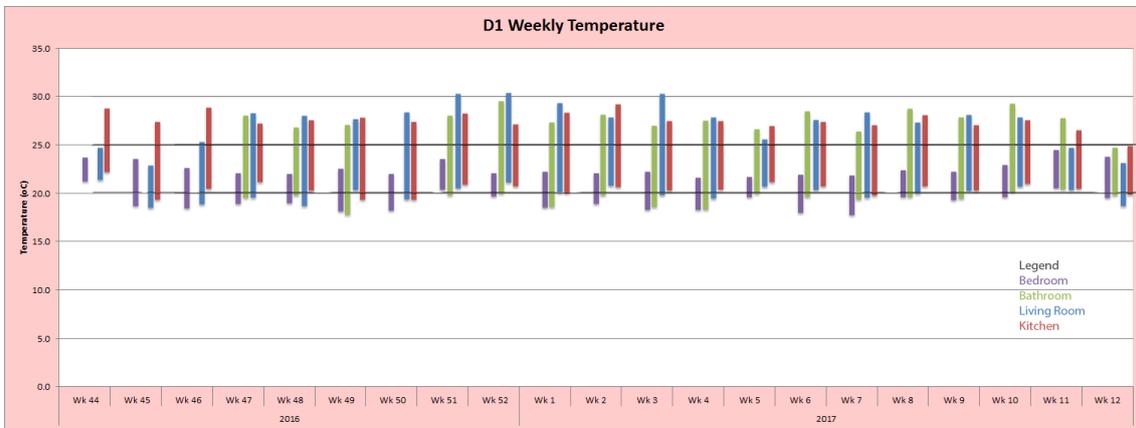
The living room sometimes reached a maximum of 30°C, however, the occupant did not state that the temperature in the living room was uncomfortable.

Figure 8: Average weekly internal temperatures in D1 post-retrofit

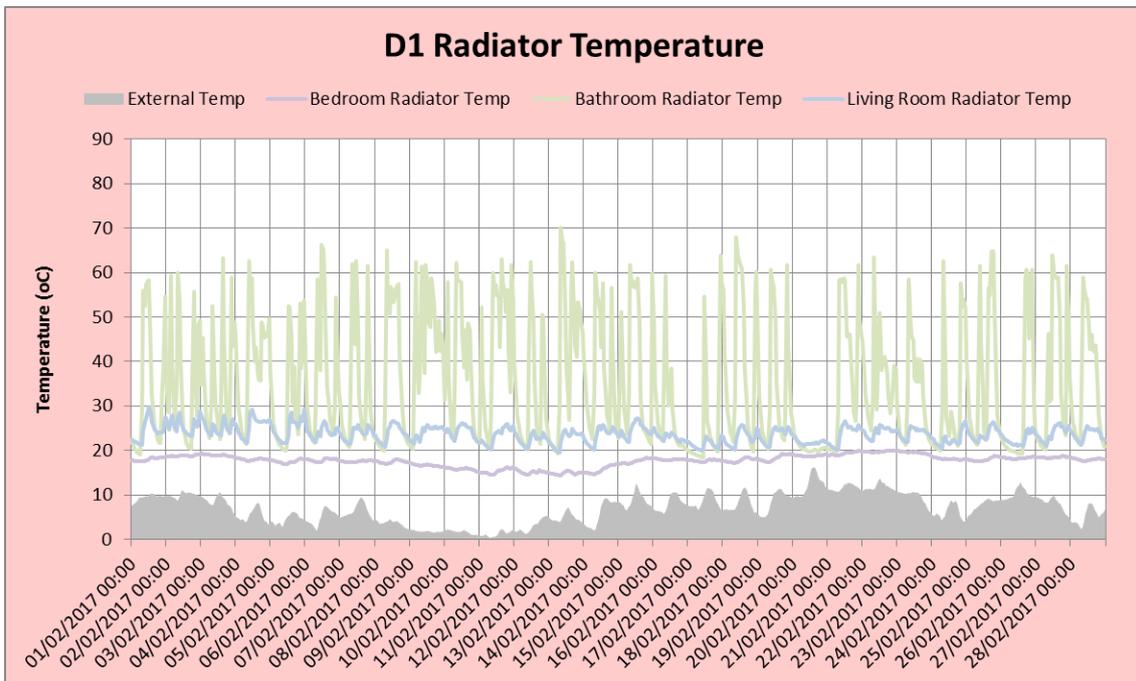
Data suggested that the radiator was turned on regularly in the bathroom while the radiator was not turned on at all in the bedroom and rarely in the living room. Figure 9 below shows a snapshot of the heating pattern for this property in February 2017. It is worth noting that the radiator temperature in the bathroom was a lot higher than the one in the living room, even though the average internal room temperatures in these rooms were quite similar. This suggested that the bathroom was heated constantly for various uses (including bathing the children and drying robes, as confirmed by the occupant), and that the radiator in the bathroom might have helped in heating the hall leading to the side door in the rear extension.

Figure 9: Average hourly radiator temperatures in D1 in February 2017 (post-retrofit)

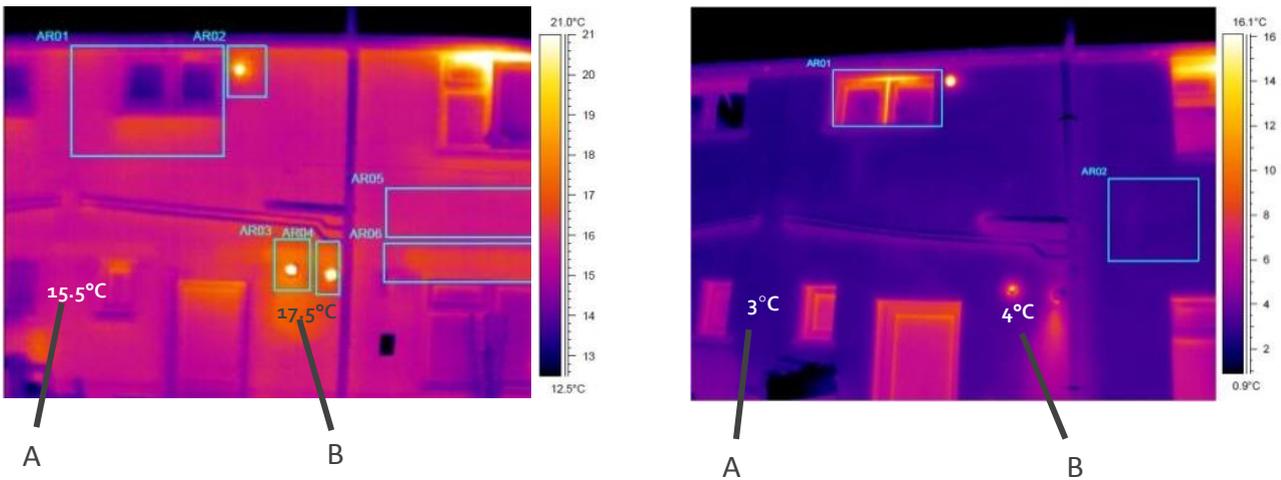
Figure 10: Thermal images of an external wall on D3 prior to retrofit (left) and post (right).

Figure 10 shows the thermal improvements post-retrofit on an external wall on D3 with 150mm of wall insulation added. The external surface of the wall was at a consistently lower temperature, which indicates that the retrofit worked well. Temperature losses decreased at point A from 15.5°C to 3°C and 17°C to 4°C at point B; an average improvement of 13°C across the two points.

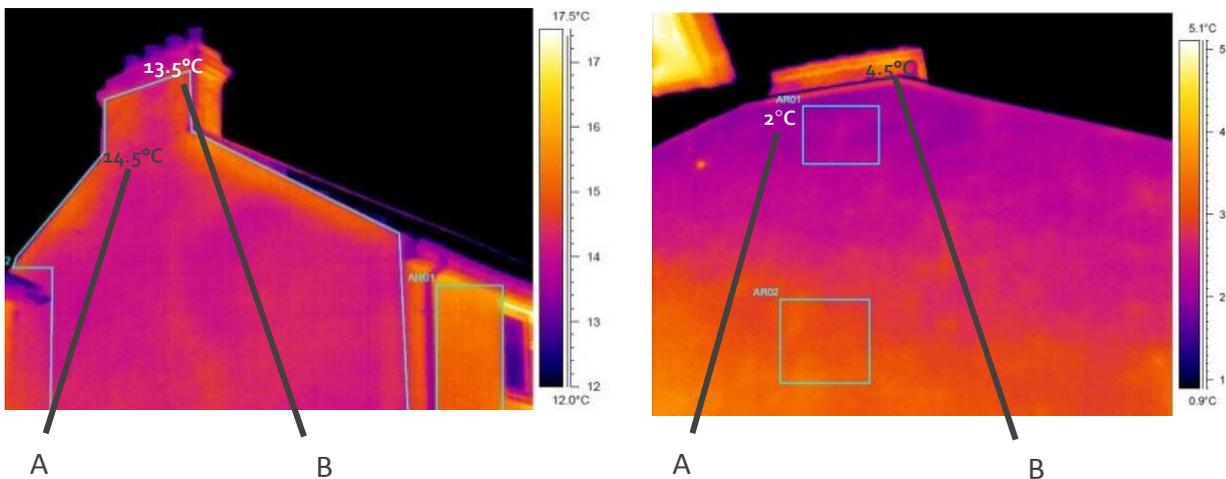
Figure 11: Thermal images of the roof on D3 prior to retrofit (left) and post (right).

The thermal image on the left of Figure 11 shows the roof on D3 prior to retrofit, with 200mm of uneven insulation, and post-retrofit (right), where the insulation was topped up to 320mm (making the cold roof wall 1.5°C -2°C colder than the rest of the façade). Again, points A and B were examples of the effectiveness of the retrofit measures. Point A, below the roofline, showed a 14.5°C heat loss and 2°C after the work; a 12.5°C of decrease in heat loss or an 86% of improvement. Point B showed 13.5°C of heat loss prior to the work and 4.5°C after. This equates to a 67% of decrease in heat loss.

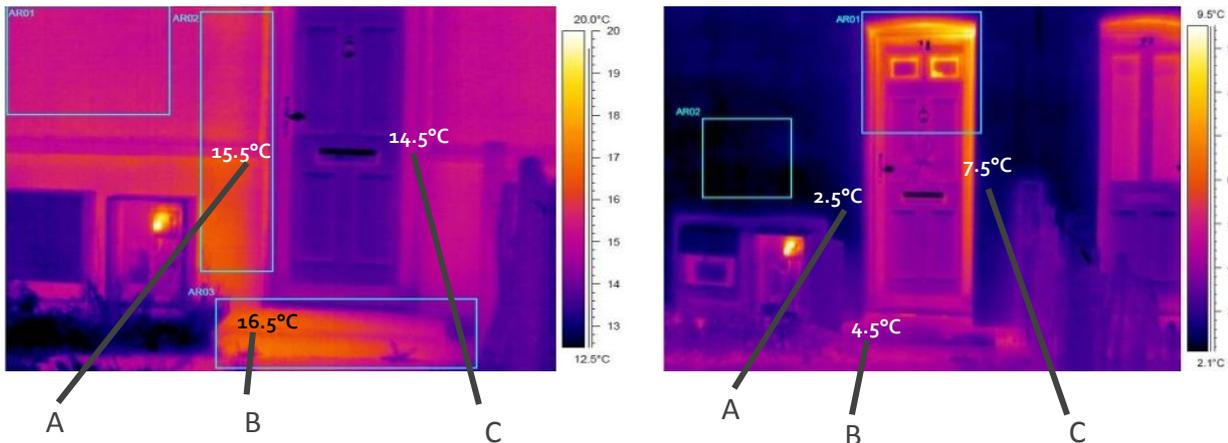
Figure 12: Thermal images of the front door on D3 prior to retrofit (left) and post (right).

Figure 12 shows the thermal improvements around the front door area of D3, which was draughtstripped. The area surrounding the door, points A and C, showed a decrease in heat loss; 2.5°C compared to 15.5°C for point A and 7.5°C compared to 14.5°C for point C. Point B showed the heat loss below the door which was reduced from 16.5°C to 4.5°C, this equates to a 73% decrease in heat loss after retrofit measures were installed.

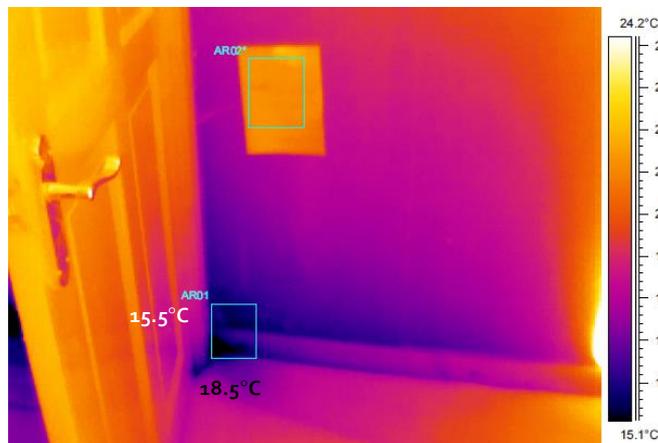
Figure 13: Thermal image of the entrance in D3.

Figure 13 shows an area of thermal bridging which posed a risk for damp developing. However, as there were meters on the other side of this wall the area was difficult to insulate. A temperature of 15.5°C and TI value of 0.45 in area AR01 also indicated that there was a slight risk of condensation and mould growth.

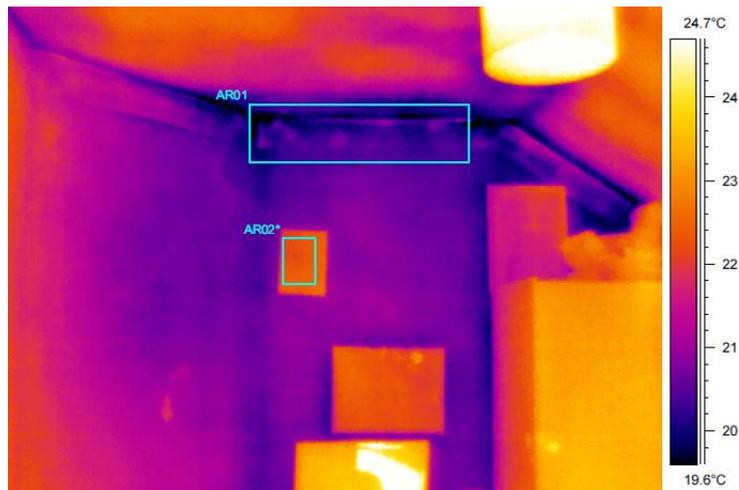
Figure 14: Thermal image of the back bedroom of D3

Figure 14 shows the back bedroom of D3; a TI value of 0.82 meant that the risk of condensation would be unlikely.

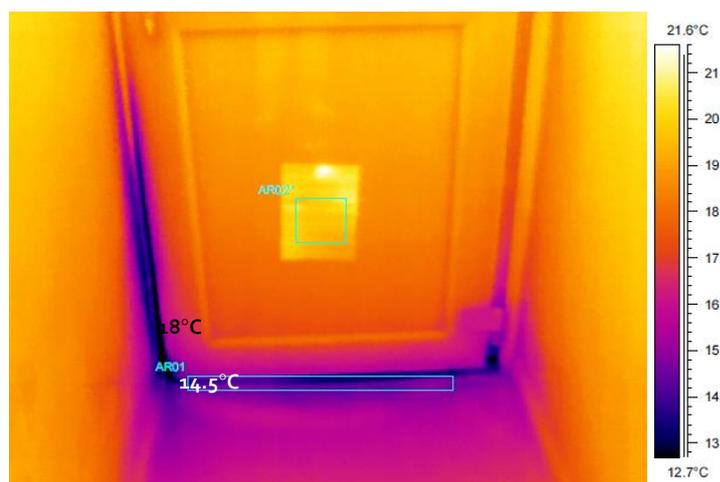
Figure 15: Thermal image of the wall door in the back hall of D3

Figure 15 shows areas that might be a risk of condensation around the door in the back hall of D3, because area AR01 was colder than the surroundings (14.5°C compared to 18°C). This indicated that a further draught-stripping could have been beneficial in this area.

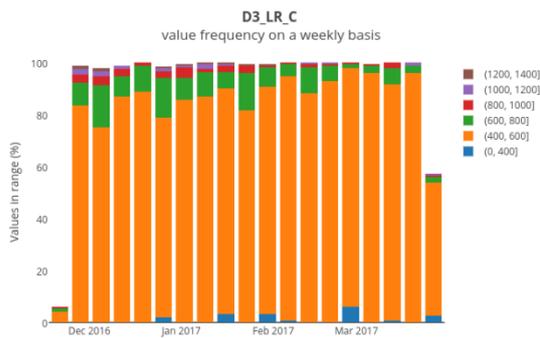
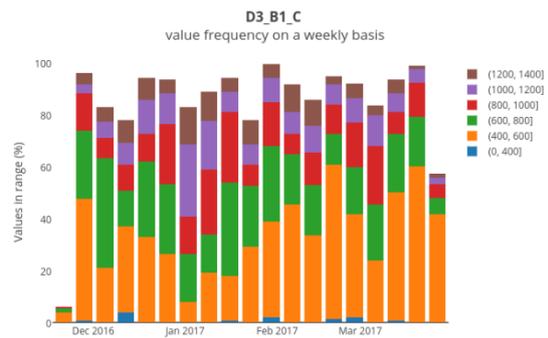
The graphs below show the frequency of the CO<sub>2</sub> levels in the living room and the bedroom post-retrofit. The CO<sub>2</sub> levels in the living room and the bedroom were both below the ASHRAE (American Society of Heating, Refrigerating and Air-Conditioning Engineers) recommendation threshold of 1,000ppm, which suggested good air exchange in these rooms. The results also showed that the bedroom was less well-ventilated than the living room, in line with the information gathered in the interview.

Figure 16: Frequency chart for CO<sub>2</sub> levels in D3's living room    Figure 17: Frequency chart for CO<sub>2</sub> levels in D3's bedroom

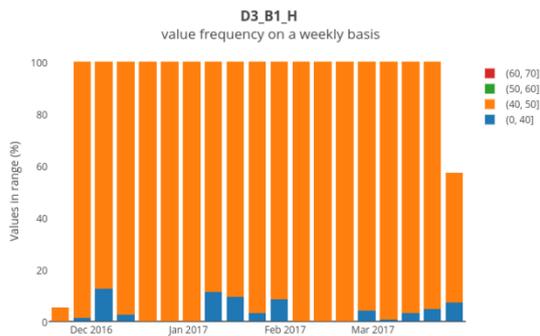
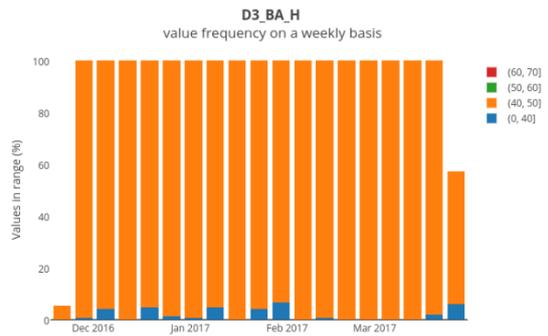
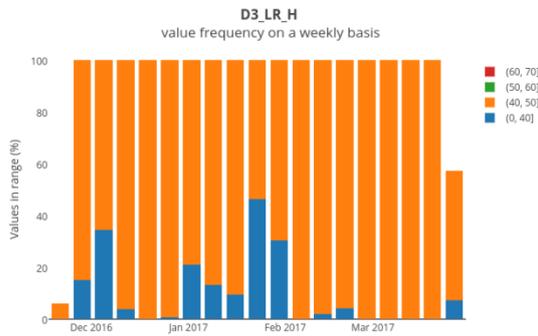
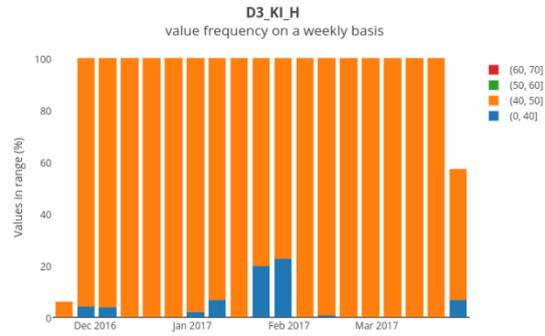
The graphs below show that the average monthly relative humidity levels were mostly between 40% and 50%.

Figure 18: Frequency chart for RH in D3's bedroom

Figure 19: Frequency chart for RH in D3's bathroom

Figure 20: Frequency chart for RH in D3's living room

Figure 21: Frequency chart for RH in D3's kitchen

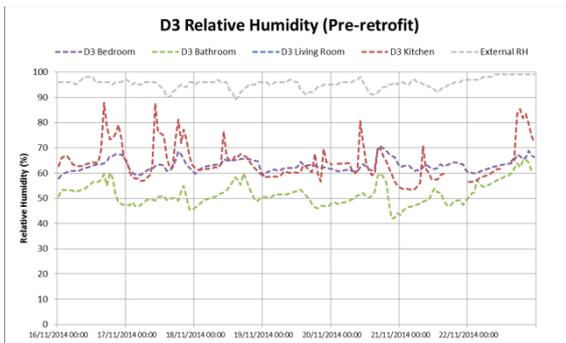
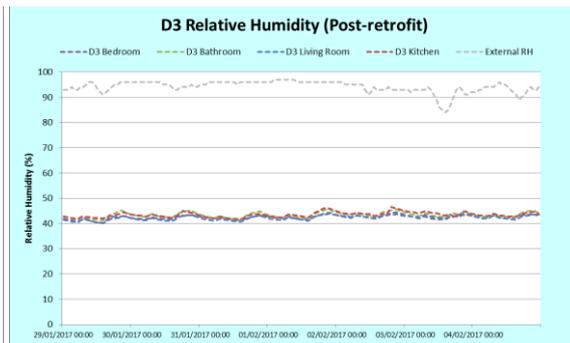
Data from one week in the pre-retrofit period and one week in the post-retrofit period was selected for closer inspection, taking into account the similarity between the external weather conditions (similar average external temperature and RH, and similar estimated HDH for the week), as shown below. Data showed that the average relative humidity levels in the rooms were lower and more regulated post-retrofit.

Figure 22: Average RH in D3 for a week pre-retrofit

Figure 23: Average RH in D3 for a week post-retrofit

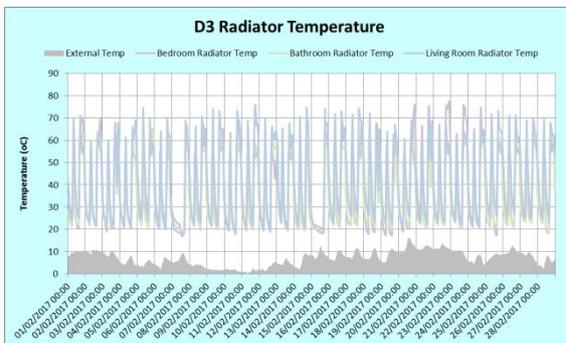
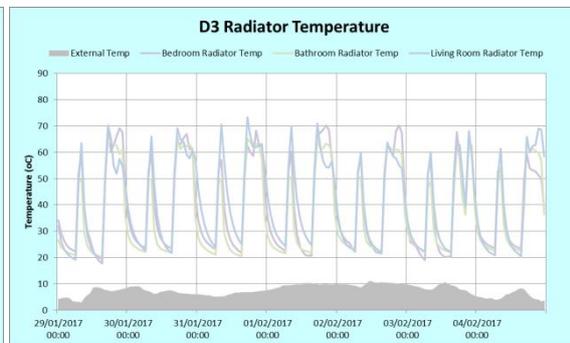
The graph below suggested that the radiator was turned on regularly in all the rooms, and that the heating system was programmed to be turned on at certain times of the day. This was confirmed by the occupant who said that the heating system was set on a timer during the winter period to be turned on at 6:30am for an hour and then again between 2:30pm and 9:30pm.

Figure 24: Average radiator temperatures in D3 in Feb 2017

Figure 25: Average radiator temperatures in D3 for a week

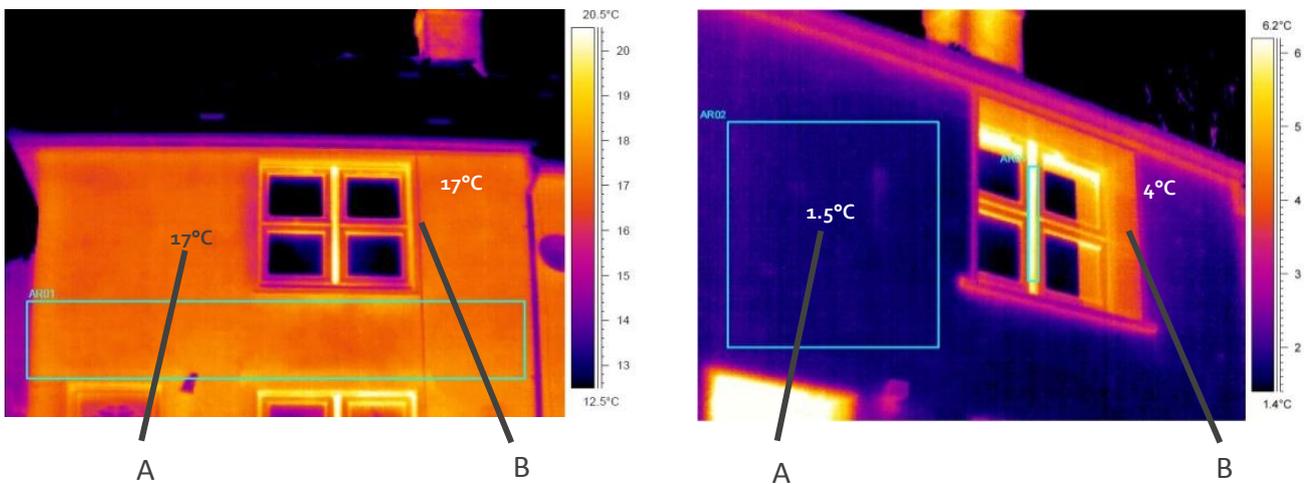
Figure 26: Thermal images of a window and eaves on D6 prior to retrofit (left) and post (right).

Figure 26 shows how solid wall insulation had improved the thermal performance of the building on the external front wall. The window reveals were warmer than the average temperature recorded on the walls (from 17°C to 1.5°C, point A) as shown in the right hand side picture, which was expected due to the thickness of the insulation installed in this area, however, the temperature decreased considerably as opposed to the pre-retrofit scenario, where temperature had decreased from 17°C to 4°C (point B).

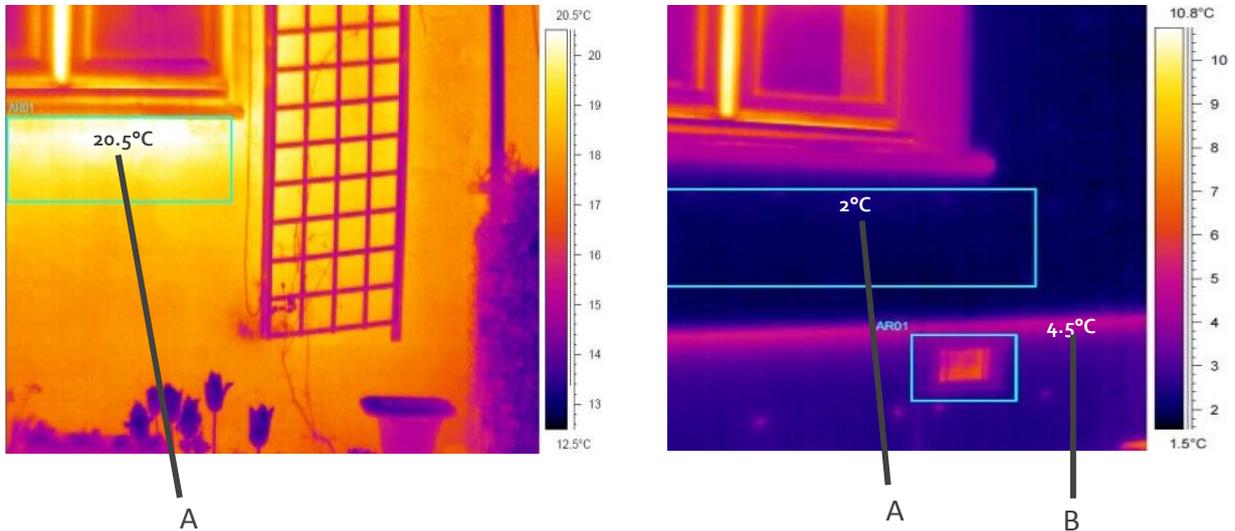
Figure 27: Thermal images of a window on property D6 prior to retrofit (left) and post (right)

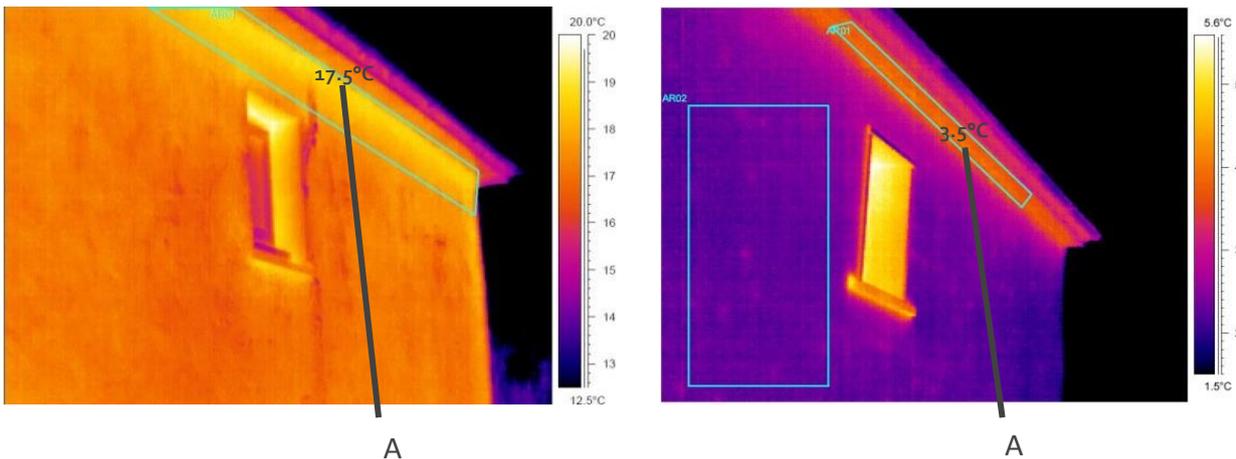
Figure 28: Thermal images of a window on property D6 prior to retrofit (left) and post (right)

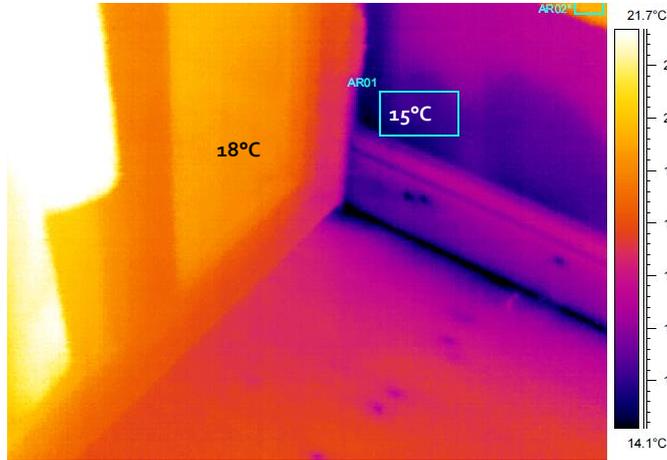
Figure 29: Thermal image of the living room skirting in property D6 post-retrofit.

Figure 29, taken in the living room corner, shows air leakage above the skirting, where it met the floor and wall. The temperature of this area, 15°C, was colder than its surroundings. Furthermore, a TI value of 0.62 in area AR01, caused by the low surface temperature compared to the internal temperature, indicated that there was a slight risk of damp and mould growth.

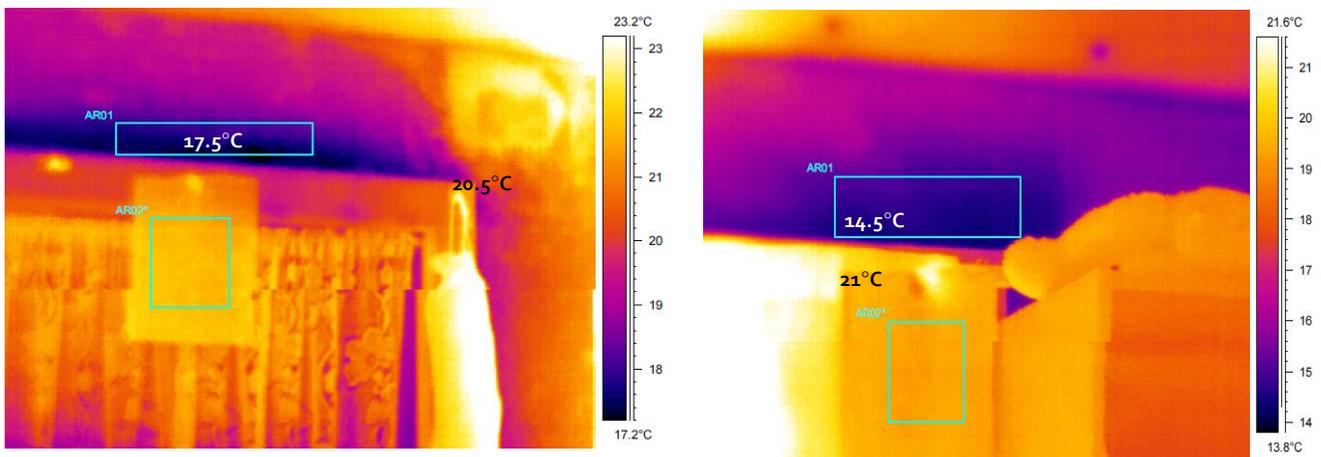
Figure 30: Thermal images of window areas in the kitchen (left) and bedroom (right) in property D6.

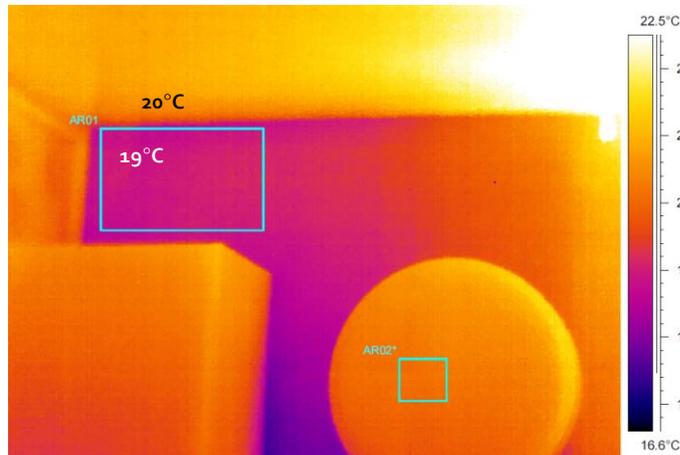
Figure 31: Thermal image of kitchen wall in property D6 with a TI value of 0.90

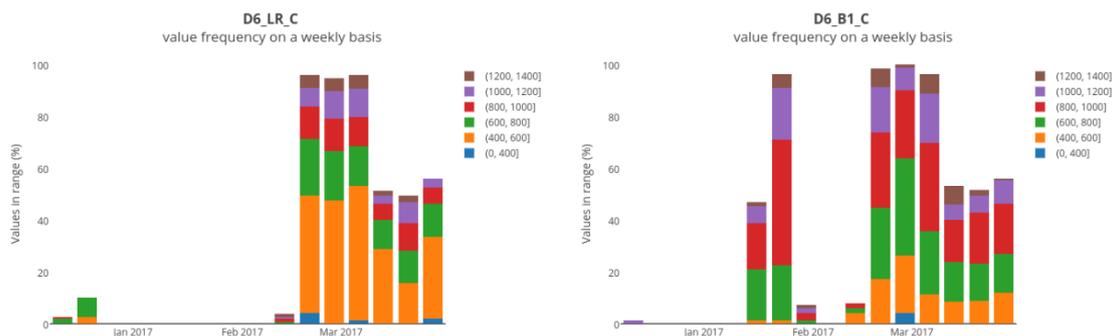
The graphs below shows the frequency of the CO<sub>2</sub> levels in the living room and the bedroom post-retrofit. Although there was very limited data available, it appears that the air exchange was considered generally acceptable at the property, and would only occasionally go over the ASHRAE recommendations of 1,000ppm.

Figure 32: Frequency chart for CO<sub>2</sub> levels in D6's living room    Figure 33: Frequency chart for CO<sub>2</sub> levels in D6's bedroom

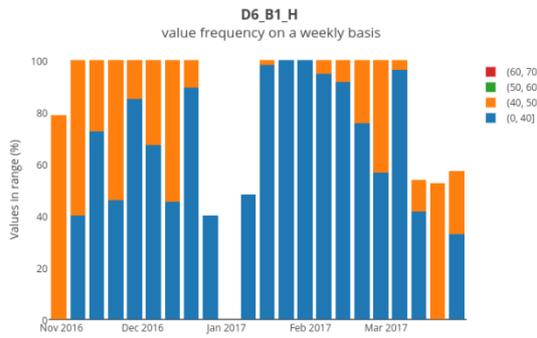
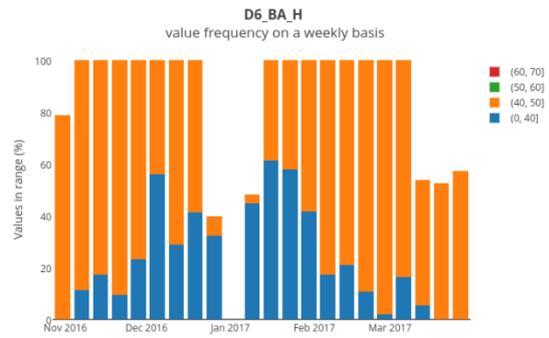
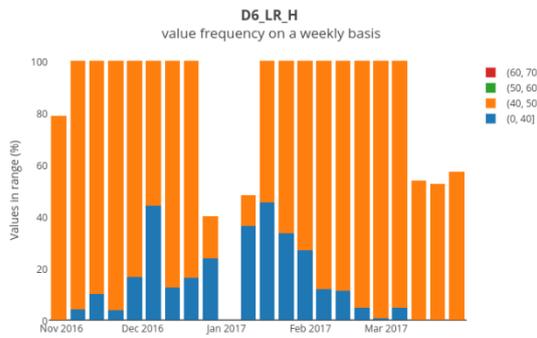
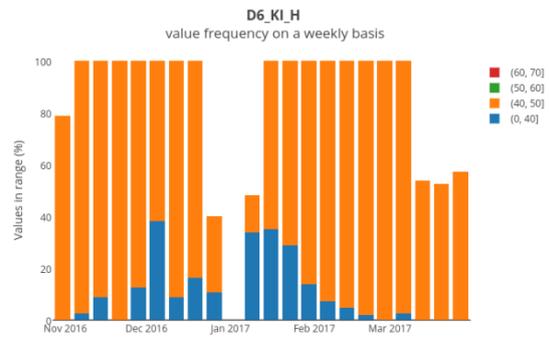
Results showed that the average relative humidity levels were typically around 40% during the monitoring period. The below graphs show the frequency of the relative humidity levels from a number of data ranges and suggests that the humidity levels did not exceed 50% during the monitoring period.

Figure 34: Frequency chart for RH in D6's bedroom

Figure 35: Frequency chart for RH in D6's bathroom

Figure 36: Frequency chart for RH in D6's living room

Figure 37: Frequency chart for RH in D6's kitchen

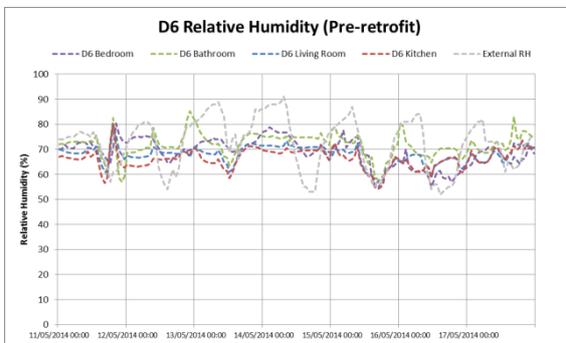
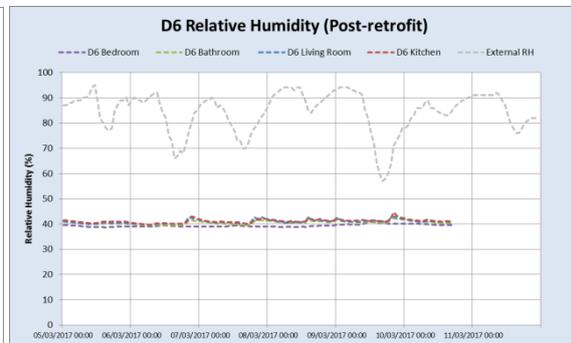
Data from one week from the pre-retrofit period and one week from the post-retrofit period was selected for closer inspection. For D6, as there was not much data in the winter period pre-retrofit (the retrofit work started in September 2014), a week in May 2014 was selected to compare with a week in March 2017, as shown below. Data showed that the average relative humidity levels in the rooms were more effectively regulated and lower in the post-retrofit scenario.

Figure 38: Average RH in 63 for a week pre-retrofit

Figure 39: Average RH in D6 for a week post-retrofit

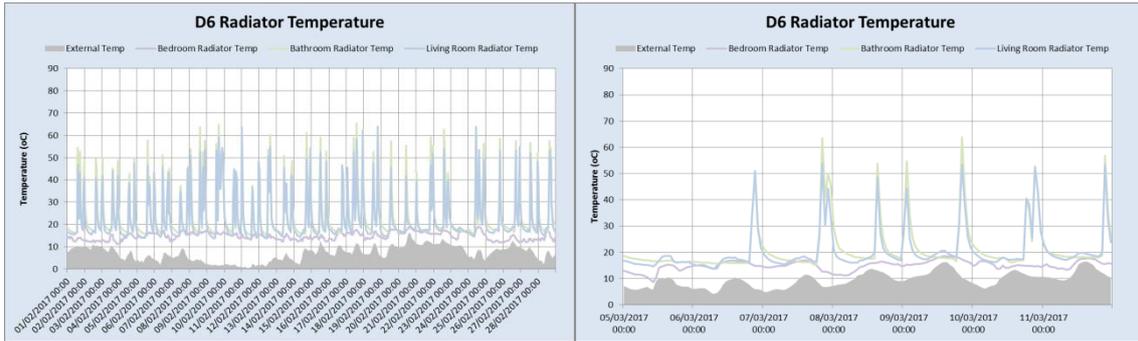
On closer investigation (by looking at the temperature on a chosen week, i.e., week 10, in March 2017), it was confirmed that the heating system usage pattern matched the occupant's description in the interview.

Figure 40: Average radiator temperatures in D6 in Feb 2017 Figure 41: Average radiator temperatures in D6 for a week

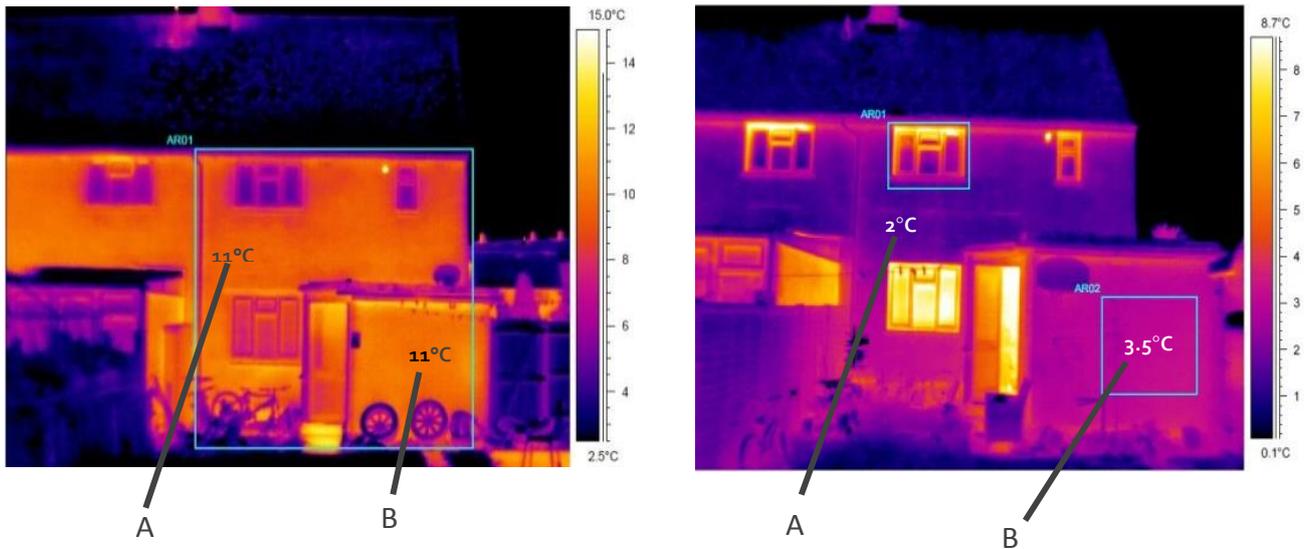
Figure 42: Thermal images of the front of D10 prior to retrofit (left) and post (right)

Point B showed the heat loss from the ground floor extension, this area was not retrofitted. The image on the left demonstrates that there was significant heat loss from the extension; the same as the exterior wall. The image on the right, taken post-retrofit, shows that the internal insulation on the main house had reduced the heat loss from the extension. It should be noted that the extension was not inhabited and was used as a storage room.

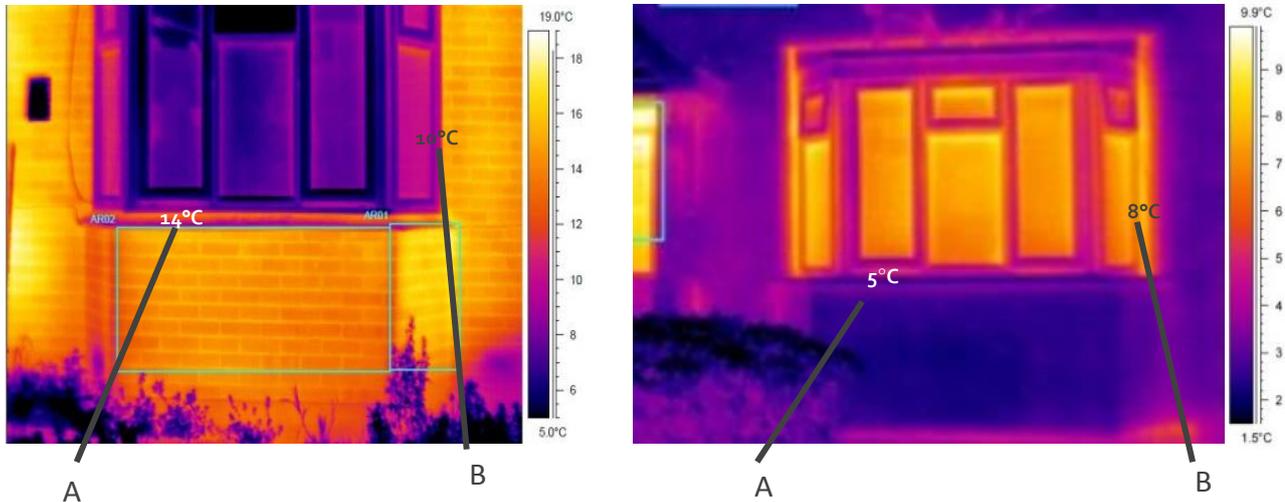
Figure 43: Thermal images of the front window on D10 prior to retrofit (left) and post (right)

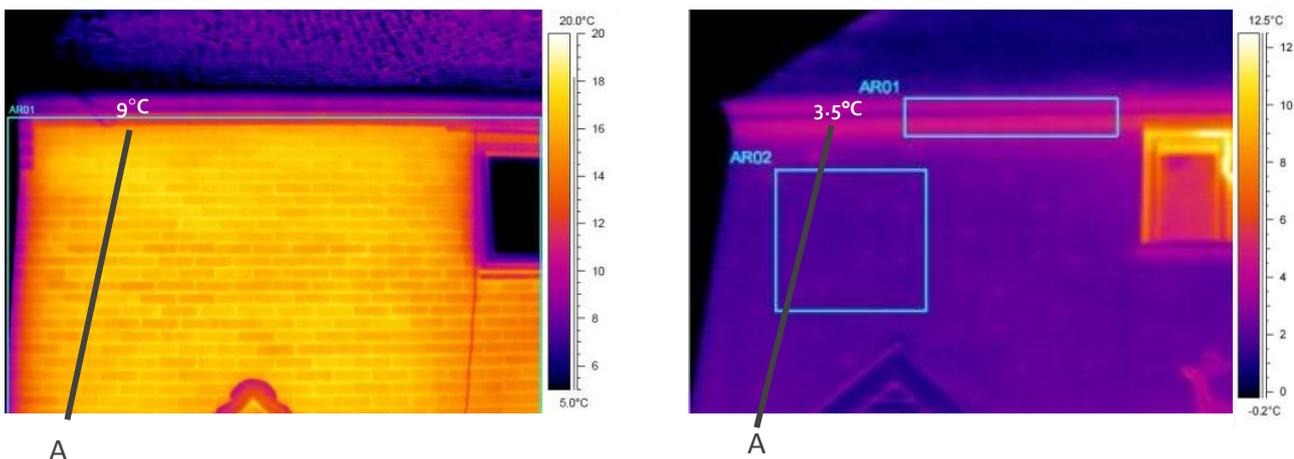
Figure 44: Thermal images of the eaves on D10 prior to retrofit (left) and post (right)

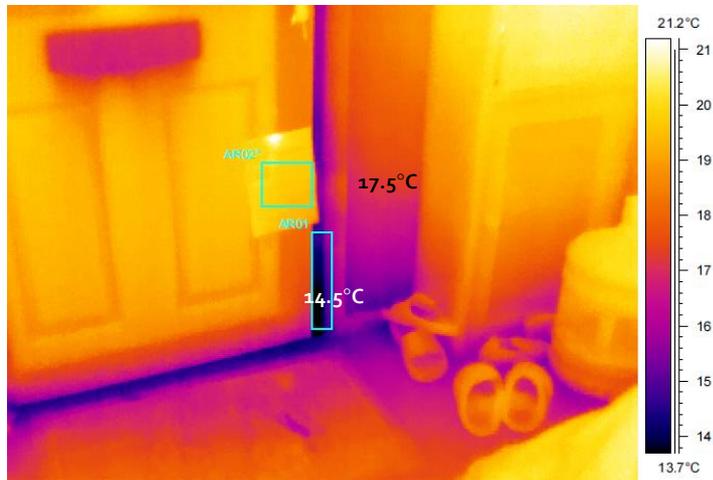
Figure 45: Thermal image of the front door and hallway in D10

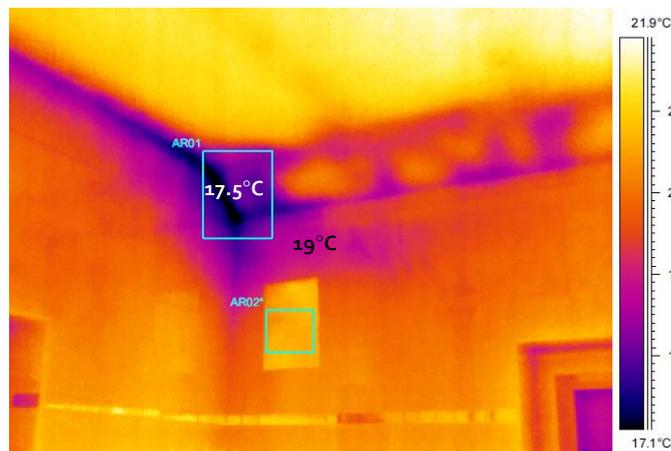
Figure 46: Thermal image of the corner of the bathroom in D10

Figure 46 shows the thermal bridging occurred at the corner of the sloped internal ceiling and the external wall in property D10. Temperatures in the corner, 17.5°C, were lower than the surrounding areas, 19°C, which resulted in a TI value of 0.71. It indicated that there was a risk of condensation and mould growth due to an existing condition (insulation installed unevenly prior to the retrofit works).

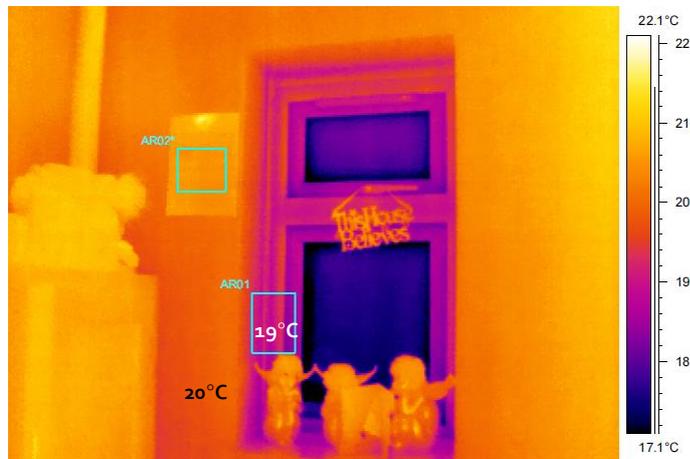
Figure 47: Thermal image of the hallway of property D10

Figure 47 shows the hallway in property D10 where retrofit had been successful in reducing heat loss and areas of thermal bridging. The TI value of 0.88 and temperature of 19°C in the area surrounding the window meant that heat loss had been reduced and damp was less likely to form.

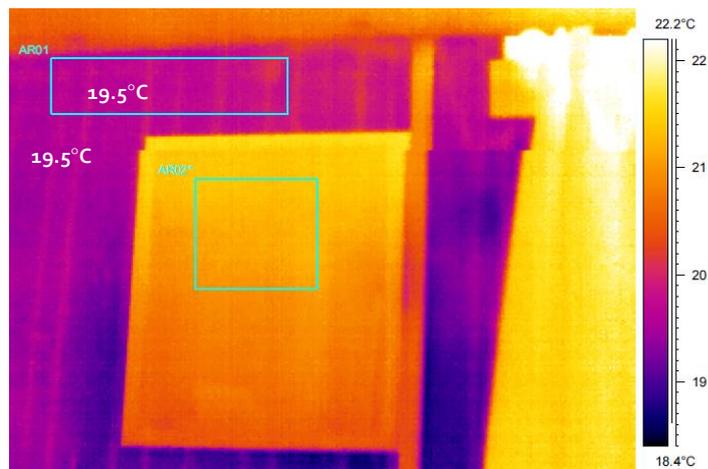
Figure 48: Thermal image of the living room of property D6

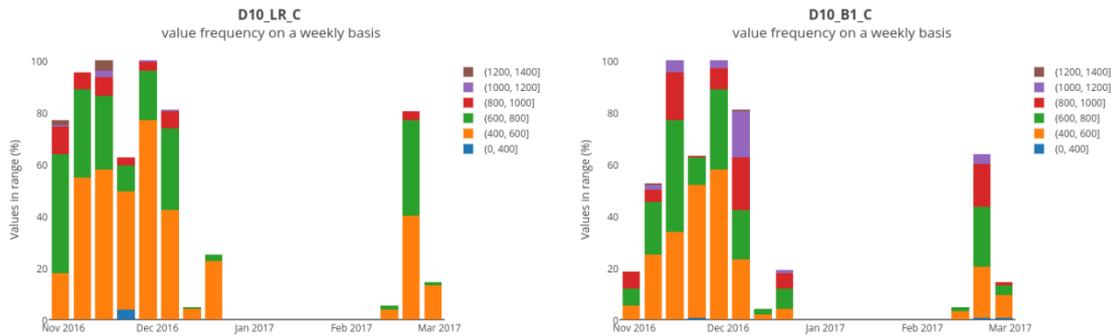
The graphs below show the frequency of the CO<sub>2</sub> levels in the living room and the bedroom collected from the real time loggers. From the very limited data available on the CO<sub>2</sub> levels, it could still be deduced that the CO<sub>2</sub> levels were below the ASHRAE threshold of 1,000 ppm which suggested good air exchange, although the occupant stated that they would regularly open windows out of habit.

Figure 49: Frequency chart for CO<sub>2</sub> levels in D10's living room    Figure 50: Frequency chart for CO<sub>2</sub> levels in D10's bedroom

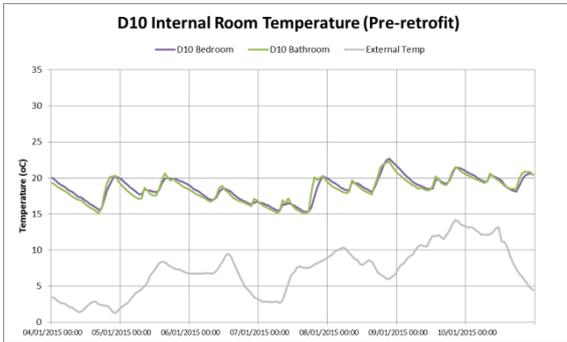
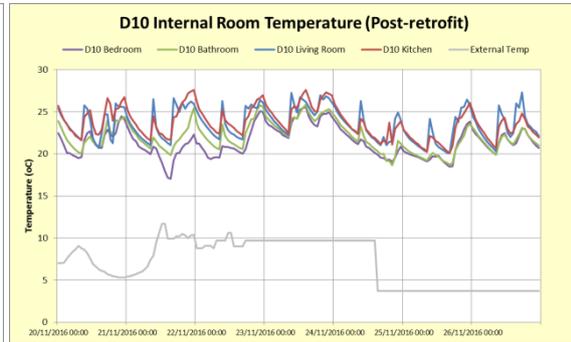
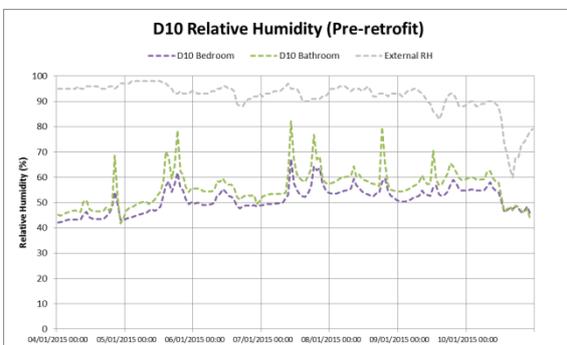
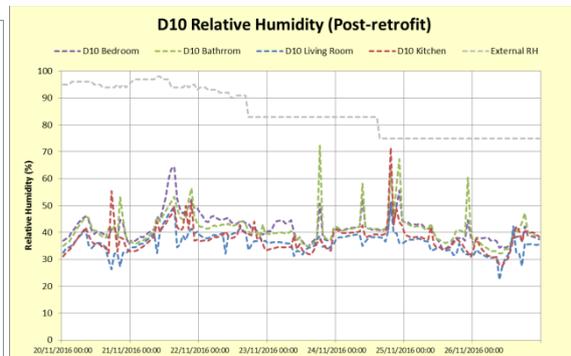
Data from one week from the pre-retrofit period and one week from the post-retrofit period was selected for closer inspection, taking into account the similarity between the external weather conditions (similar average external temperature and RH, and similar estimated HDH for the week), as shown below. Data showed that the average room temperatures in the rooms had increased and the average relative humidity levels had decreased in the post-retrofit scenario.

Figure 51: Average internal temp in D10 for a week pre-retrofit

Figure 52: Average internal temp in D10 for a week post-retrofit

Figure 53: Average RH in D10 for a week pre-retrofit

Figure 54: Average RH in D10 for a week post-retrofit

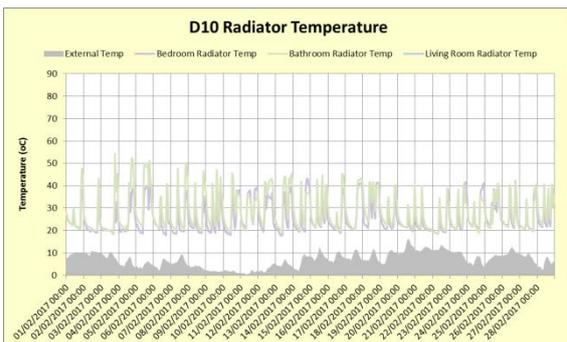
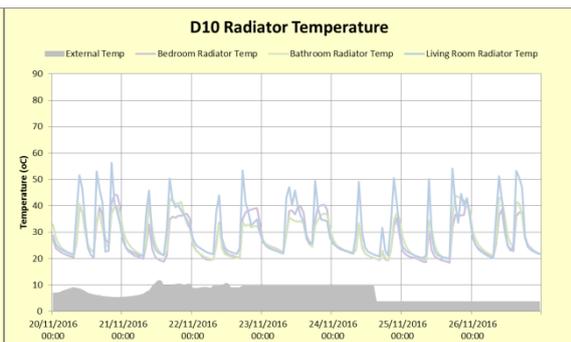
The graphs below confirmed that that all the radiators in all the rooms were turned on at the same time.

Figure 55: Average radiator temperatures in D10 in Feb 2017

Figure 56: Average radiator temperatures in D10 for a week
