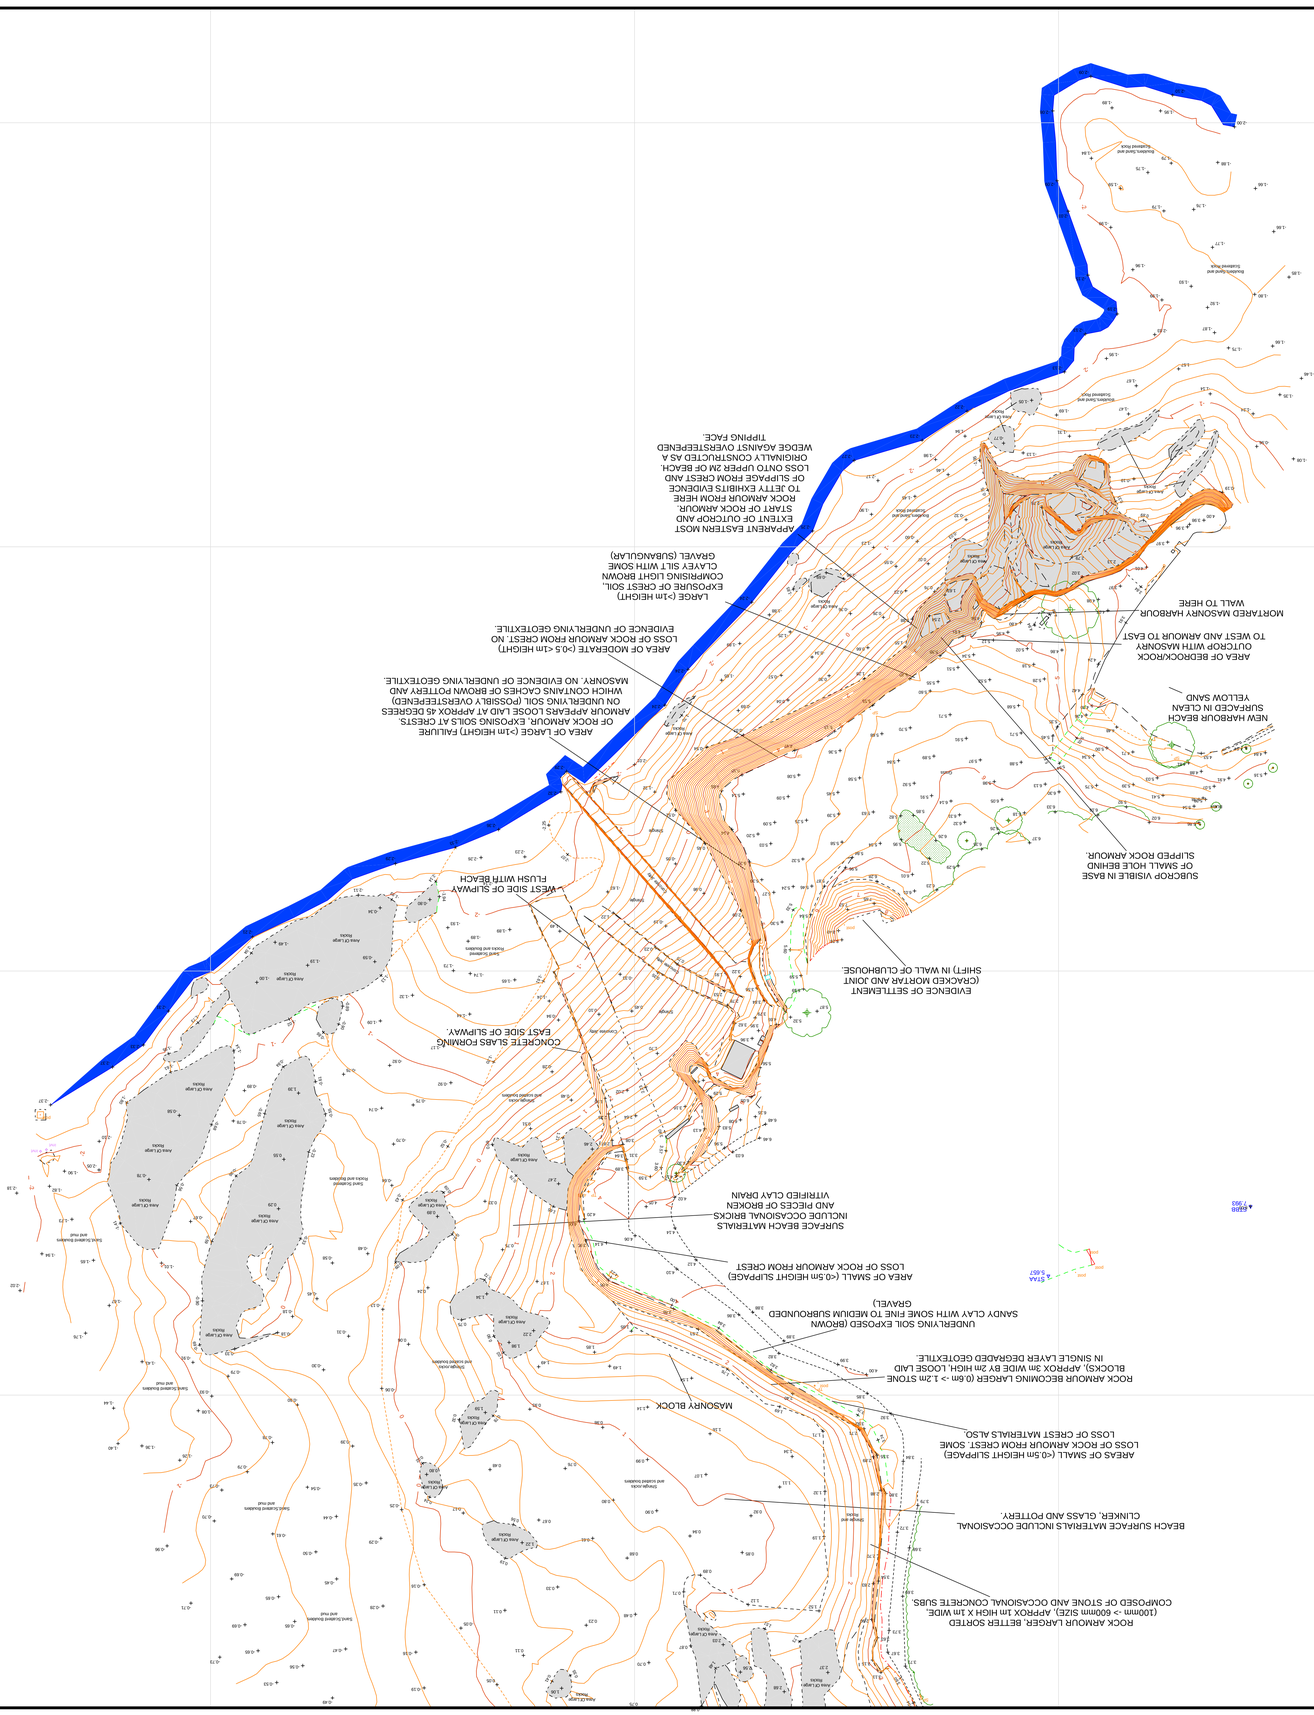
ROCK ARMOUR LARGER. BETTER SORTED (100mm -> 600mm SIZE). APPROX 1m HIGH X 1m WIDE. COMPOSED OF STONE AND OCCASIONAL CONCRETE SUBS.
BEACH SURFACE MATERIALS INCLUDE OCCASIONAL CLINKER, GLASS AND POTTERY.
AREAS OF SMALL (<0.5m HEIGHT SLIPPAGE) LOSS OF ROCK ARMOUR FROM CREST. SOME LOSS OF CREST MATERIALS ALSO.
MASONRY BLOCK
ROCK ARMOUR BECOMING LARGER (0.6m -> 1.2m STONE BLOCKS). APPROX 3m WIDE BY 2m HIGH, LOOSE LAID IN SINGLE LAYER DEGRADED GEOTEXTILE.
UNDERLYING SOIL EXPOSED (BROWN SANDY CLAY WITH SOME FINE TO MEDIUM SUBROUNDED GRAVEL)
AREA OF SMALL (<0 5m HEIGHT SLIPPAGE) LOSS OF ROCK ARMOUR FROM CREST
SURFACE BEACH MATERIALS INCLUDE OCCASIONAL BRICKS AND PIECES OF BROKEN VITRIFIED CLAY DRAIN
CONCRETE SLABS FORMING EAST SIDE OF SLIPWAY.
EVIDENCE OF SETTLEMENT (CRACKED MORTAR AND JOINT SHIFT) IN WALL OF CLUBHOUSE
SUBCROP VISIBLE IN BASE OF SMALL HOLE BEHIND SLIPPED ROCK ARMOUR.
WEST SIDE OF SLIPWAY FLUSH WITH BEACH

APPARENT EASTERN MOST EXTENT OF OUTCROP AND START OF ROCK ARMOUR. ROCK ARMOUR FROM HERE TO JETTY EXHIBITS EVIDENCE OF SLIPPAGE FROM CREST AND ORIGINALLY CONSTRUCTED AS A LOSS ONTO UPPER 2M OF BEACH, WEDGE AGAINST VOERSTEEPENED TIPPING FACE.
LARGE (>1m HEIGHT) EXPOSURE OF CREST SOIL. COMPRISING LIGHT BROWN CLAYEY SILT WITH SOME GRAVEL (SUBANGULAR)
AREA OF MODERATE (>0.5 <1m HEIGHT) LOSS OF ROCK ARMOUR FROM CREST. NO EVIDENCE OF UNDERLYING GEOTEXTILE.
AREA OF LARGE (>1m HEIGHT) FAILURE OF ROCK ARMOUR. EXPOSING SOILS AT CRESTS. ARMOUR APPEARS LOOSE LAID AT APPROX 45 DEGREES ON UNDERLYING SOIL (POSSIBLY OVERSTEEPENED) WHICH CONTAINS CACHES OF BROWN POTTERY AND MASONRY. NO EVIDENCE OF UNDERLYING GEOTEXTILE.
AREA OF BEDROCK/ROCK OUTCROP WITH MASONRY TO WEST AND ARMOUR TO EAST
NEW HARBOUR BEACH SURFACED IN CLEAN YELLOW SAND
MORTARED MASONRY HARBOUR WALL TO HERE
Boulders Lined and Scattered Rock
Boulders Lined and Scattered Rock
