SECTION 1.4.3 – EJECTION SEAT FAILURE

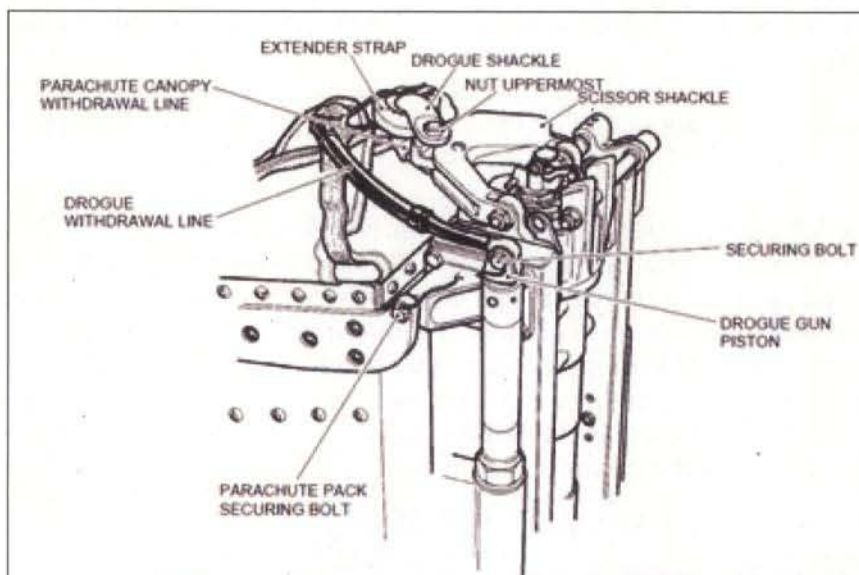
Figure 36 – Scissor and drogue shackle location.

1.4.3.5. **Drogue and Scissor Shackle Fitment.** The drogue shackle is retained within the scissor shackle assembly at the top of the Mk10B ejection seat (see Figure 36) using the drogue shackle nut and bolt.

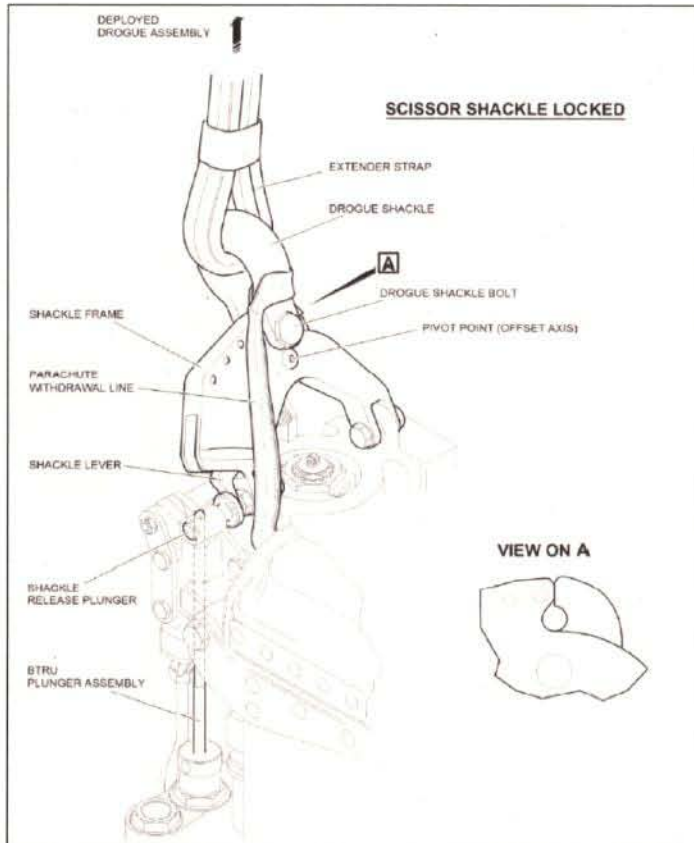
Figure 37 – Scissor assembly in locked condition.

a. **Scissor Shackle.** This comprises a fixed shackle frame and a pivoting shackle lever which move fore and aft around the main beam attachment in response to changes in directional forces from the drogue parachutes during ejection. Under normal conditions the drogue shackle bolt is held by the closed 'jaws' of the scissor shackle (see Figure 37 view A) which secures the drogue assembly to the ejection seat, preventing main parachute deployment until release conditions are obtained. The scissor shackle is held in this locked position by the shackle release plunger, which in turn is restrained by the BTRU. Post ejection, once the seat velocity is within the operating envelope and in a stable attitude the BTRU releases the plunger which removes the lock on the scissor lever. This allows the drogue assembly to be withdrawn (see Figure 38 view A) under the forces from the drogue parachutes, leading to main parachute deployment.

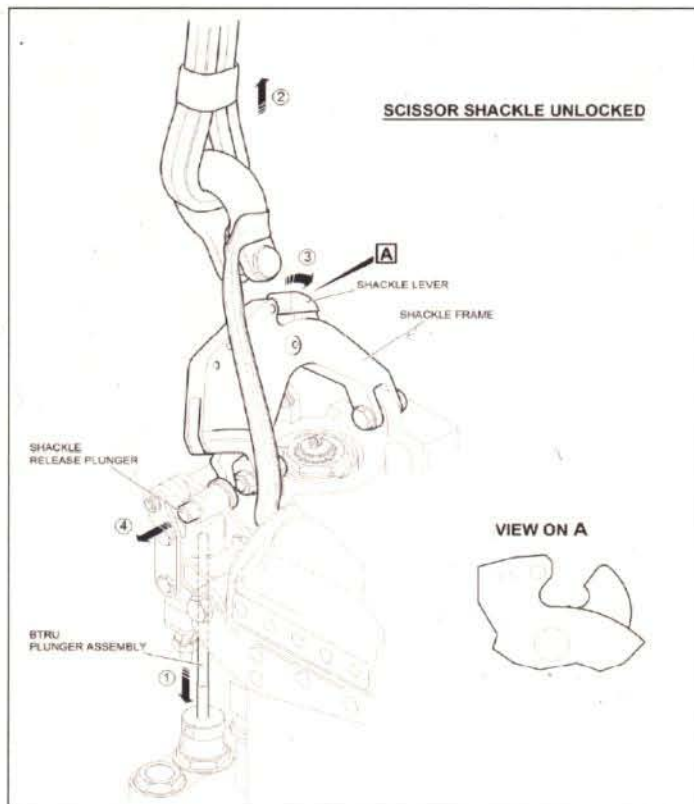
Figure 38 – Scissor assembly in un-locked condition.

b. **Drogue Shackle Assembly.** Drogue parachute deployment occurs for two reasons; firstly to stabilise and decelerate the ejection seat⁹ and secondly to deploy the main parachute. During ejection the drogue gun fires which deploys the 22 inch and then 5ft drogue parachutes. The sequence is then halted; the drogue shackle is held within the jaws of the scissor assembly (see Figure 37). Once released, the force of the drogue parachutes is transferred through the parachute withdrawal line resulting in deployment of the main parachute from its housing (see Figure 38).

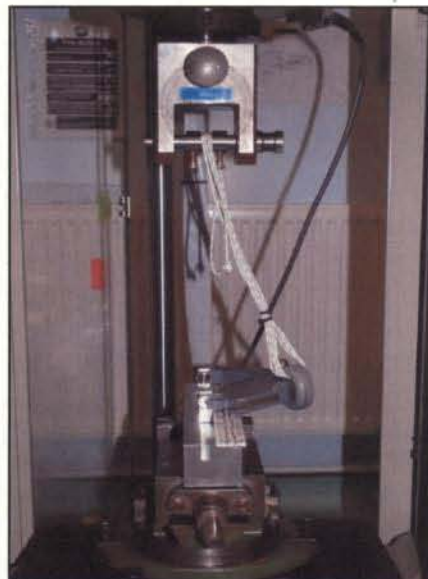
Figure 46 – Drogue and scissor shackle test rig

1.4.3.9. **Testing of Drogue and Scissor Shackle Components.** A test rig was designed and built at 1710 NAS to simulate the sequence of events and loading for a deployed drogue parachute on a drogue and scissor shackle (see Figure 46). This enabled consistent and replicable testing to be carried out to provide supporting evidence for the investigation into the failure of the XX177 drogue shackle to release. This was initially carried out on representative in-service components and subsequently on those from XX177. Different drogue shackle assembly configurations were trialled to measure the interference or clearance between drogue shackle lugs and the scissor shackle and to ascertain the effect on drogue shackle release:

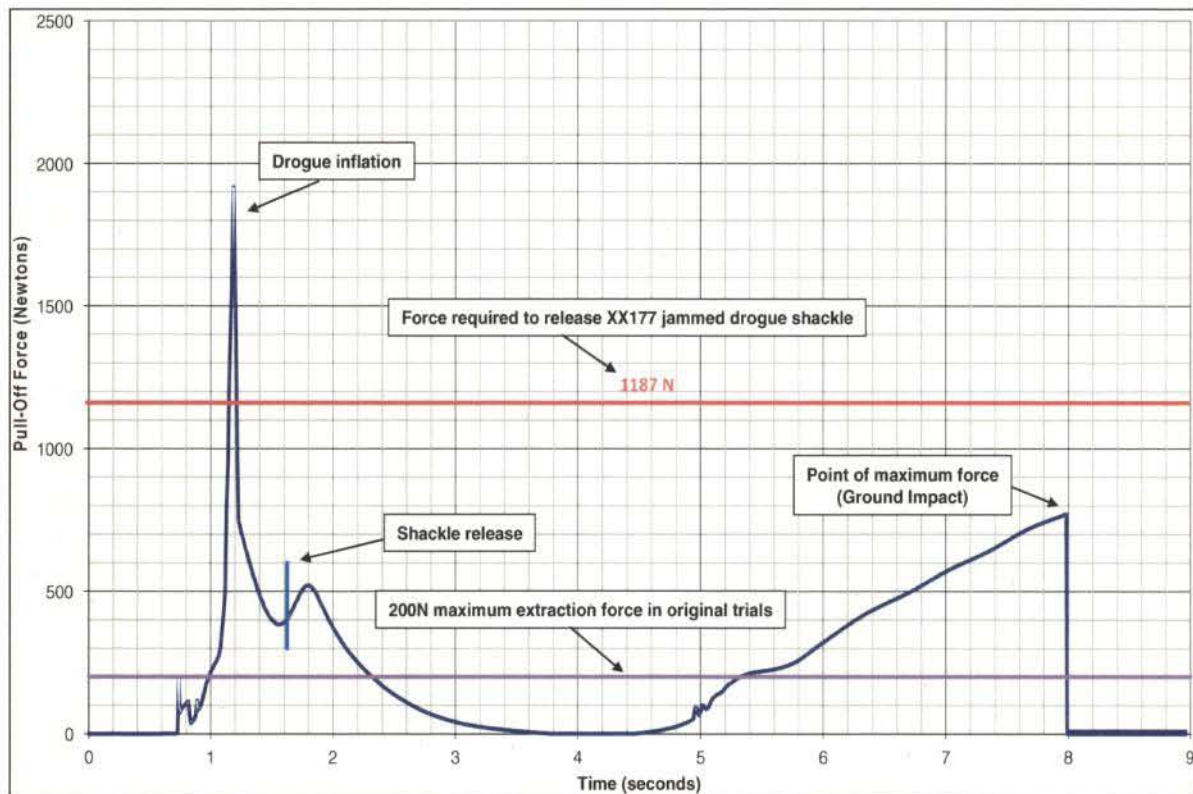
Figure 48 – Graph showing forces during a zero/zero ejection.

c. **Drogue and Scissor Shackle from XX177.** The XX177 components were assembled to the accident configuration, resulting in a 0.009 inch interference fit with the scissor shackle. Of note, when fitted but not deployed, lateral movement of the drogue shackle was possible, giving no indication of an interference fit until loading was applied. As the force was applied to the drogue shackle it became jammed on the scissor lever jaw and did not release until a force of 1187N was applied. This force was in excess of that expected from a zero/zero ejection once the BTRU had operated, where testing showed that a non-jammed drogue shackle would be expected to release at 200N. In the case of XX177, the maximum force experienced by the drogue shackle post BTRU operation would have been just short of 800N and hence insufficient to affect release (see Figure 48). Analysis suggested that XX177 would have required speed in excess of 50 knots¹³ to overcome the jammed components in order to achieve successful main parachute deployment.
