Review of Incidents at Hazardous Waste Management Facilities (Version 2.7 October 2013)

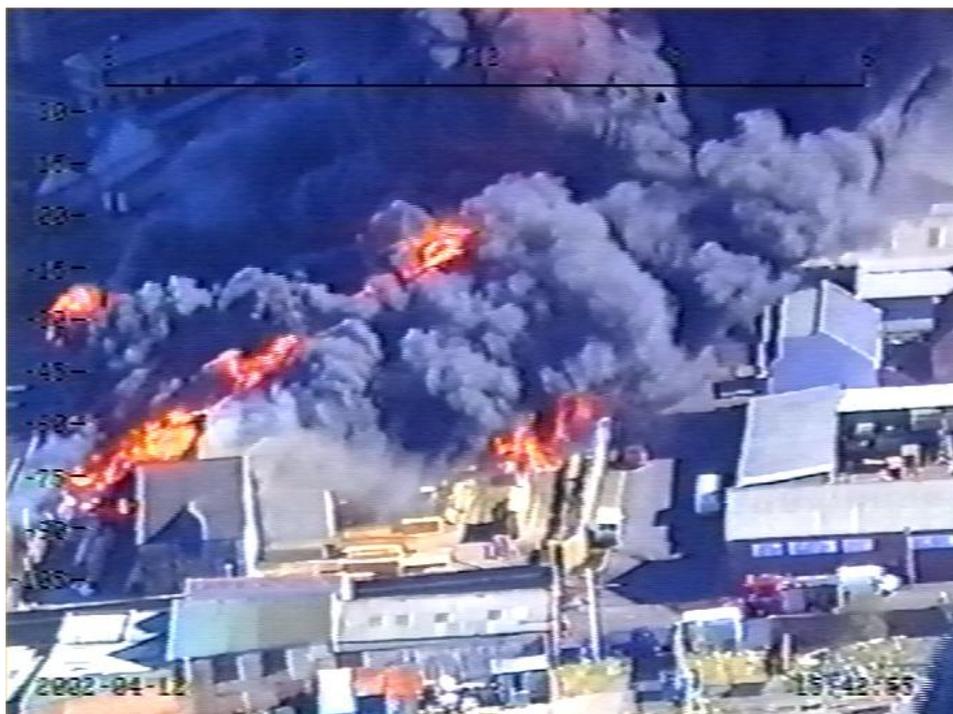
A major fire developed on the site after an IBC containing flammable substances was cut for disposal using an angle grinder. The angle grinder produced a large number of sparks that ignited the contents of the IBC. Despite attempts by site operatives to tackle the fire, it spread quickly through the site.

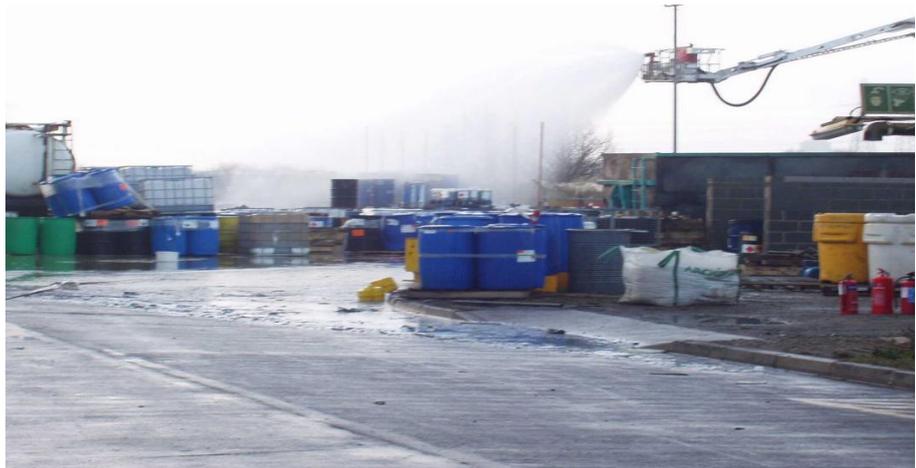
A water curtain was set up to cool the fire and thermal imaging equipment used to monitor the heat of the fire at its seat, the 160 litre drum. After cooling for an hour the fire service stood the incident down as temperatures were returning to normal. At 21:00 a large explosion occurred in the drum storage area and burning spools of Li/Cu was showered over the entire site causing numerous secondary fires. The local residents at Seaton Carew were warned to close all doors and windows and stay inside as smoke was being blown in the Towns direction. The smoke situation was further exacerbated by the secondary fires in the tank farm and flammable waste storage area. The main "non-haz" tanks were made

of glass reinforced resin which was burning rapidly and giving off acrid toxic fumes. Five firemen were treated for smoke inhalation with two being admitted to hospital for monitoring overnight.

Throughout the incident numerous flammable liquids in storage exploded, ranging from 25 litre to 205 litre drums of solvents. Due to fact that an inventory of materials on the site could not be provided the Agency advised the fire service of the waste streams allowed under the licence and the fire was fought with the aim of containing it and preventing it spreading to other areas. At its height 12 fire engines and 60 firemen were fighting the blaze. By 09:00 the following day the situation was under control and all secondary fires were out, with only the water monitor continuing to cool the drummed waste bays.

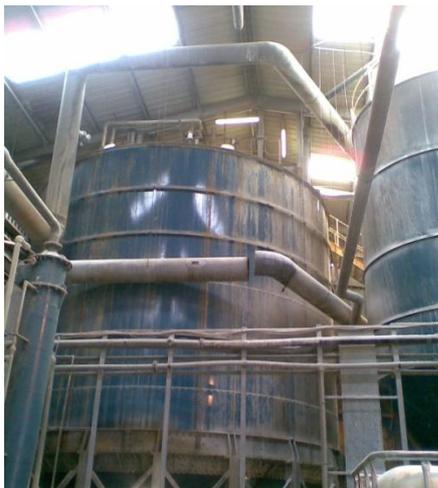
A release of hydrogen sulphide occurred during a treatment process. The release led to two explosions within the plant which damaged a tank and associated extraction fan, and ductwork.
