learning from experience

Post-incident reporting for UK dams
2008 Annual Report

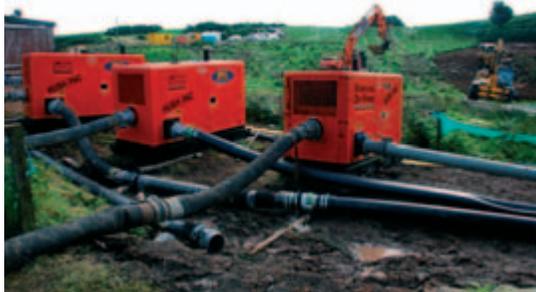
This non-statutory reservoir had been leased to a local fishing club. As it was not subject to the terms of the Reservoirs Act 1975 there was no supervision by a panel engineer. During a heavy rainstorm the dam was overtopped. This caused serious erosion of the downstream face of the dam. A number of local residents were evacuated from their homes and roads were closed.

The situation was made worse by screens being placed across the overflow to retain fish and the outlet pipework not being maintained. The screens were removed from the overflow and the embankment dam was demolished.

This incident shows how important regular supervision and maintenance is. It also highlights the value of emergency planning procedures.
