SS Richard Montgomery 2008 Survey Report

1. Executive Summary

1.1 In October 2008, the Maritime and Coastguard Agency commissioned a repeat high-definition multibeam sonar survey of the wreck of the SS Richard Montgomery and the prohibited area around it. The aim was to gather information about the current state of the wreck for comparison with previous surveys. Particular attention was to be paid to the masts and to areas where previous surveys have identified signs of deterioration.

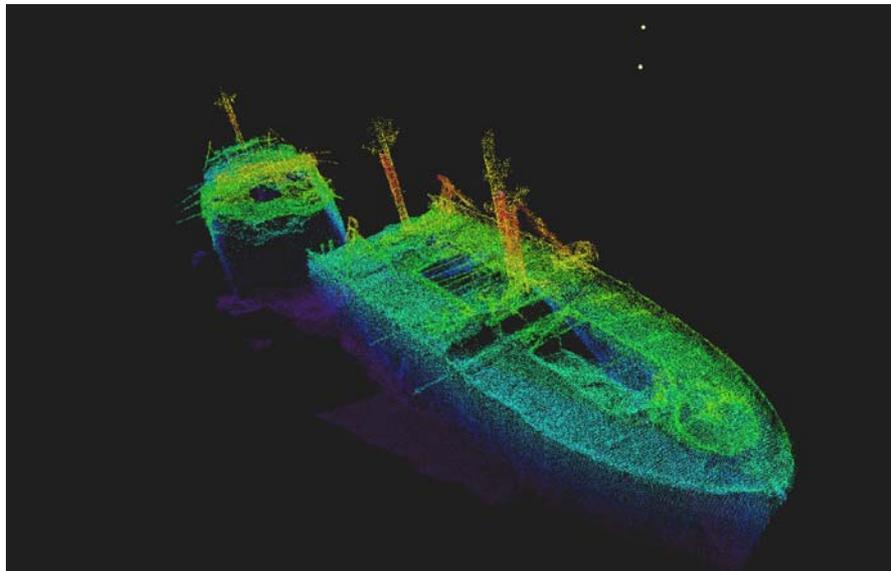
Figure 1 Multibeam sonar and laser scanning data 2008

5.2 Although the survey gathered detailed information about both sections of the wreck and the surrounding seabed, attention was particularly focused on the masts, the area around the break in the two sections, the crack at hold 2, sediment support at bow and stern, and the area of collapsed decking on the port side of hatch 3. The stern section of the wreck is known to have been salvaged at time of loss and, for this reason, the areas of specific focus are mostly on the forward section of the wreck where the remaining cargo is situated.
