MARINE ACCIDENT
INVESTIGATION BRANCH

SAFETY DIGEST

**Lessons from Marine
Accident Reports
1/2004**

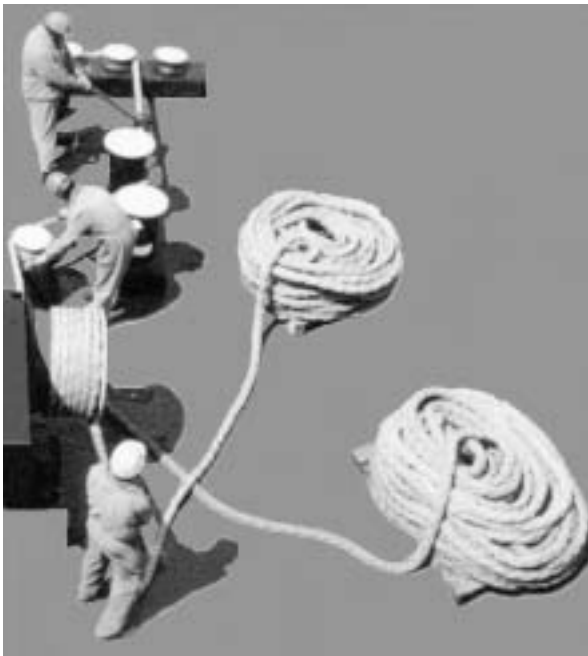
A sternline was led from a roller fairlead, through a set of bitts, around a pedestal fairlead and on to a warping drum. The officer was operating the winch. On heaving the sternline tight, one of the seamen used a stopper to secure the rope in readiness for it to be turned up on the bitts. The officer then reversed the warping drum, and a second seaman began removing the slack rope from the pedestal fairlead. While doing so, the rope suddenly slipped through the stopper, thus tightening, striking the second seaman and causing him abdominal injuries.

1. The sternline was a multiplait synthetic rope. The stopper, which was a singleplait synthetic rope, failed to stop the sternline slipping under tension while it was being transferred from the warping drum to the bitts.

2. The casualty removed the rope from the pedestal fairlead in the expectation that the stopper would do its job. Both he, and the officer in charge, failed to take account of the possibility of the stopper failing. Had they done so, they could have ensured that he approached the rope from the opposite direction, causing it to move away from him when it came under load.

If a stopper is to function effectively, it is essential that it is applied correctly. The *Code of Safe Working Practices for Merchant Seamen* recommends the “West Country” method (double and reverse stoppering), which requires two rope tails.

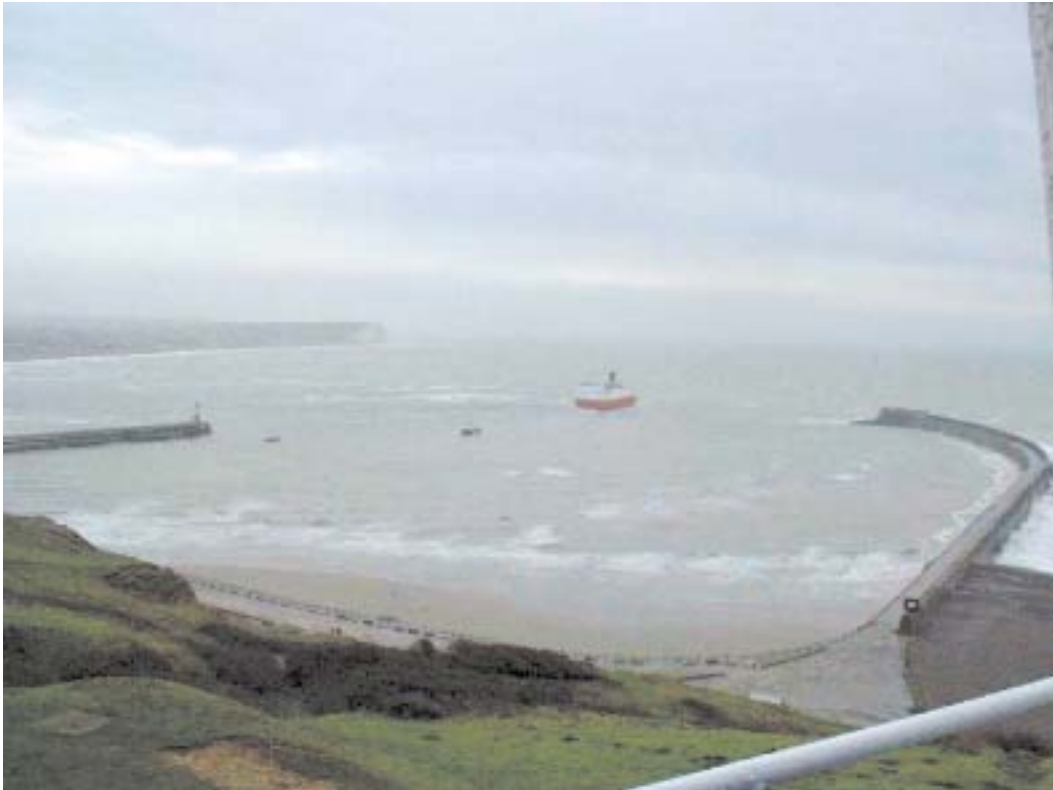
was 1.42m. The approach channel was prone to silting, and a warning to this effect was shown on the appropriate Admiralty chart.

Fortunately, because the bottom was soft silt, nobody was injured and the ship was undamaged. She was refloated about 2 hours later on the rising tide.

1. When a channel of 'maintained' depth is shown on a chart, it is probably not unfair to assume that most mariners consider the depth shown to be reliable. Unfortunately, this is not always the case. Some areas are particularly prone to silting at varying rates depending on tidal and weather conditions. This can make it very difficult for port authorities to maintain channels to the depths advertised, and their failure to do so can spoil a master's day, particularly if no warning is given. Don't take maintained depths in channels, or at alongside berths, for granted; make sure you have the latest information from the port or harbour authority. Where doubt exists, at least proceed with caution.

2. Echo sounders appear to be used less and less, possibly due in part to the improved accuracy and reliability of both charts and navigation systems in recent years. When in restricted waters, however, particularly where survey information is old or scant, or where the nature of the seabed is known to change, it is foolhardy to ignore them. Take the opportunity to compare *actual* against *expected* depths. It costs nothing, and might prevent your aspirations becoming high and dry.

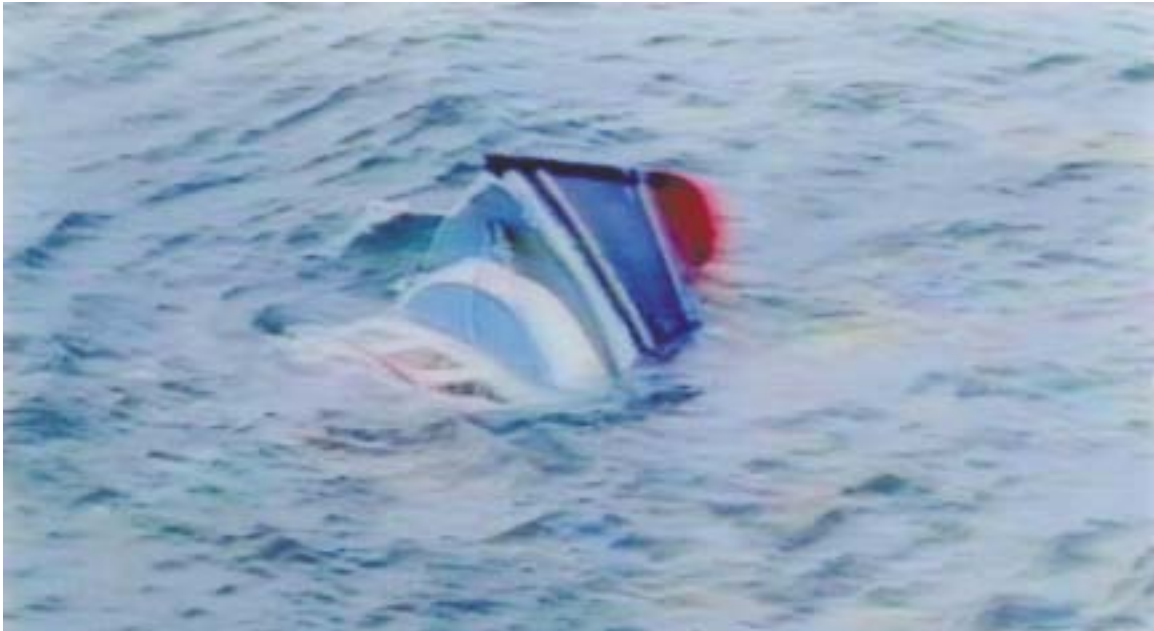
Estimated loading condition after recovery

1. Most vessels are modified over the course of their time in service so that they keep pace with technology, are more efficient and comfortable, or as a result of a change in the type of fishing conducted. Consequently, some vessels have 'grown' considerably since build. However, any structural modifications have the potential to adversely affect a vessel's stability, which might not be obvious. So before making any significant alterations, such as adding a winch, extending a wheelhouse, fitting a deck and freeing ports, and adjusting ballast, it is always wise to seek the advice of a qualified person.
