MAIB
MARINE ACCIDENT INVESTIGATION BRANCH

SAFETY DIGEST

Lessons from Marine Accident Reports

No 2/2003

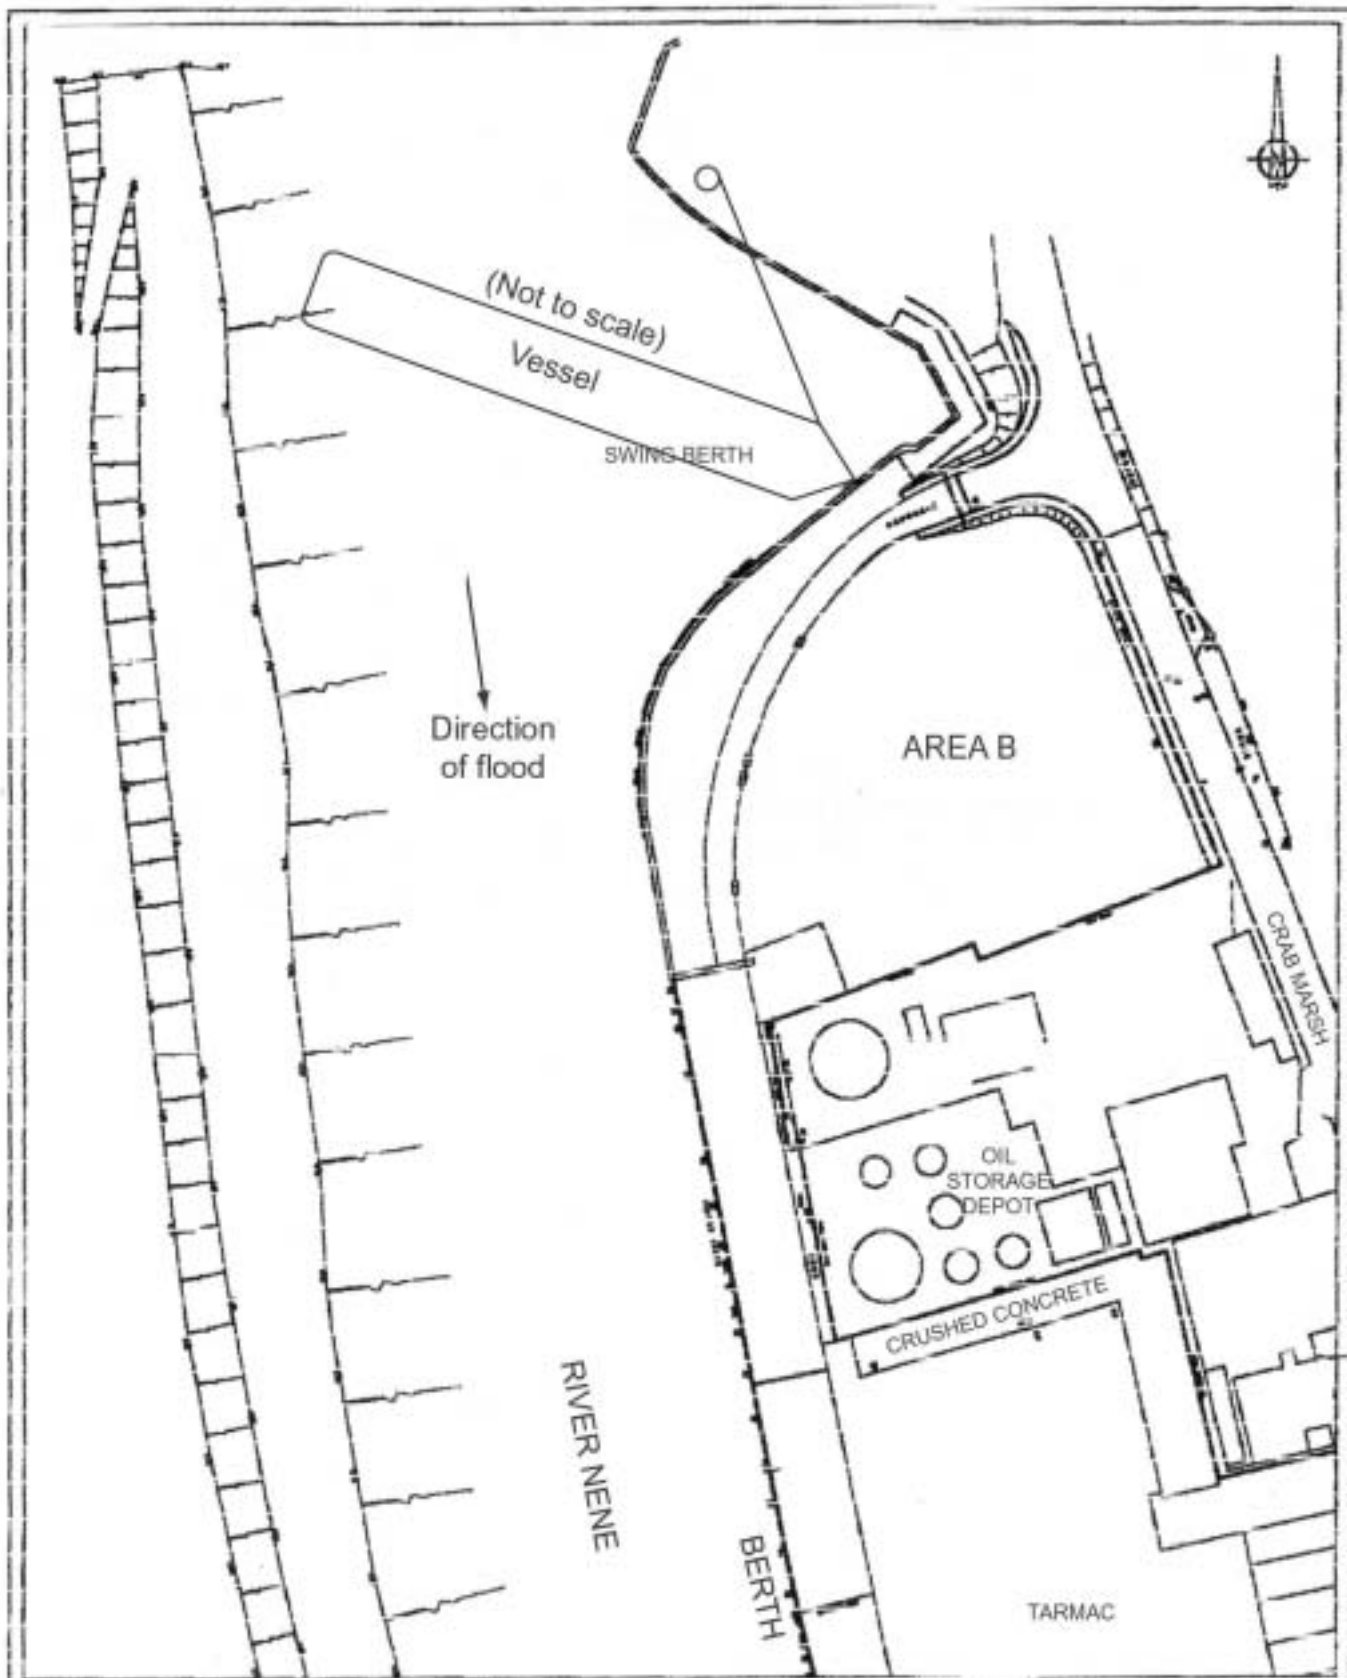
Project: WISBECH PORT TURNING BASIN

The tide was falling and the vessel was unable to refloat. She settled in the mud and remained straddled across the river during the low water period.

The next morning, the vessel was refloated with the aid of a tug, and was then able to berth and discharge her cargo as normal. Fortunately, she had suffered no damage. The fendering in the swinging basin had sustained minor damage, and some scouring had occurred on the west bank of the river, owing to the emergency engine movements.
