CONTENTS

AAIB Field Investigation reports

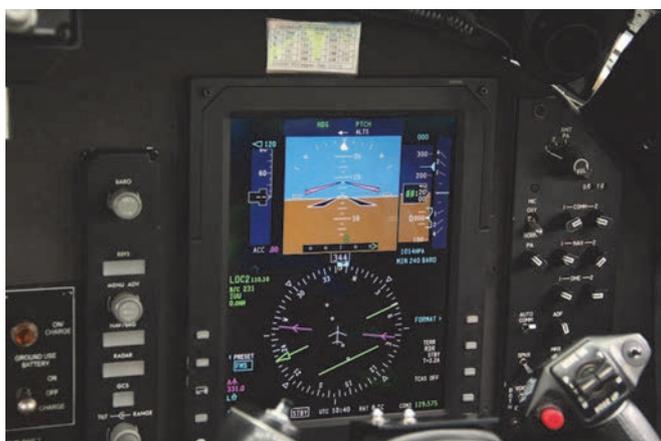
The co-pilot's main instrument display for a Pro Line 21 B200 is shown in Figure 2 and the associated power levers are shown in Figure 4.

Pro Line 21 - Right primary flight instrument display

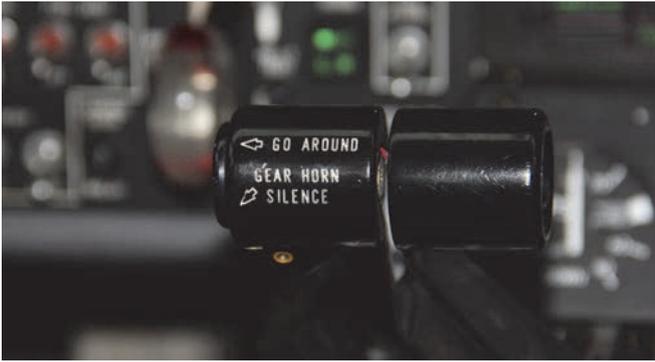
Figure 4

Pro Line 21 – Power levers

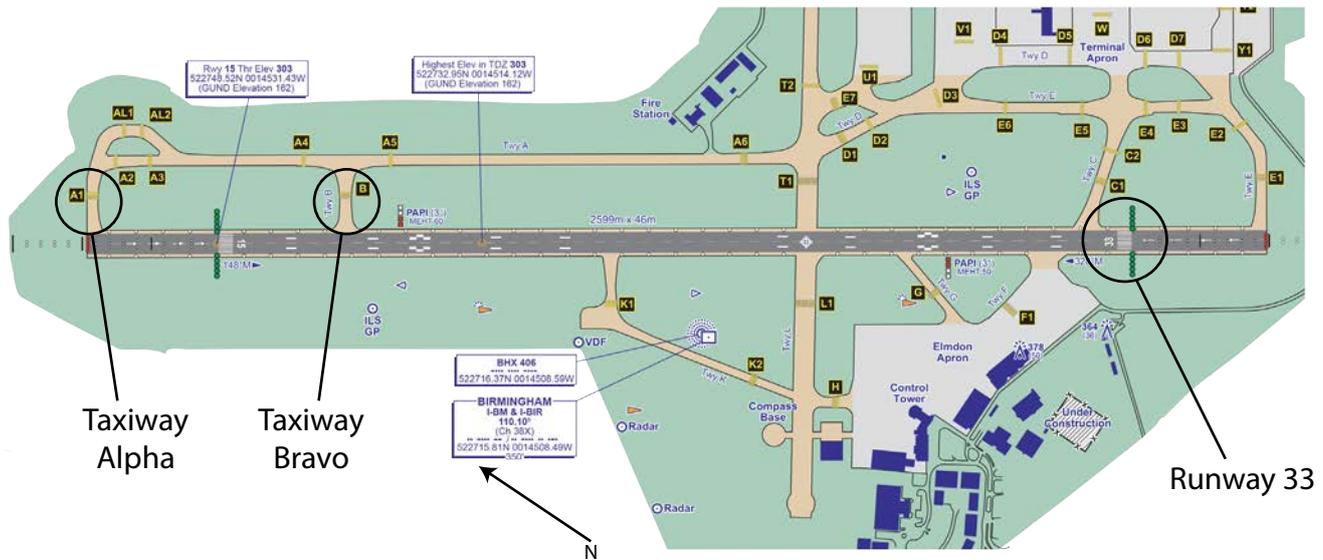
During the arrival brief the commander selected Autobrake 2 and planned to vacate Runway 33 at Taxiway Bravo. Figure 1 shows the layout of Birmingham International Airport. After an uneventful

Birmingham International Airport Layout

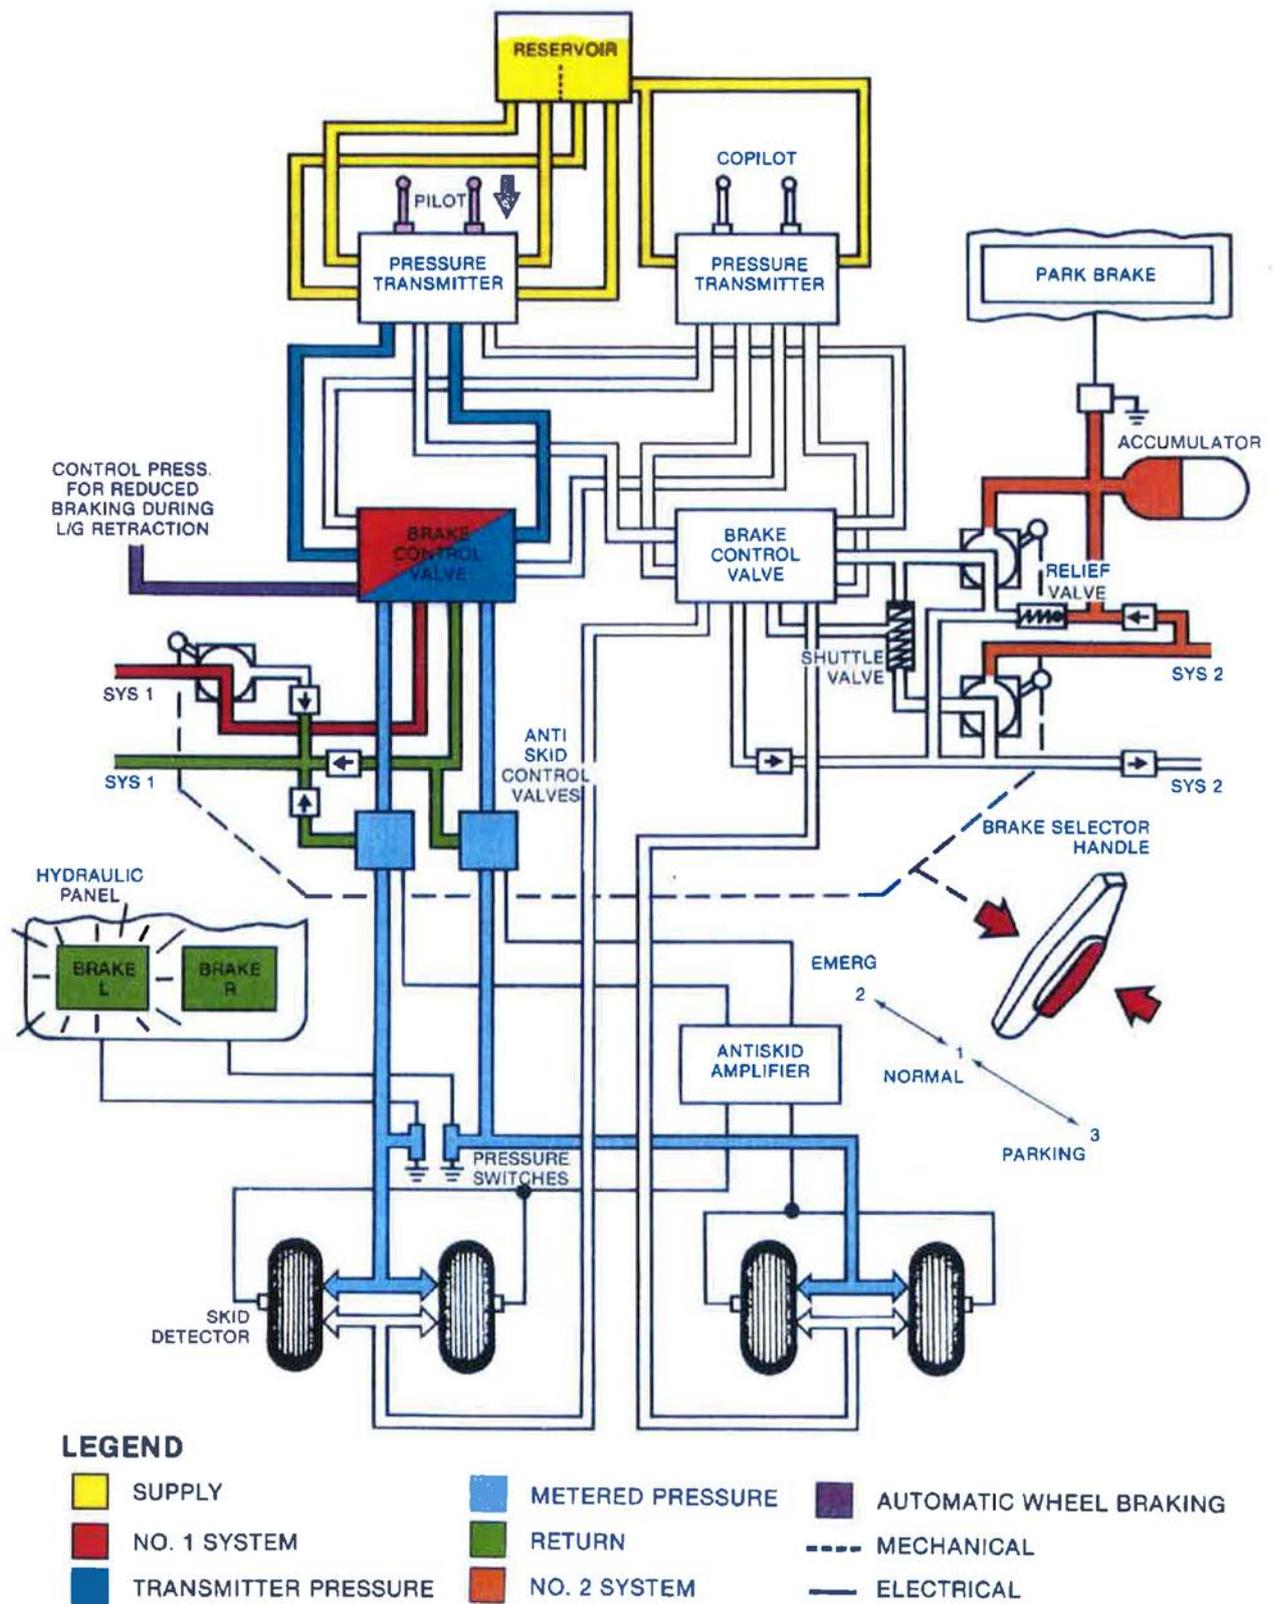
Figure 3

The aircraft has twin-wheel main landing gears (Figure 3) and each mainwheel is equipped with a three-rotor disk brake assembly. The brake rotors are keyed such that they rotate with the mainwheels and are coated with a friction lining on both faces. The fixed section of the brake assembly consists of a housing plate accommodating ten brake pistons in addition to

Falcon 20E braking system operation in the normal mode

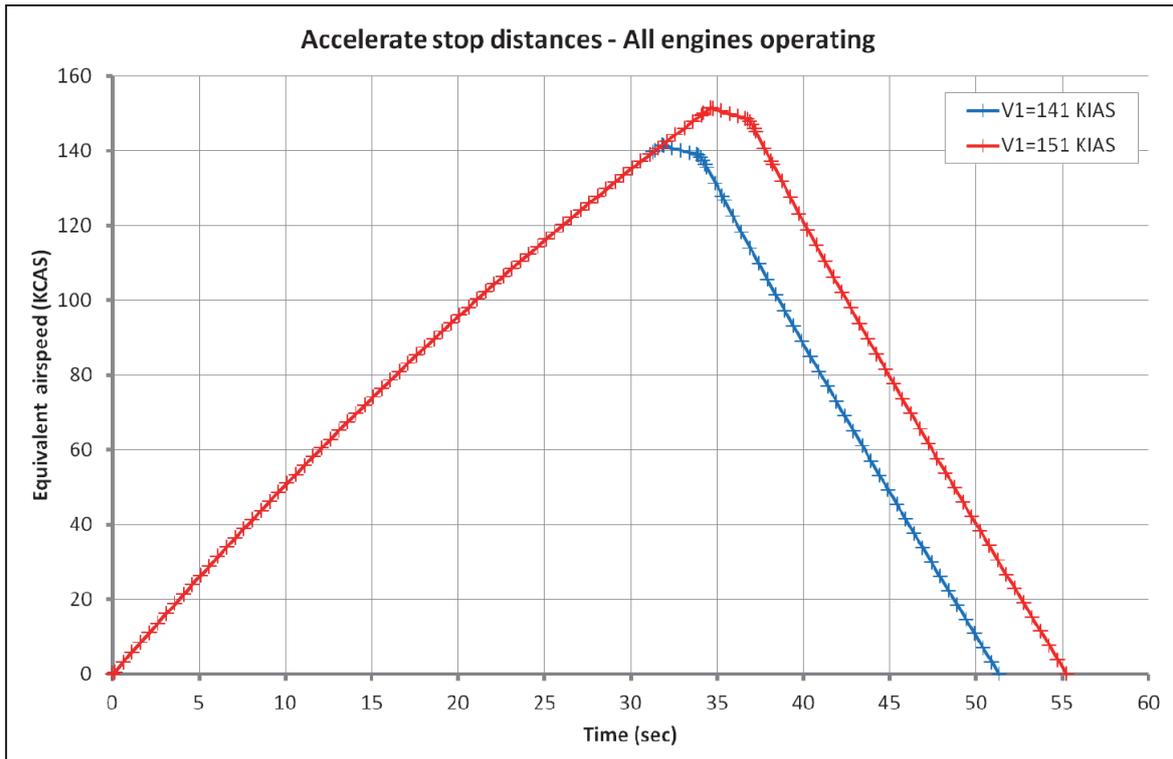
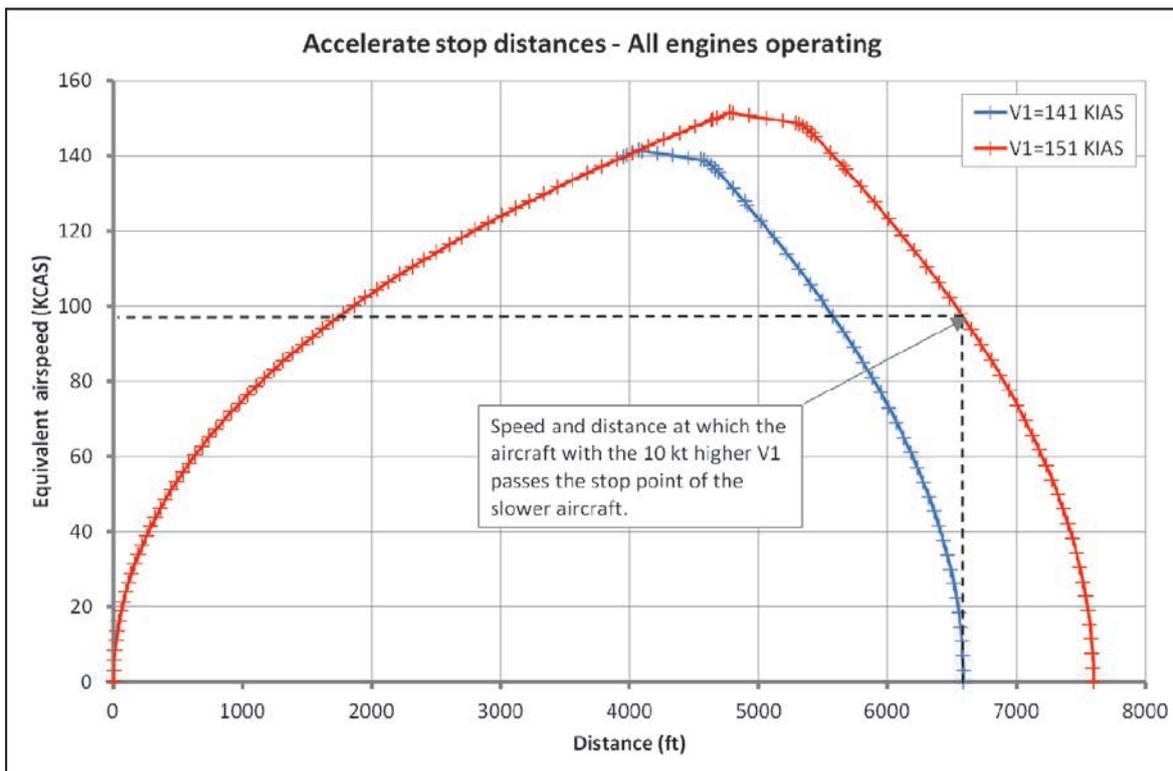
Figure 5 shows the manufacturer's modelled speed profiles for V_1 speeds of 141 KIAS and 151 KIAS.

Figure 5 (b) illustrates that with a V_1 of 151 KIAS an aircraft would only decelerate to a speed of about
