SPECIAL BULLETINS / INTERIM REPORTS

AAIB FIELD INVESTIGATIONS

Aircraft Type and Registration:	Airbus A319-131, G-EUOE
No & Type of Engines:	2 x IAE V2522-A5 turbofan engines
Year of Manufacture:	2001 (Serial No 1574)
Date & Time (UTC):	24 May 2013 at 0716 hrs
Location:	London Heathrow Airport
Type of Flight:	Commercial Air Transport (Passenger)
Persons on Board:	Crew - 5 Passengers - 75
Injuries:	Crew - None Passengers - None
Nature of Damage:	Fire damage to the right engine; mechanical damage to: fuel and hydraulic pipes, slats, flaps, horizontal stabiliser, landing gear and fuselage skin
Commander's Licence:	Airline Transport Pilot's Licence
Commander's Age:	50 years
Commander's Flying Experience	14,337 hours (of which 8,036 were on type)
Information Source:	AAIB Field Investigation

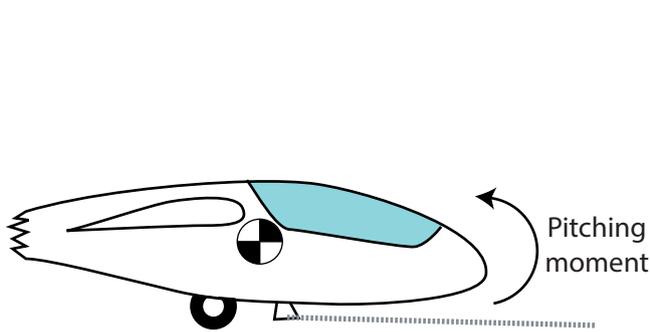
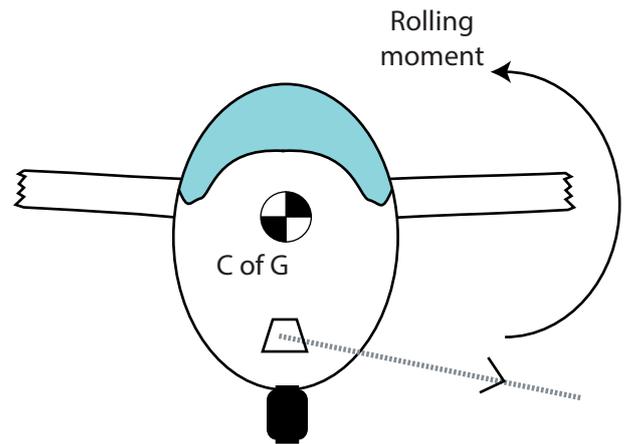
Figure 8a and 8b

The hook used for winch launching is normally located below and forward of the glider Centre of Gravity (C of G) (Figure 8a). If the hook is located along the centre of the lower fuselage, then during the launch the force on the cable will initially attempt to rotate the glider nose upwards about the C of G. If the hook is off-set from the centre line, or the winch cable is set at an angle to the glider's heading, then there will be an additional rolling moment during the launch once airborne (Figure 8b). In general, the greater the misalignment between the glider and the winch cable the greater the rolling moment.
