## CONTENTS

### SPECIAL BULLETINS / INTERIM REPORTS

S4/2013 Britten-Norman BN2A-26 Islander	VP-MON	07-Oct-12	3
---	--------	-----------	---

**(ALL TIMES IN THIS BULLETIN ARE UTC)**

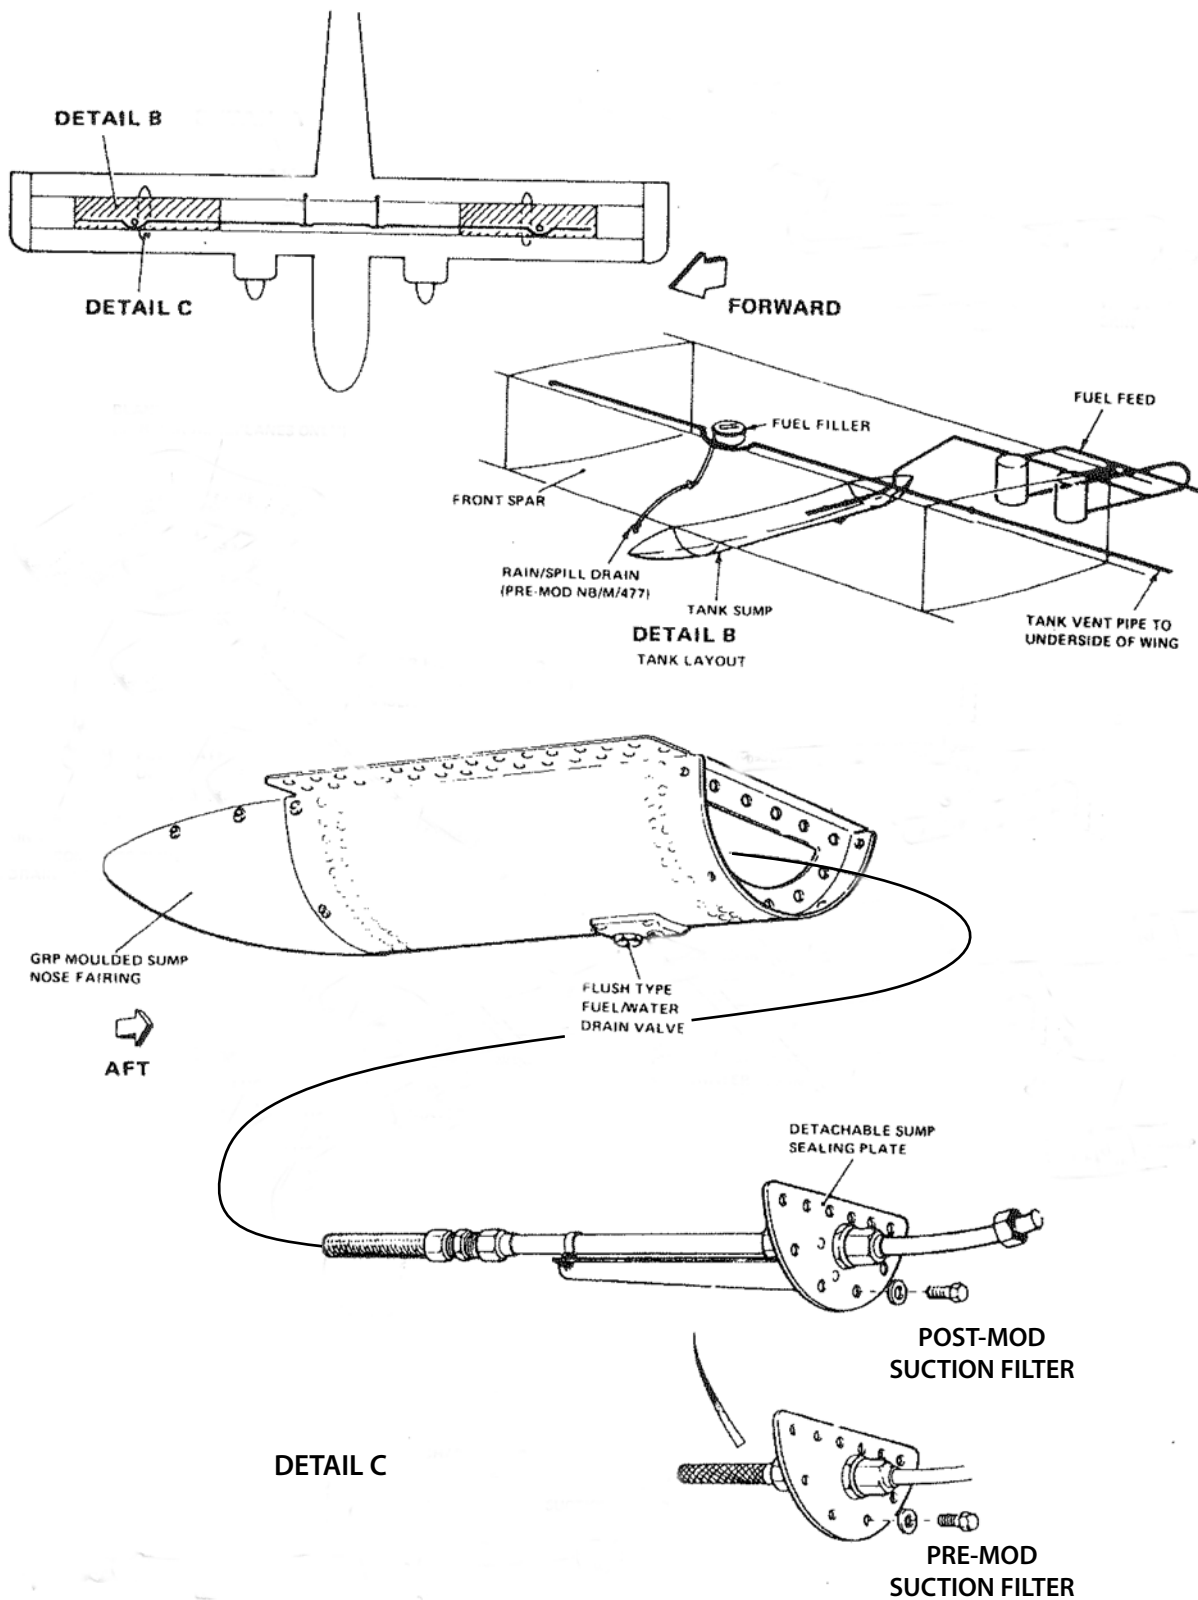
Figure 1 shows the aircraft fuel tank installation and the detail of a modification to the fuel suction filter assembly.

This modification, Mod NB/M/350, mounted the suction filter 8.5 in forward of the sealing plate, on the end of a tube, and raised the filter from 1.05 in to 2.25 in above the bottom of the sump. The modification, issued in 1968, was intended to provide increased protection from water contamination of the fuel. Water, if present, collects at the bottom of the sump and tends to move aft during takeoff and climb. The modified filter is more likely to remain above the water level, as represented in Figure 2.

The modified suction filter offers an improved tolerance to water in the fuel tank sumps, and therefore the following Safety Recommendation is made:

**Safety Recommendation 2013-014**

It is recommended that the European Aviation Safety Agency takes action to require that Britten-Norman Islander aircraft are equipped with fuel suction filter assemblies which minimise the likelihood of any water present in the fuel tank sumps being fed to the engines.

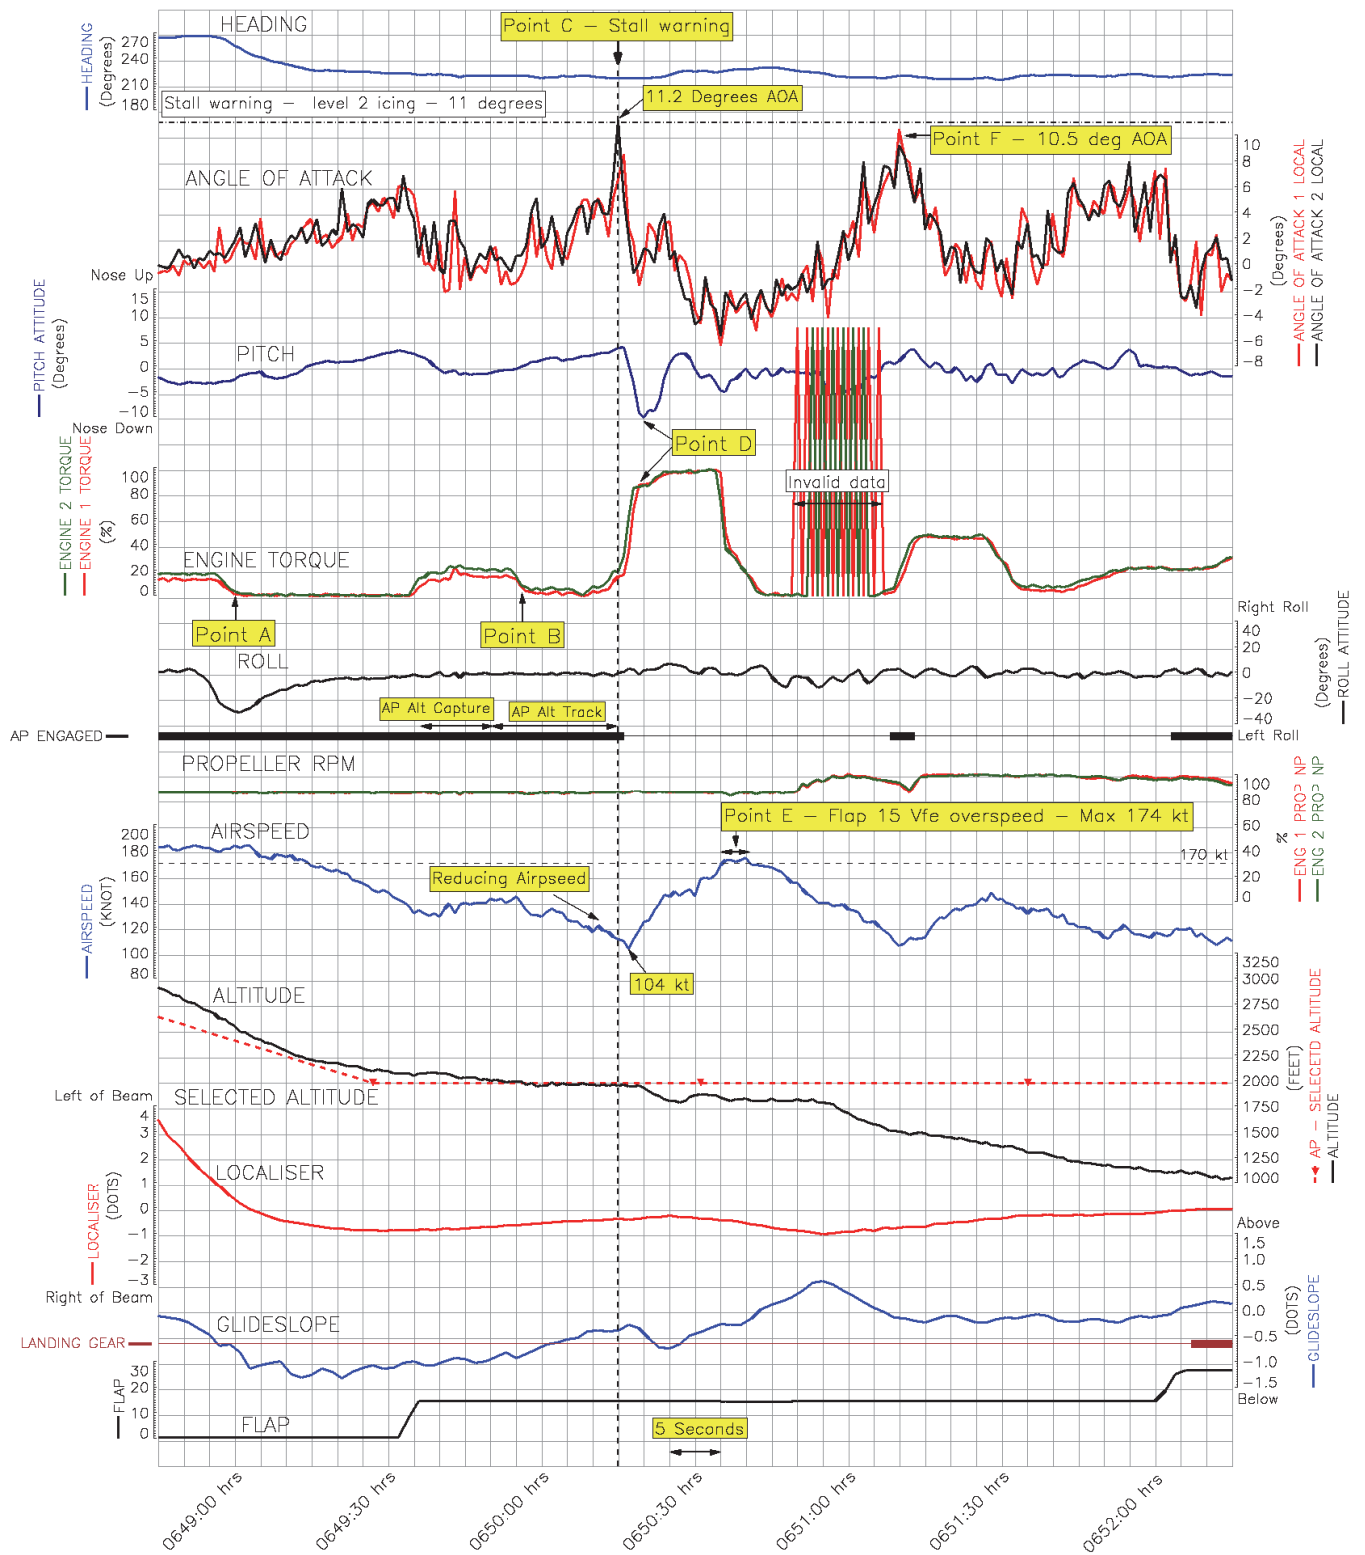
**Figure 1**  
Approach to Glasgow Airport Runway 23

As the flight director captured the localiser the commander instructed the co-pilot to arm the approach mode. Engine torques were reduced to approximately 0% and the rate of descent was reduced. The aircraft was now 8.2 nm from the runway at 2,500 ft and 185 KIAS (see Figure 1, Point A).

At 140 KIAS and 2,100 ft amsl, flap 15 was deployed and the engine torque was increased to about 20%. Approximately 15 seconds later, the autopilot levelled the aircraft at the selected altitude of 2,000 ft amsl. Engine torques were reduced to about 3% (see Figure 1, Point B), airspeed reduced, and the autopilot progressively pitched the aircraft nose-up as it maintained 2,000 ft amsl. Neither of the flight crew mentioned the gradually reducing airspeed.

The co-pilot commented that they were 6.5 nm from the runway, but that the autopilot had not yet captured the glideslope. With the aircraft below the glideslope, the approach controller inquired whether it was established on the ILS. As the first officer keyed the radio to respond, the stall alert sounded and the stick shaker activated. Simultaneously, the autopilot disconnected (see Figure 1, Point C). The aircraft was approximately 1,700 ft agl at 111 KIAS and the angle of attack was +11.2°. The co-pilot called "FLY THE AIRCRAFT [EXPLETIVE]". The commander almost immediately pitched the aircraft nose down to -10° and advanced the power levers almost to full power (see Figure 1, Point D), saying as he did so "I'VE GOT IT I'VE GOT IT DON'T WORRY".

As the aircraft descended, its airspeed reduced to a minimum of 111 KIAS and the angle of attack reached  $10.5^\circ$  ( $0.5^\circ$  below the stall alert/stick shaker threshold) (see Figure 1, Point F). Passing approximately 1,500 ft amsl, the flight crew attempted to re-engage the autopilot but it disconnected immediately. Simultaneously, engine torque was increased to 45%, airspeed increased and the angle of attack reduced. The controller asked if the aircraft was still on frequency and the co-pilot replied "AFFIRM, STANDBY WE'VE JUST GOT...
