AAIB Special Bulletins / Interim Reports

SERIOUS INCIDENT

Aircraft Type and Registration:	Boeing 787-8, ET-AOP
No & Type of Engines:	2 General Electric GEnx-1B turbofan engines
Year of Manufacture:	2012 (MSN 34744)
Location	London Heathrow Airport
Date & Time (UTC):	12 July 2013, 1534 hrs UTC
Type of Flight:	Not applicable
Persons on Board:	None
Injuries:	Not applicable
Nature of Damage:	Extensive heat damage in upper portion of rear fuselage
Commander's Licence:	Not applicable
Commander's Age:	Not applicable
Commander's Flying Experience:	Not applicable
Information Source:	AAIB Field Investigation

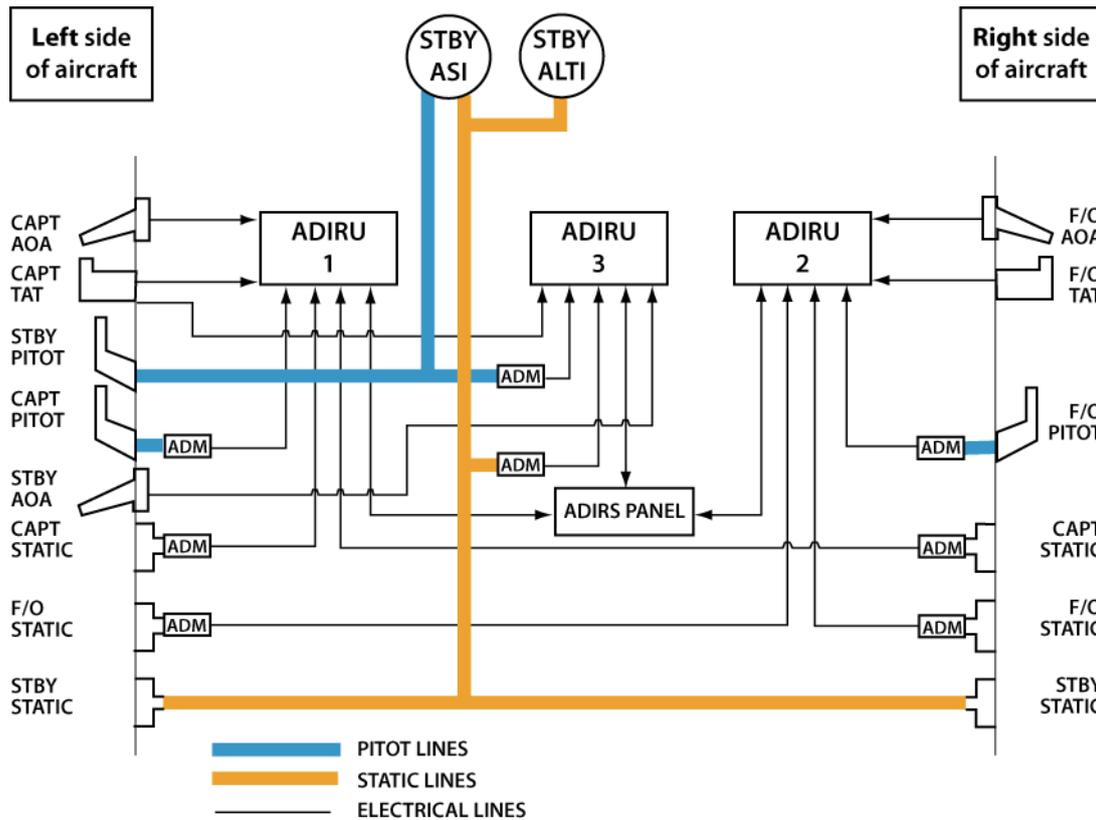
Figure 1

The air data is provided to the ADIRU from three pitot probes, six static pressure probes, three Angle of Attack (AOA) sensors and two Total Air Temperature (TAT) probes (Figure 1). The data from the AOA and TAT probes is provided directly to the ADIRU as an electrical signal, whereas air pressure from the pitot and static probes is first converted at an Air Data Module (ADM) into an electrical signal. Air pressure is provided directly to the standby airspeed indicator and altimeter from static and pitot probes that are also linked by two ADMs to ADIRU 3. The pitot head probes, static ports, AOA probes and TAT probes are electrically heated by three independent Probe Heat Computers (PHC) that automatically control and monitor the electrical power to the Capt, F/O and standby probes.

Air data system

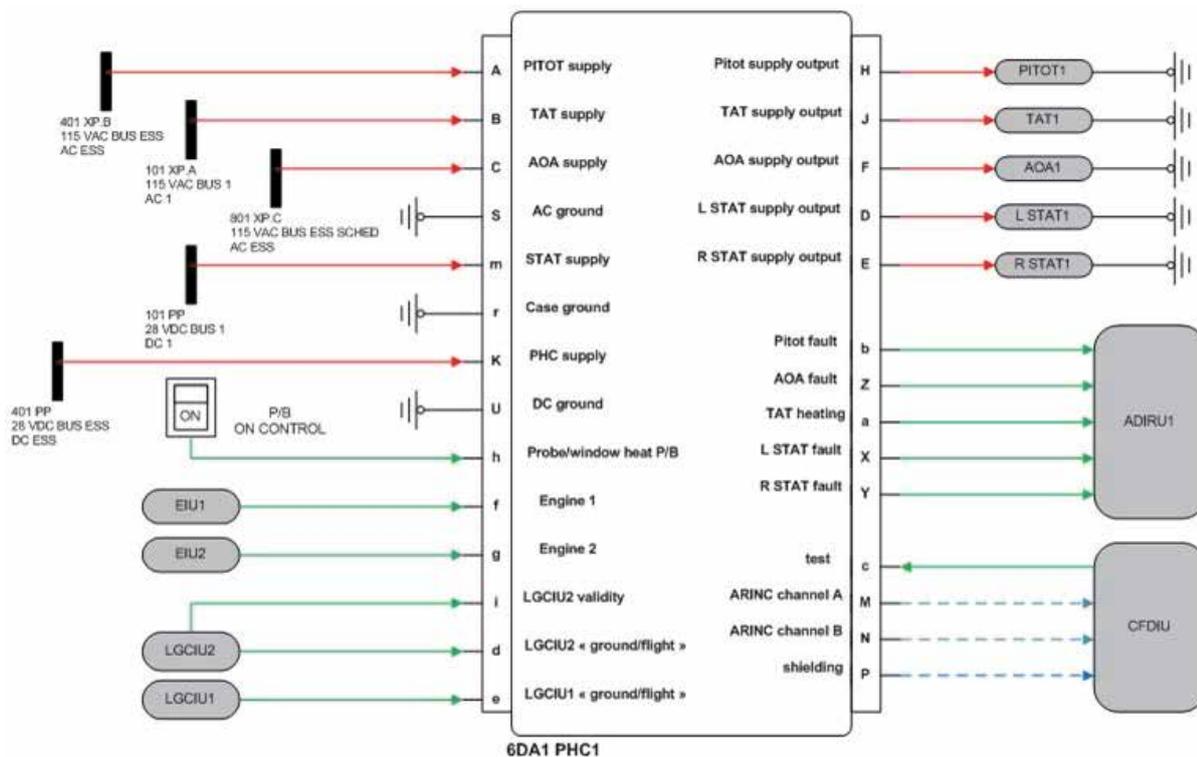
Figure 2

The three Probe Heat Computers (PHC) monitor and control the electrical power to the heating elements in the probes, ports and AOA sensors. If the electrical current consumption is outside limits, ECAM warnings are generated by the FWS, using discrete signals sent by the PHC through the ADIRU (Figure 2). BITE messages are generated directly by the PHC and recorded in non-volatile memory (NVM) as well as being sent to the CFDIU on two ARINC channels (data buses). In the event that the data communication between the PHC and

PHC, input and output signals

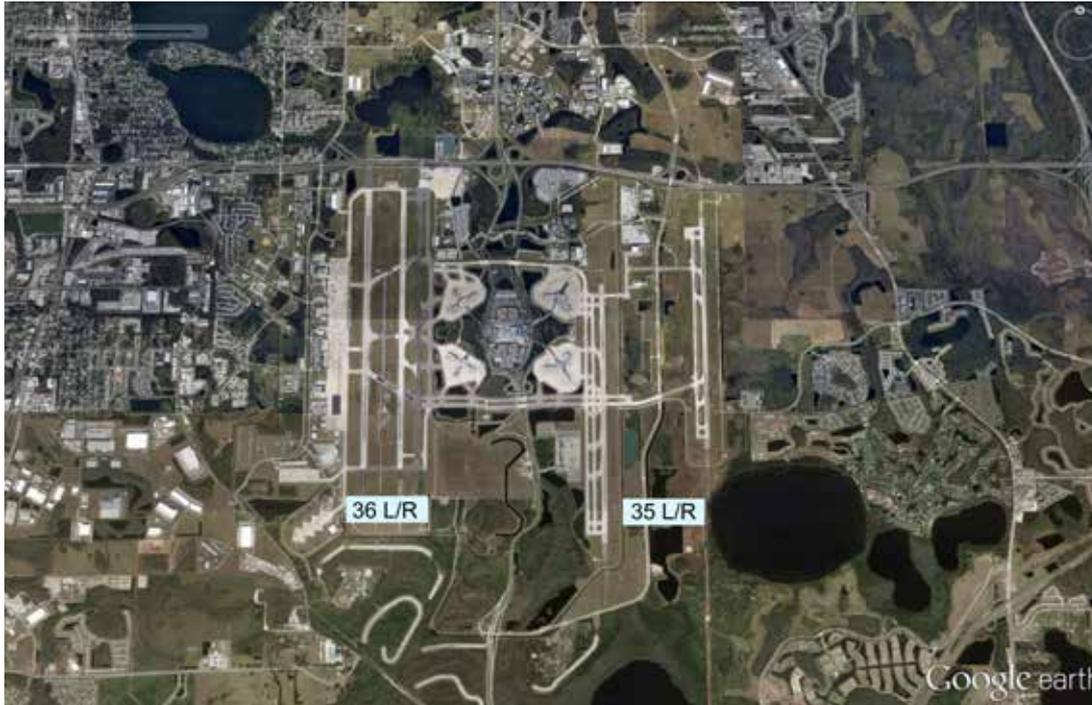
Figure 1

During 2011 there were 317,020 aircraft movements. 115 aircraft were struck by birds of which arriving aircraft accounted for 72% of the strikes. The majority of strikes (44%) occurred on Runway 17L/35R, 22% on Runway 17R/35L, 22% on Runway 18L/36R and 12% on 18R/36L. Approximately 66% occurred on the eastern airport complex which is considerably less developed than the western complex (Figure 1).

Orlando International Airport

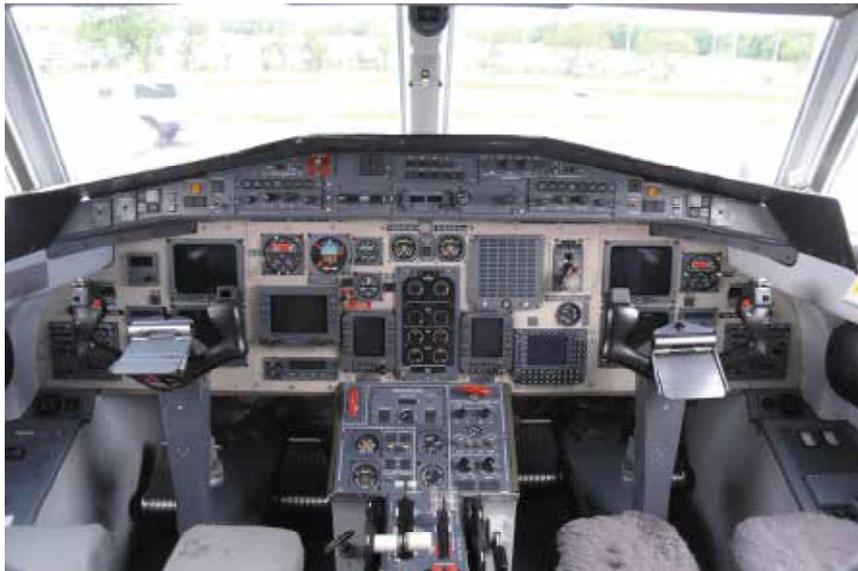
About 2 minutes after initial failure, the three remaining EFIS screens went blank. The commander took control and flew the aircraft with reference to the aircraft's main altimeter and standby instruments, situated left

Figure 1
G-MAJA cockpit

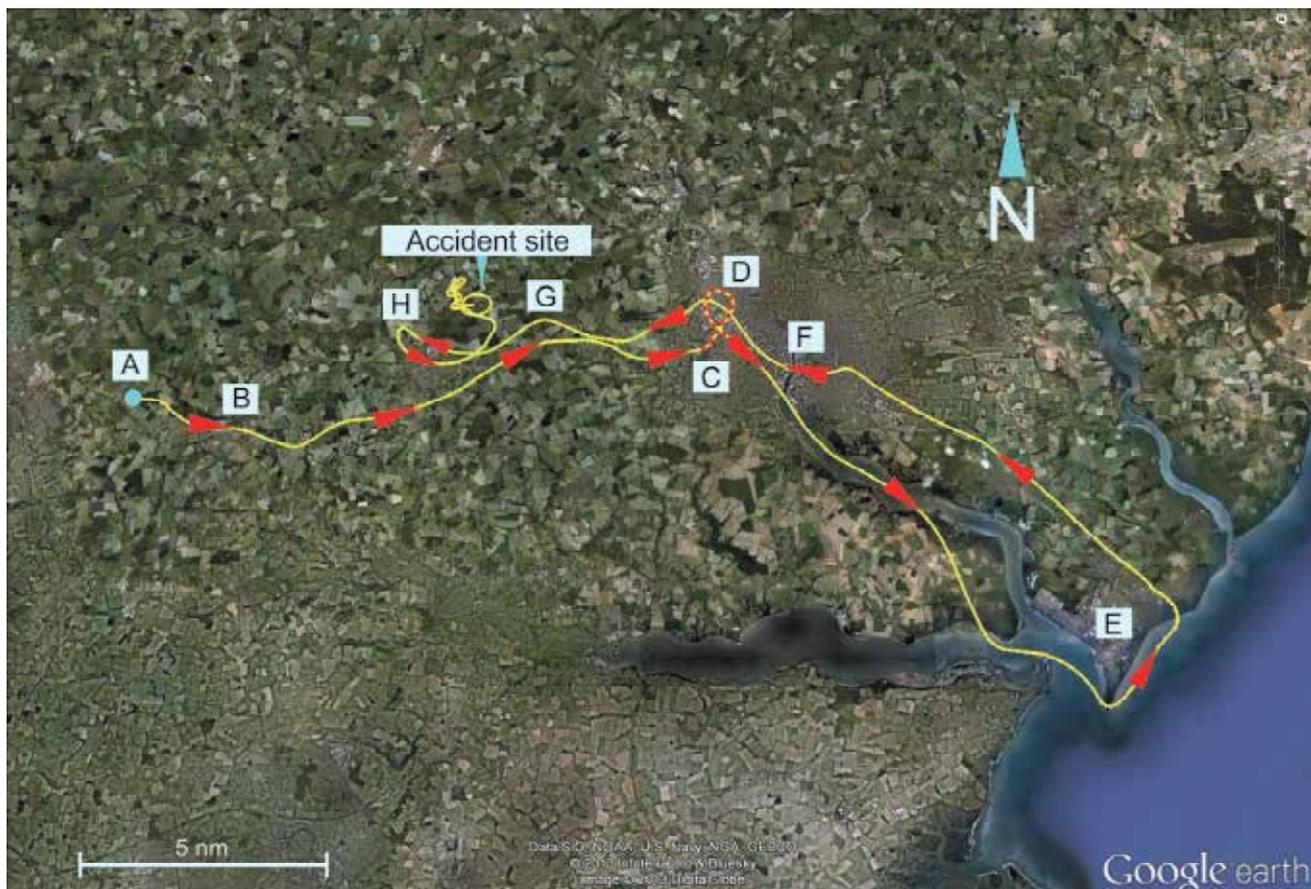
Figure 1 shows the progress of the flight. G-VILA departed from Newton airstrip (Point A in Figure 1) at

Overview of track of G-VILA (Points A to H)

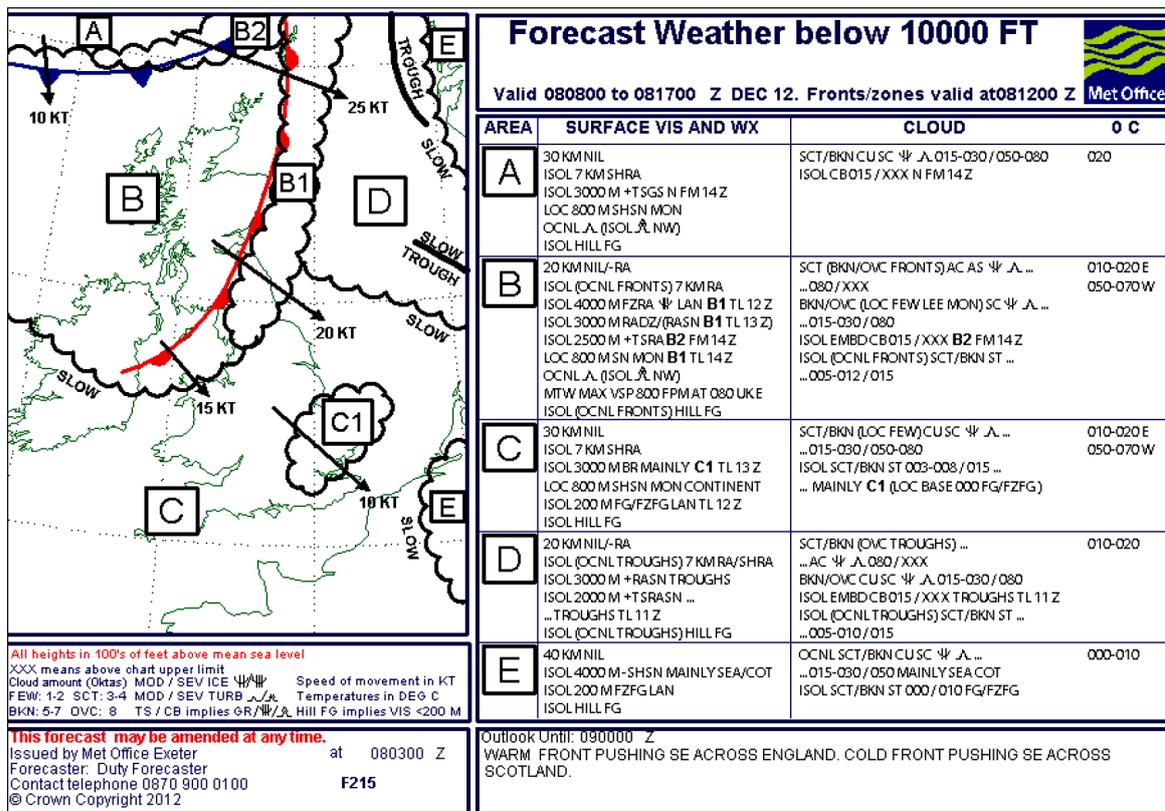
The UK Met Office provided an aftercast of the accident area, along with additional data. On the morning of the accident the forecast available to pilots included Metform F215, (Figure 4) The accident occurred in area C1 for which the Met Office report had the following forecast:

Figure 4
Metform F215

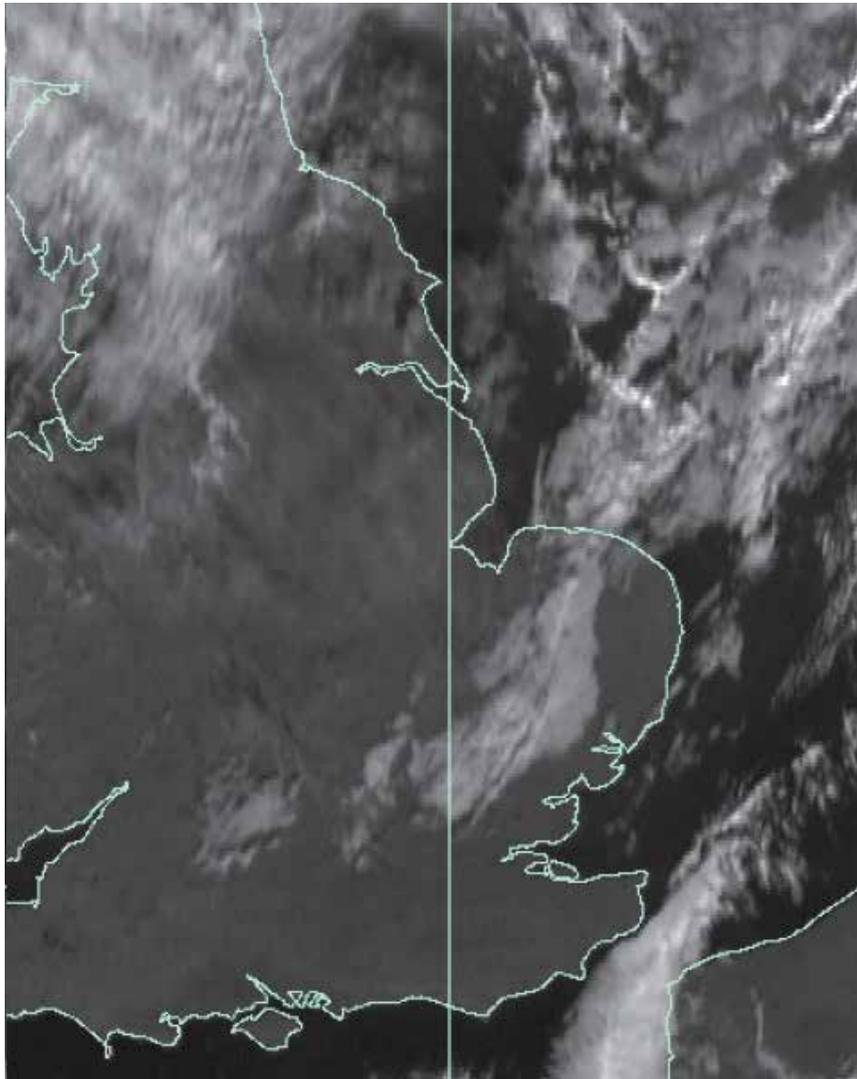
Figure 5

'The weather over England was settled under a ridge of high pressure, however there were some areas of fog and low cloud. Looking at the satellite pictures from that morning much of the fog and low cloud cleared but there was a significant area over East Anglia which did not clear and was moving slowly south east. (Figure 5)

Satellite image of visible cloud and fog at 1115 hrs, 8 December 2012
