AAIB FIELD INVESTIGATIONS

AAIB Field Investigation reports

Aircraft Type and Registration:	1) Grob G115E Tutor, G-BYUB 2) Grob G115E Tutor, G-CGKC
No & Type of Engines:	1 Lycoming AEIO-360-B1F piston engine
Year of Manufacture:	1) 1999 2) 2009
Date & Time (UTC):	1) 23 August 2012 at 0834 hrs 2) 09 Jan 2013 at 1225 hrs
Location:	Fields adjacent to RAF Cranwell, Lincolnshire
Type of Flight:	Military Training
Persons on Board:	Crew - 2 Passengers - N/A
Injuries:	Crew - None Passengers - N/A
Nature of Damage:	(Both aircraft) Propeller counterweight assembly detached and severe damage to corresponding propeller blade and spinner
Commander's Licence:	Both aircraft were being operated by military personnel with service qualifications
Commander's Age:	N/K
Commander's Flying Experience:	N/K
Information Source:	AAIB Field Investigation

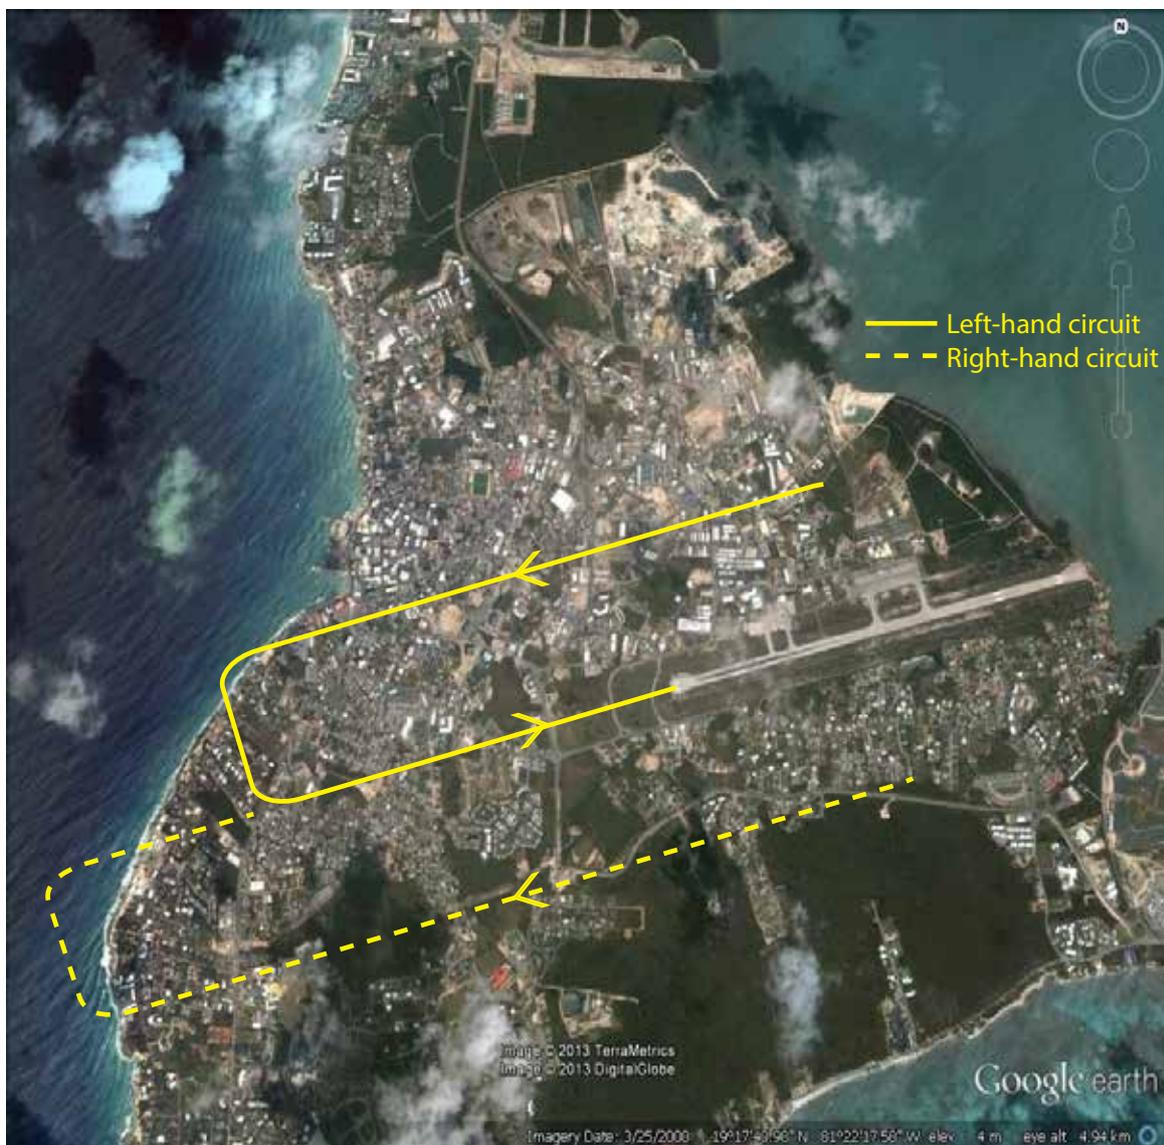
Figure 1

The pilot attributed the heavy, nosewheel-first landing to several factors. He states that he had touched down at 85 kt instead of the target 70 kt and that this was largely due to his desire to land short and clear the

runway as soon as possible since there had been much traffic waiting to land and take off. In addition, he was used to arriving 'right downwind' and turning over the coast (shown in Figure 1). He had employed the same technique with the 'left downwind' pattern but, because of the geography of the coastline, this put him about half a mile closer to the runway threshold. He believes that the propeller strike occurred on the second bounce and that he should have gone around after the first.

Aerial view of Owen Roberts Airport with left-hand circuit, and right-hand circuit more normally flown by the pilot of N450CD
