CONTENTS

AAIB FIELD INVESTIGATIONS

Aircraft Type and Registration:	Beech B200 Super King Air, OO-LET	
No & Type of Engines:	2 Pratt & Whitney Canada PT6A-42 turboprop engines	
Year of Manufacture:	1994 (Serial no: BB-1473)	
Date & Time (UTC):	28 July 2012 at 1540 hrs	
Location:	Cambridge Airport	
Type of Flight:	Aerial Work	
Persons on Board:	Crew - 4	Passengers - None
Injuries:	Crew - None	Passengers - None
Nature of Damage:	Extensive to propellers, engines, undercarriage doors and luggage pod	
Commander's Licence:	Commercial Pilot's Licence	
Commander's Age:	68 years	
Commander's Flying Experience:	13,180 hours (of which 3,111 were on type) Last 90 days - 187 hours Last 28 days - 74 hours	
Information Source:	AAIB Field Investigation

Aircraft Type and Registration:	BN2A MK.III-2 Trislander, G-BDTO	
No & Type of Engines:	3 Lycoming O-540-E4C5 piston engines	
Year of Manufacture:	1976	
Date & Time (UTC):	27 March 2012 at 0724 hrs	
Location:	27 nm north-east of Alderney, Channel Islands	
Type of Flight:	Commercial Air Transport (Passenger)	
Persons on Board:	Crew - 1	Passengers - 7
Injuries:	Crew - None	Passengers - None
Nature of Damage:	Uncontained engine failure with associate

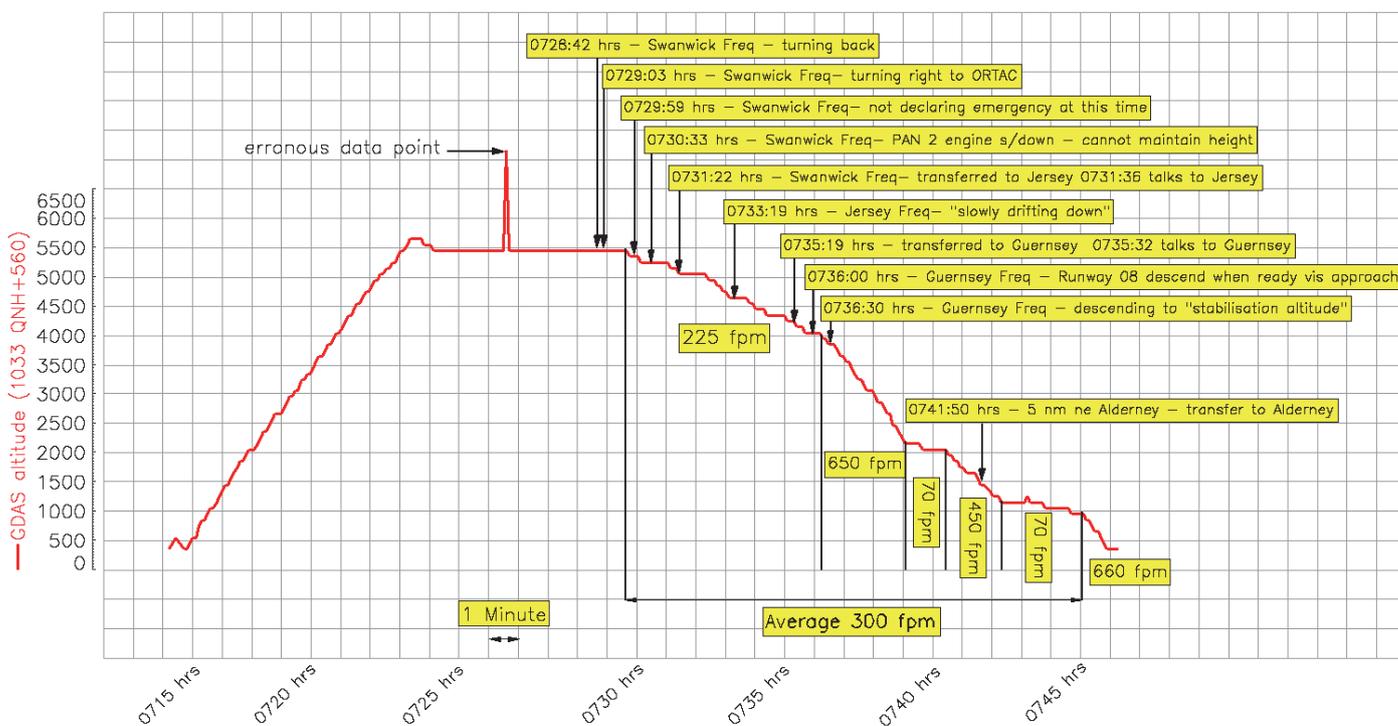
Figure 1
Radar altitude profile of the incident flight

During the return to Alderney, the pilot was cleared by ATC to fly a near continuous descent profile (Figure 1) and thus did not note the altitude the aircraft had drifted down to with one engine inoperative (OEI). The pilot made an uneventful visual approach and landing to Runway 08 at Alderney.

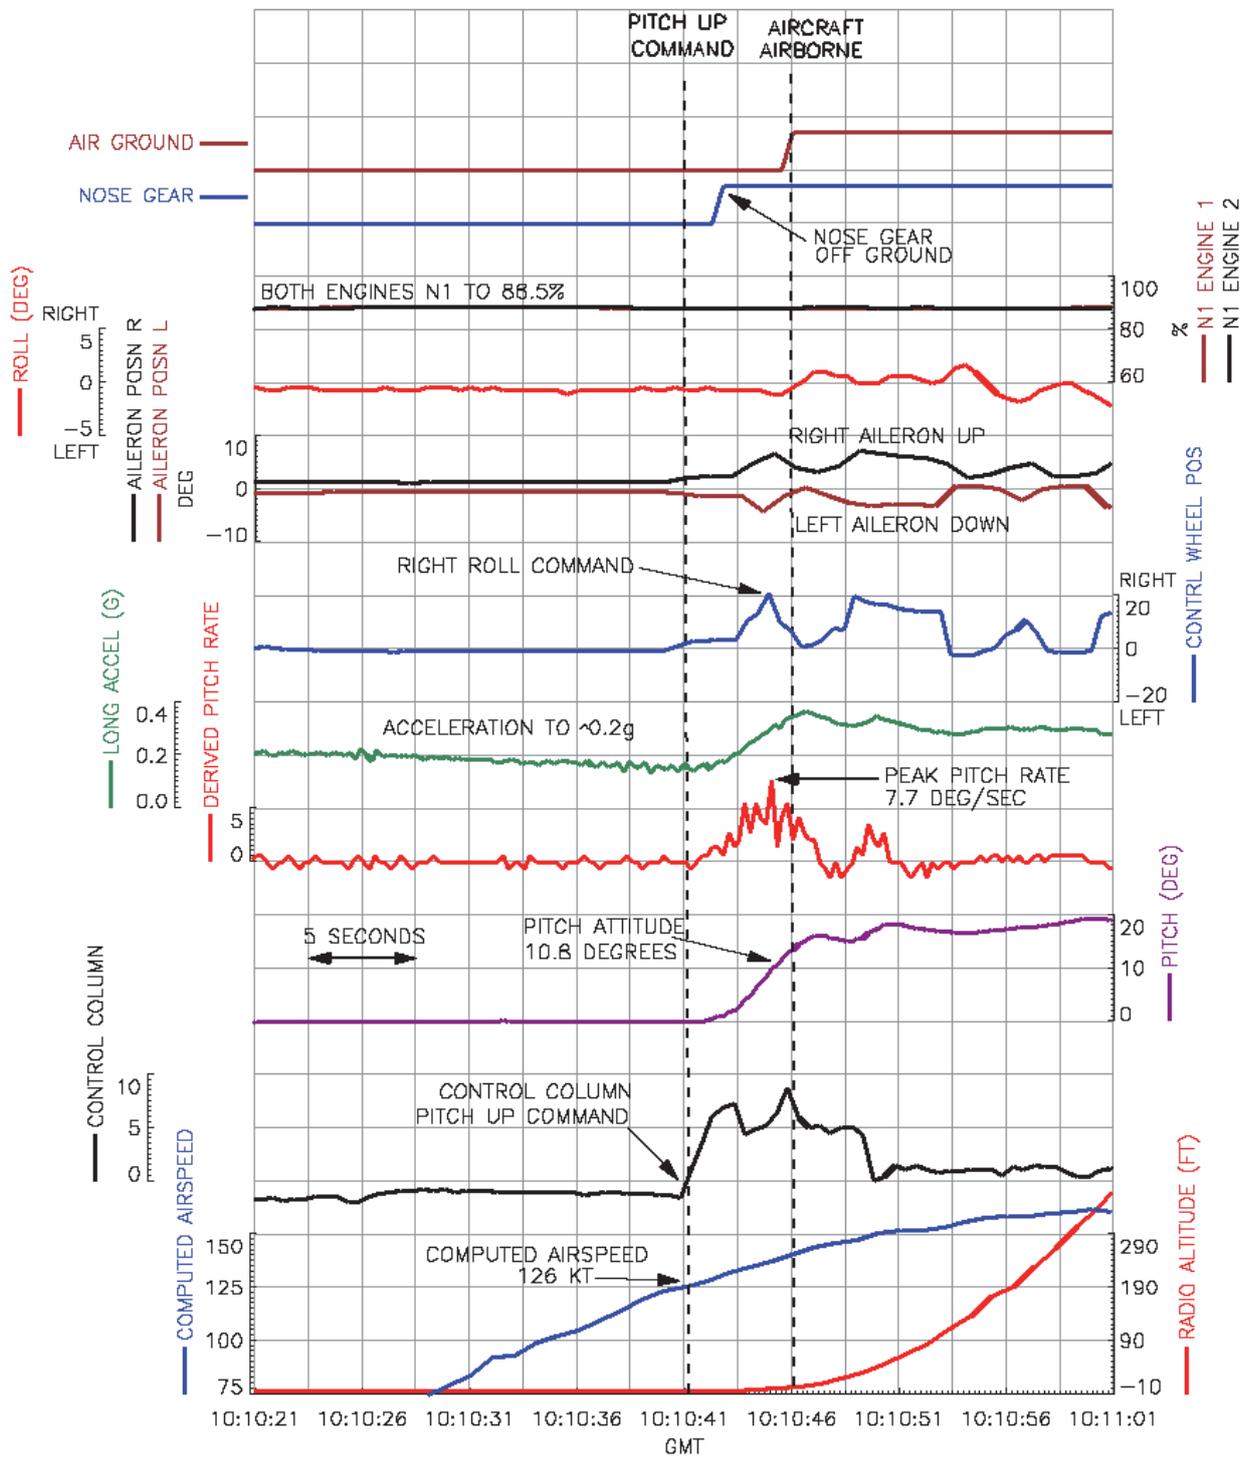
Figure 3
G-ZAPZ Chambery Takeoff FDR Parameters

Just prior to takeoff, the recorded aircraft mass was 116,560 lb (52,870 kg). Takeoff commenced at 10:10:13 hrs with N_1 on both engines increasing to 88.5% (Figure 3). At a computed airspeed (CAS) of 126 kt, the control column was pulled back to command a pitch-up attitude, the pitch attitude increased and the nosewheel left the ground. Approximately four seconds later, the pitch attitude increased through 10.8°, the threshold for a tailstrike with the landing gear compressed, and increased further as the mainwheels left the ground. The average pitch rate, calculated from the time of rotation to 10° pitch attitude, was 2.3° per second, within that recommended in the Flight Crew Training Manual.

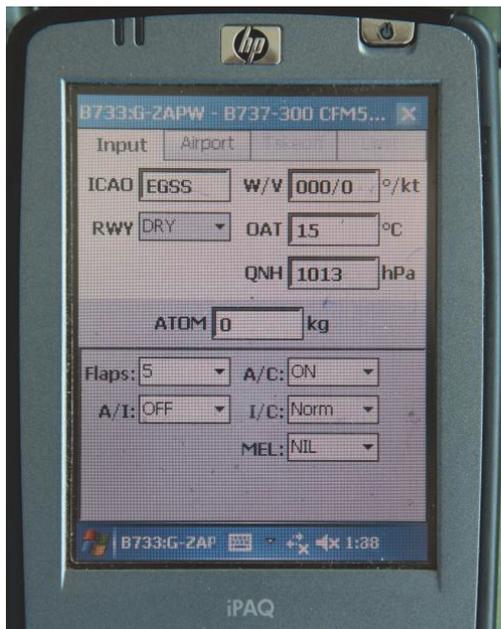
Figure 4

EFB takeoff input screen after software restart

Restarting the Guru program after shutdown takes approximately 36 seconds and results in the 'Input' data fields being reset to a standard data set (Figure 4). It also resets the 'Takeoff' and 'Limit' tabs to prevent data calculated (V speeds etc) from previous sectors being accessed.

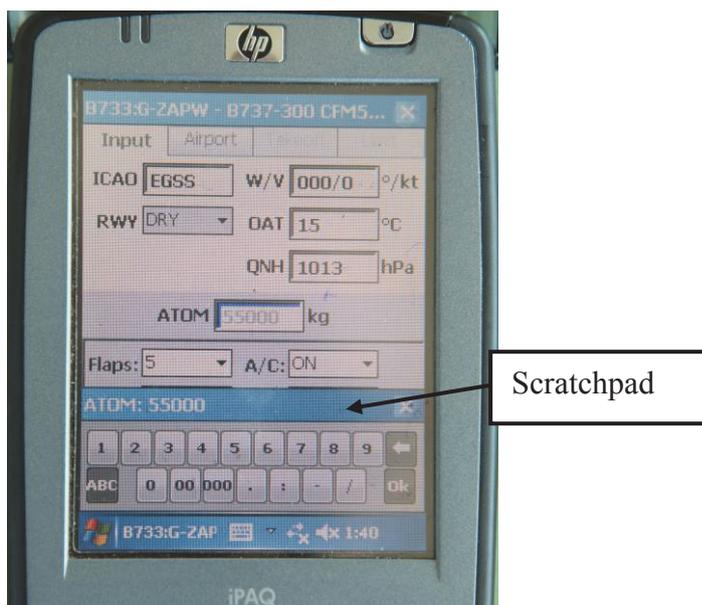
Figure 6

Both the EFB software supplier's keyboards have a 'scratchpad' which allows the user to see what is being entered even if the keyboard obscures the field being completed (Figure 6). To guard against data lying unknowingly hidden behind the open keyboard, their keyboards must be closed before different tabs can be accessed. If either of the EFB manufacturer's keyboards are selected, the device's intrinsic keyboard

EFB software supplier's keyboard

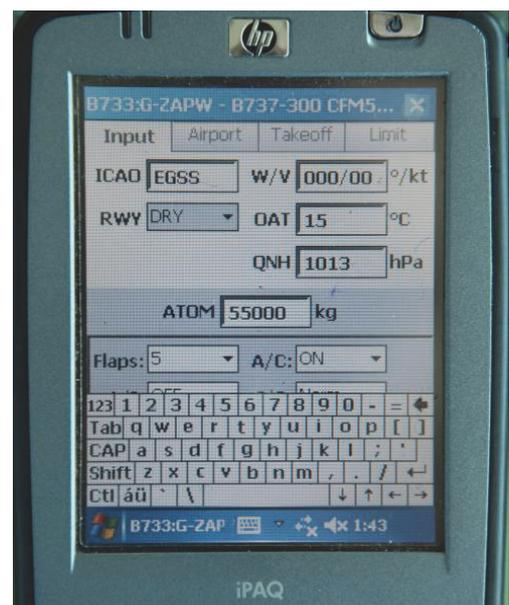
Figure 7

The device's intrinsic keyboard (Figure 7) has smaller key sizes (the number boxes are approximately 4 mm x 4 mm) than the EFB manufacturer's version. There is also no scratch pad facility, so should the keyboard cover the field being used, the numbers selected cannot be seen as they populate the field. In addition, the keyboard does not have to be hidden when moving between tabs, potentially allowing information to be hidden from view. For example, if the intrinsic keyboard was left open, the emergency turn information at the bottom of the screen shown in Figure 5 was hidden.

The EFB software supplier indicated that, for these reasons, the EFB is set to one of their bespoke keyboards by default. However, the operator preferred to use the device's intrinsic keyboard and this was the keyboard selected for use across their fleets at the time of this accident.

Device's intrinsic keyboard
