SPECIAL BULLETINS

BAE Systems Jetstream 31	G-CCPW	08-Mar-12	1
--------------------------	--------	-----------	---

ACCIDENT

Aircraft Type and Registration:	BAE Systems Jetstream 31, G-CCPW	
No & Type of Engines:	2 Garrett Airesearch TPE 331-10UGR-5164 turboprop engines	
Year of Manufacture:	1987	
Location:	Runway 26, Isle of Man Airport	
Date & Time (UTC):	8 March 2012 at 1757 hrs	
Type of Flight:	Commercial Air Transport (Passenger)	
Persons on Board:	Crew - 2	Passengers - 12
Injuries:	Crew - None	Passengers - None
Nature of Damage:	Right main landing gear yoke pintle fractured, right engine and propeller blades damaged	
Commander's Licence:	Airline Transport Pilot's Licence	
Commander's Age:	58 years	
Commander's Flying Experience:	About 6,000 hrs (of which about 1,500 hrs were on type)	
Information Source:	AAIB Field Investigation

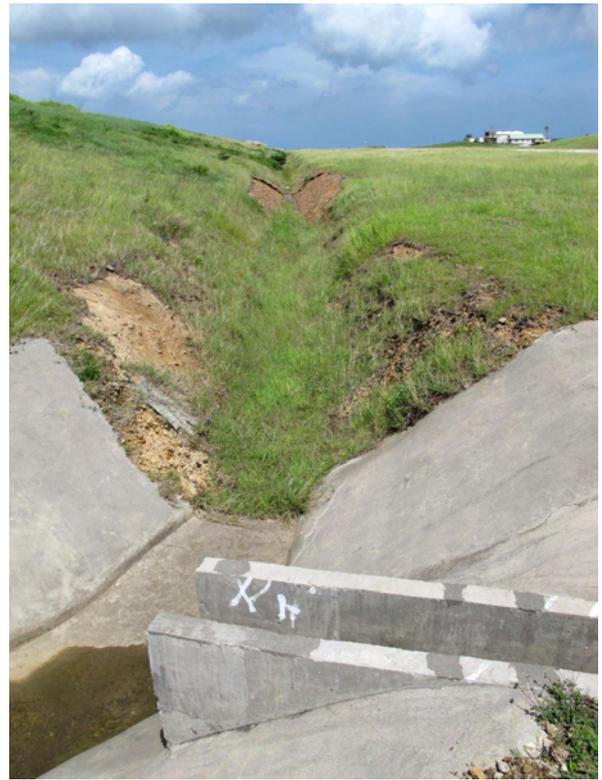
Figure 7

Ditch serving as a drain along the south side of the runway

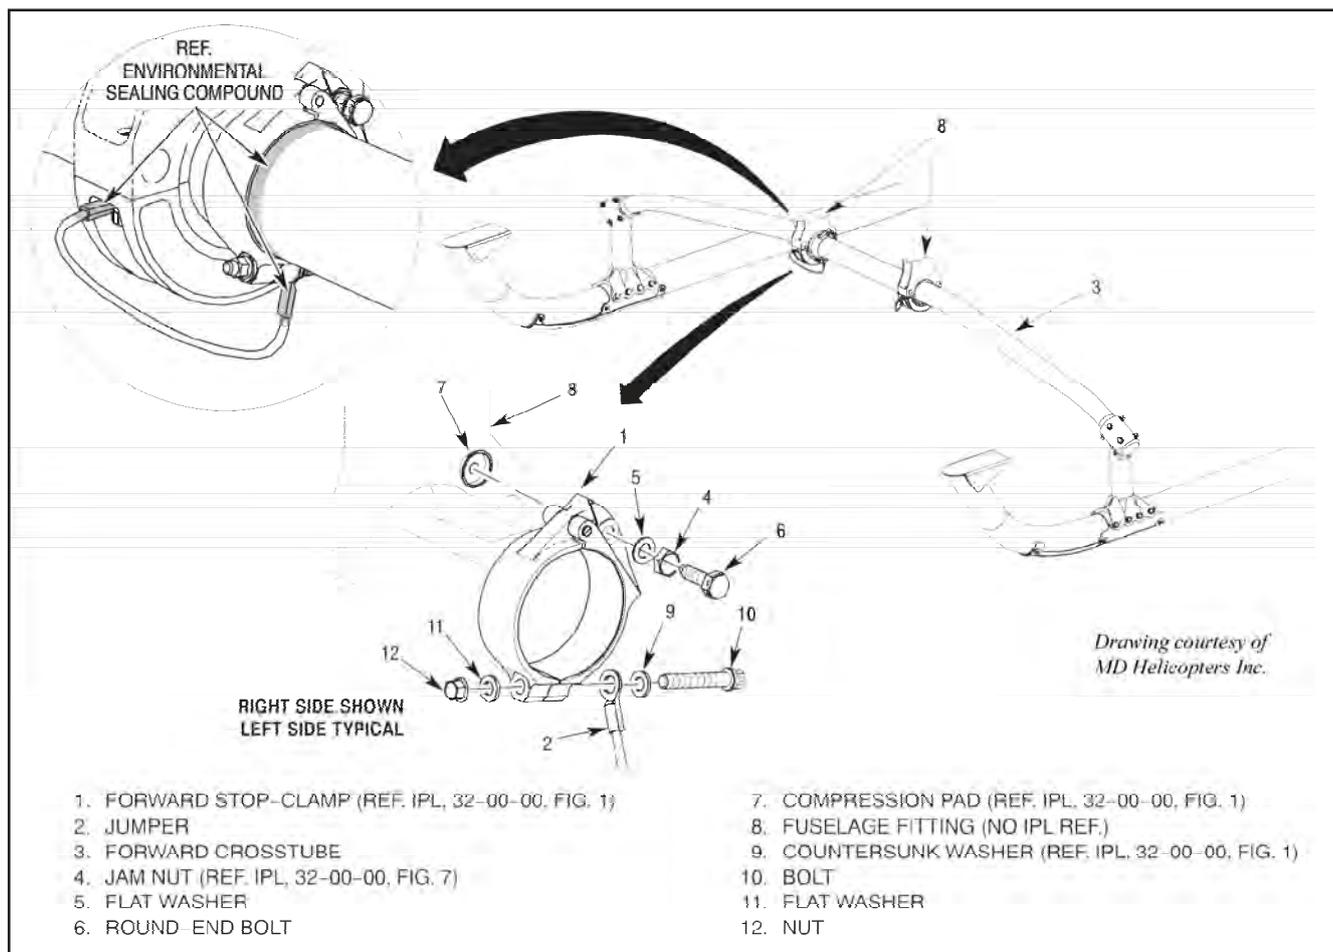
Figure 2

Forward side stop clamp detail

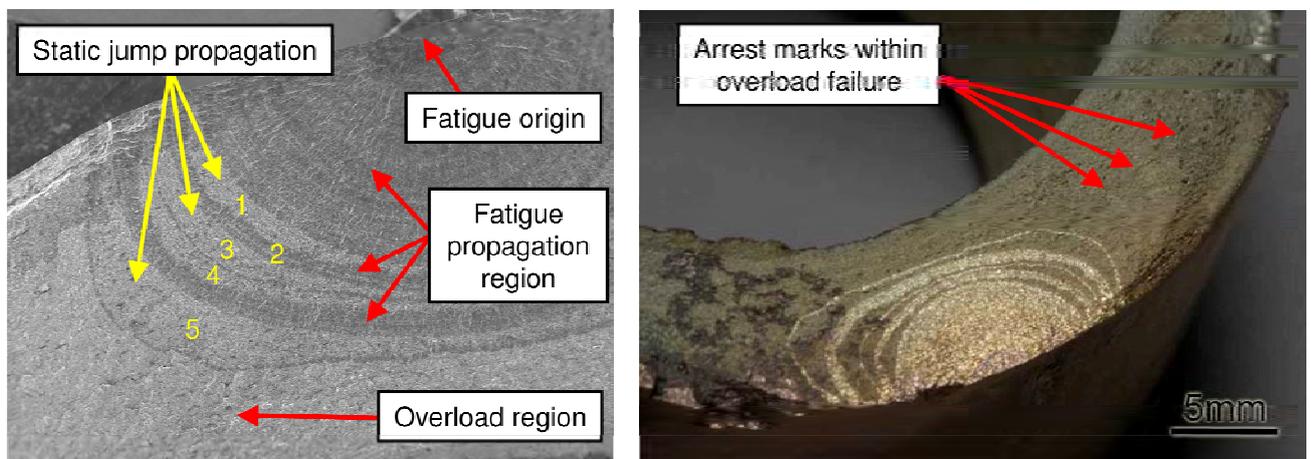
Figure 6

The fatigue crack origin was examined using both visual and scanning electron microscopy (SEM) which showed that, despite the presence of local corrosion pits, the fatigue crack had actually initiated from a shallow, curved machining mark in the tube's outer surface (Figure 5). The SEM analysis showed that the crack had initially propagated in fatigue, with at least 16 separate visible 'beachmarks', before subsequently progressing through a series of five 'static jumps' (Figure 6). A static jump is a ductile overload phenomenon in which a high load event causes a fatigue crack to propagate by localised tensile overload, before reverting back to progressive fatigue propagation under lower cyclical loading conditions. Analysis of the fracture surface away from the fatigue region revealed three 'arrest' marks within the overload failure surface.

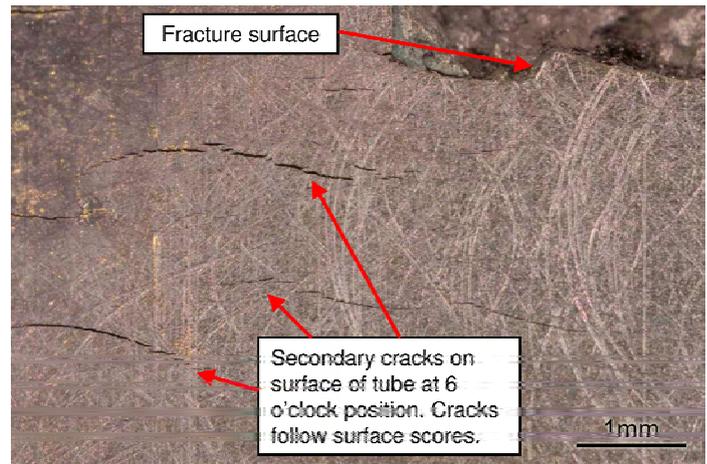
Figure 7

A significant number of secondary fatigue cracks were visible adjacent to the primary fatigue crack, with many of these originating from curved surface machining marks (Figure 7).

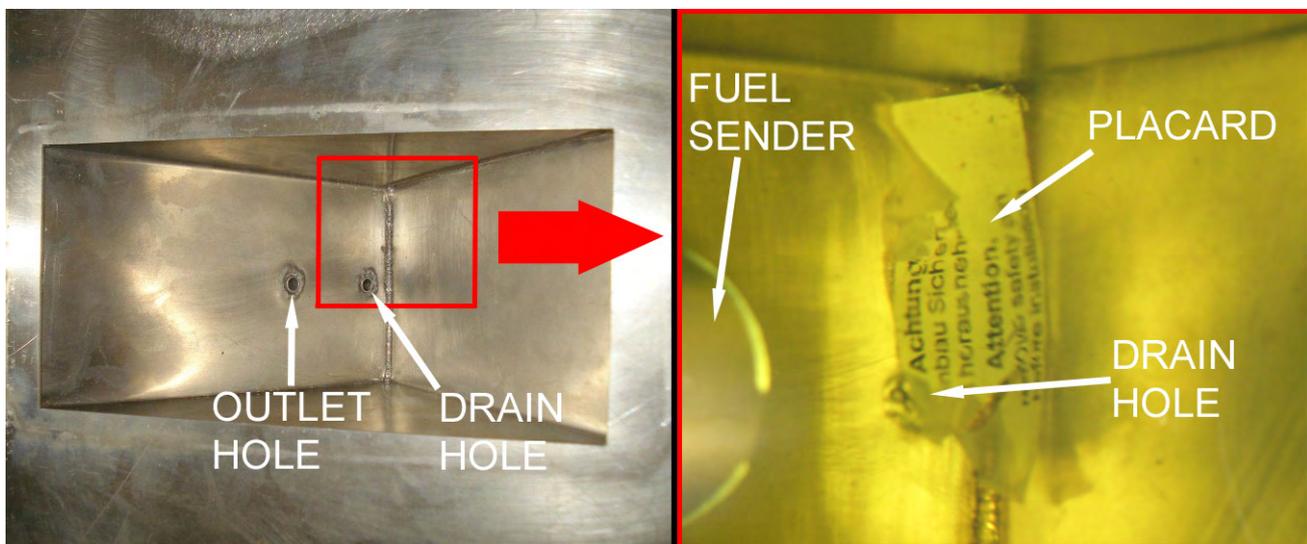
Figure 2

Base of fuel tank (left) showing outlet and drain holes; placard partially blocking drain hole in G-OLSA (right) – outlet hole not visible due to location of fuel quantity sender

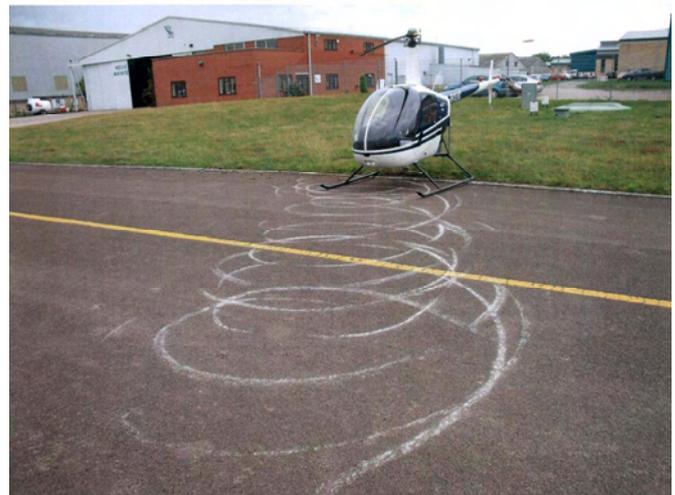
Figure 1

After landing the pilot hover-taxed the helicopter to the apron close to the helicopter operator's facilities. He then attempted to throttle back but inadvertently increased the engine power this, combined with a left yaw pedal input which had been applied during the landing, caused the helicopter to rotate rapidly to the left. It completed approximately six horizontal rotations before the pilot was able to regain control. The helicopter came to rest upright with the rear of the landing skids embedded in grass at the side of the apron, see Figure 1. The skin of the helicopter's tailboom had buckled and its supporting structure had become distorted. The pilot was uninjured.

Ground marking produced by G-BXUC during the incident

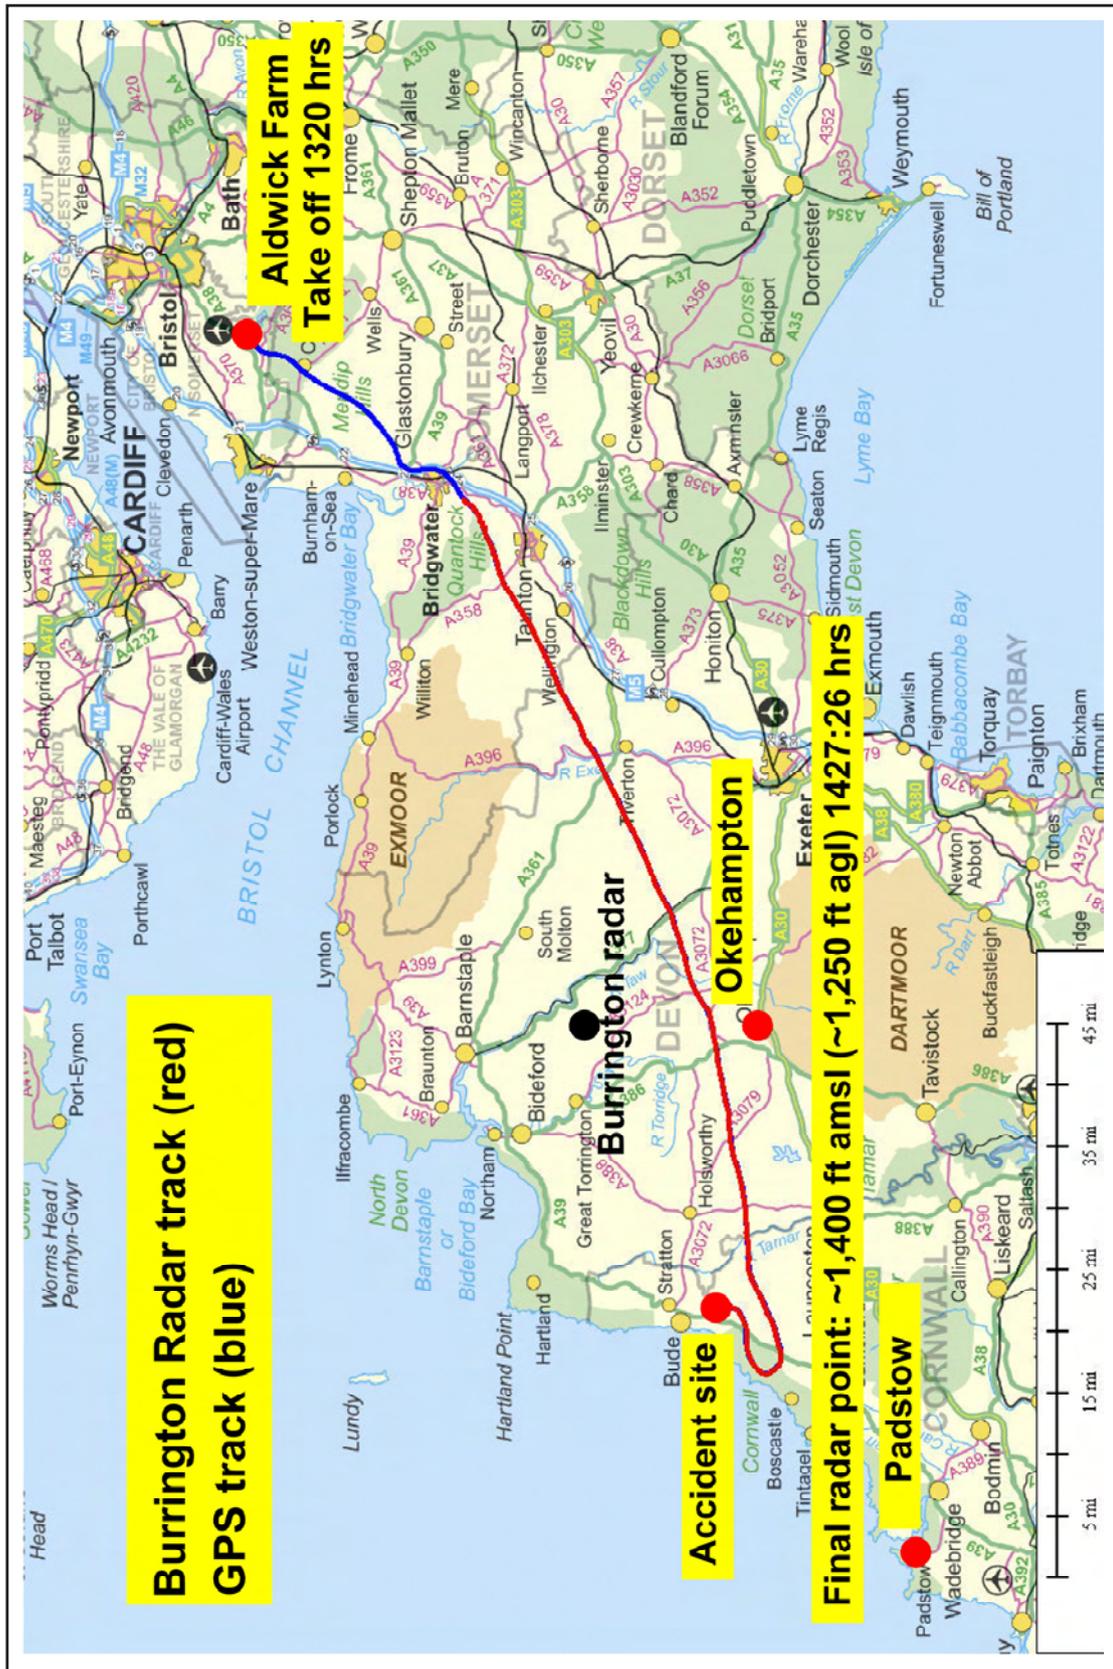
Figure 2

G-ROTG - GPS and Radar flight track

The helicopter turned through approximately 180° and then started climbing. This was probably an attempt by the pilot to turn around to find better weather conditions, a manoeuvre he would have been required to demonstrate on the JAA PPL(H) LST. This turn was flown at about 1°/sec rather than the 3°/sec required for the LST. This indicated that, while the pilot was doing

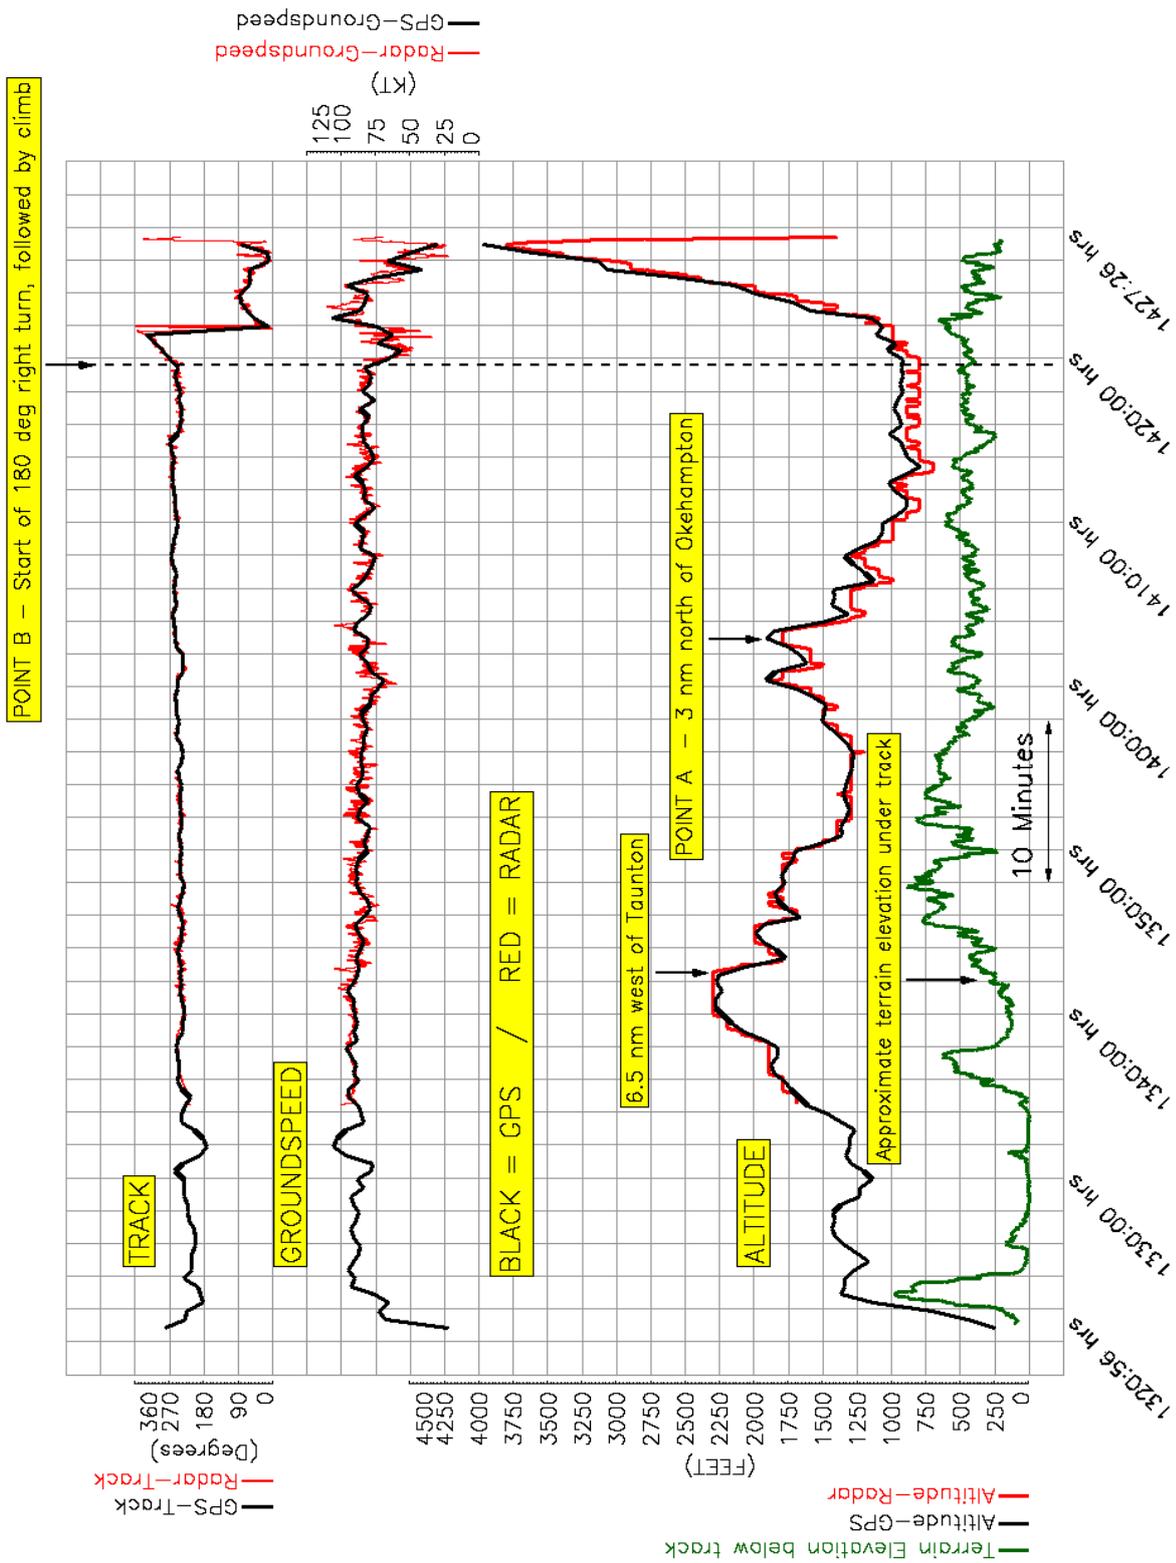
Figure 3
G-ROTG - GPS and Radar altitude profile

The pilot of G-ROTG encountered DVE and subsequently climbed in cloud to nearly 4,000 ft amsl. It is likely that he become spatially disorientated before losing control of the helicopter, which entered a very high rate of descent from which it did not recover. No mechanical fault was found with the helicopter.

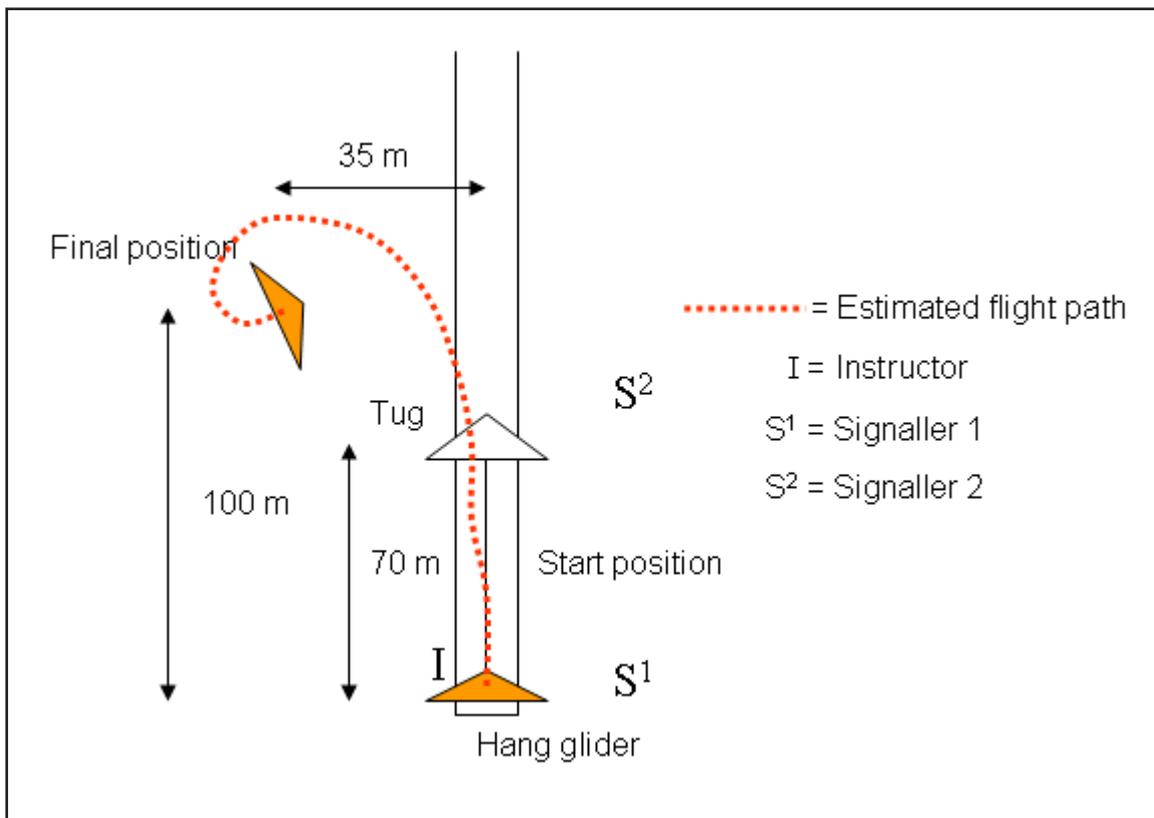
The hang glider was lying on a disused section of a concrete/asphalt runway, located approximately 35 m to the side of the runway from which it had taken off and approximately 100 m from the launch point (see Figure 1). The tow rope was found a little further along the runway in use and was lying at an angle of approximately 30° to the direction of the runway. The

Figure 1
Diagram of the accident site

hang glider was complete and intact, apart from the control frame which had suffered impact damage. The leading edge on the left side of the wing appeared to have struck the ground first, as the sail cloth along its length was torn. Some dismantling of bracing wires had taken place as part of the efforts to rescue the pilot.
