AAIB Special Bulletins / Interim Reports

ACCIDENT

Aircraft Type and Registration:	EC225 LP Super Puma, G-REDW
No & Type of Engines:	2 Turbomeca Makila 2A1 turboshaft engines
Year of Manufacture:	2009 (Serial no: 2734)
Date & Time (UTC):	10 May 2012 at 1114 hrs
Location:	20 nm east of Aberdeen
Type of Flight:	Commercial Air Transport (Passenger)
Persons on Board:	Crew - 2 Passengers - 12
Injuries:	Crew - None Passengers - 2 (Minor)
Nature of Damage:	Damage to be assessed following salt water immersion
Commander's Licence:	Airline Transport Pilot's Licence
Commander's Age:	To be advised
Commander's Flying Experience:	To be advised
Information Source:	AAIB Field Investigation

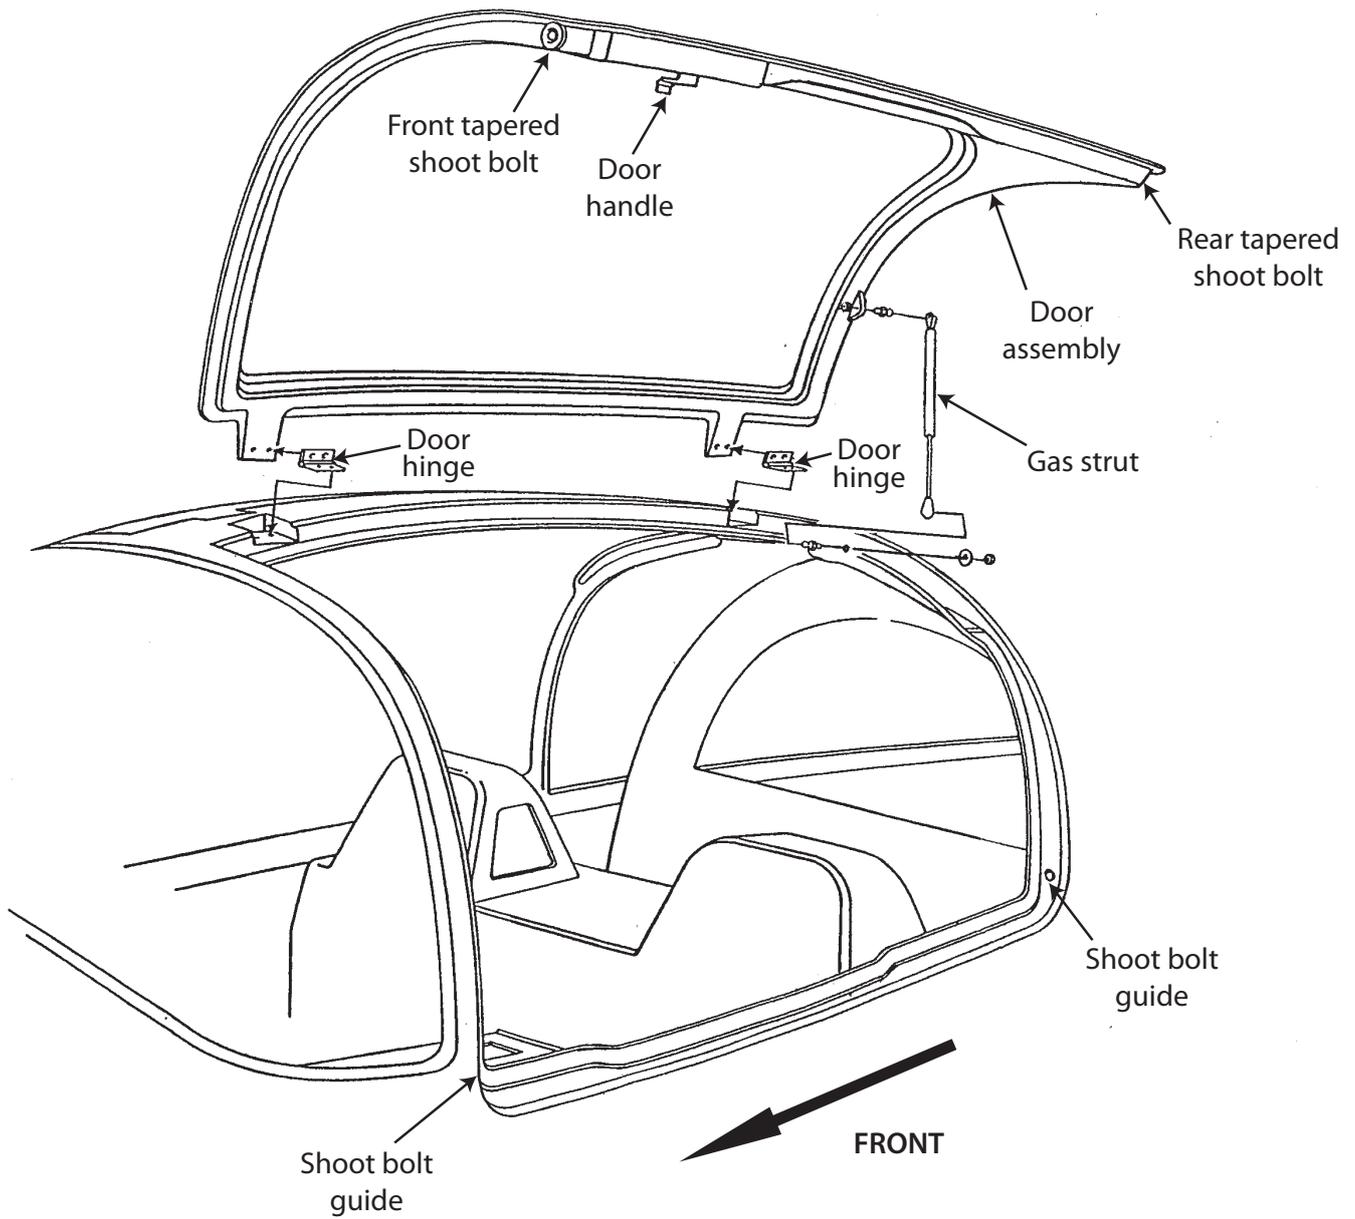
Figure 1

from the lower corners of the front and rear sides of the door, into guides in the door frame. It is possible to have the door locking lever in the closed position with only the front shoot bolt engaged in its guide.

The pilot candidly reported that it is most likely that the rear shoot bolt was not engaged on this occasion and as the airspeed increased, the increasing aerodynamic forces caused the partially closed door to open. The LAA intend to remind their members of the importance of checking all doors and hatches are closed before every takeoff.

General arrangement of door
(courtesy Europa Aircraft (2004) Ltd)

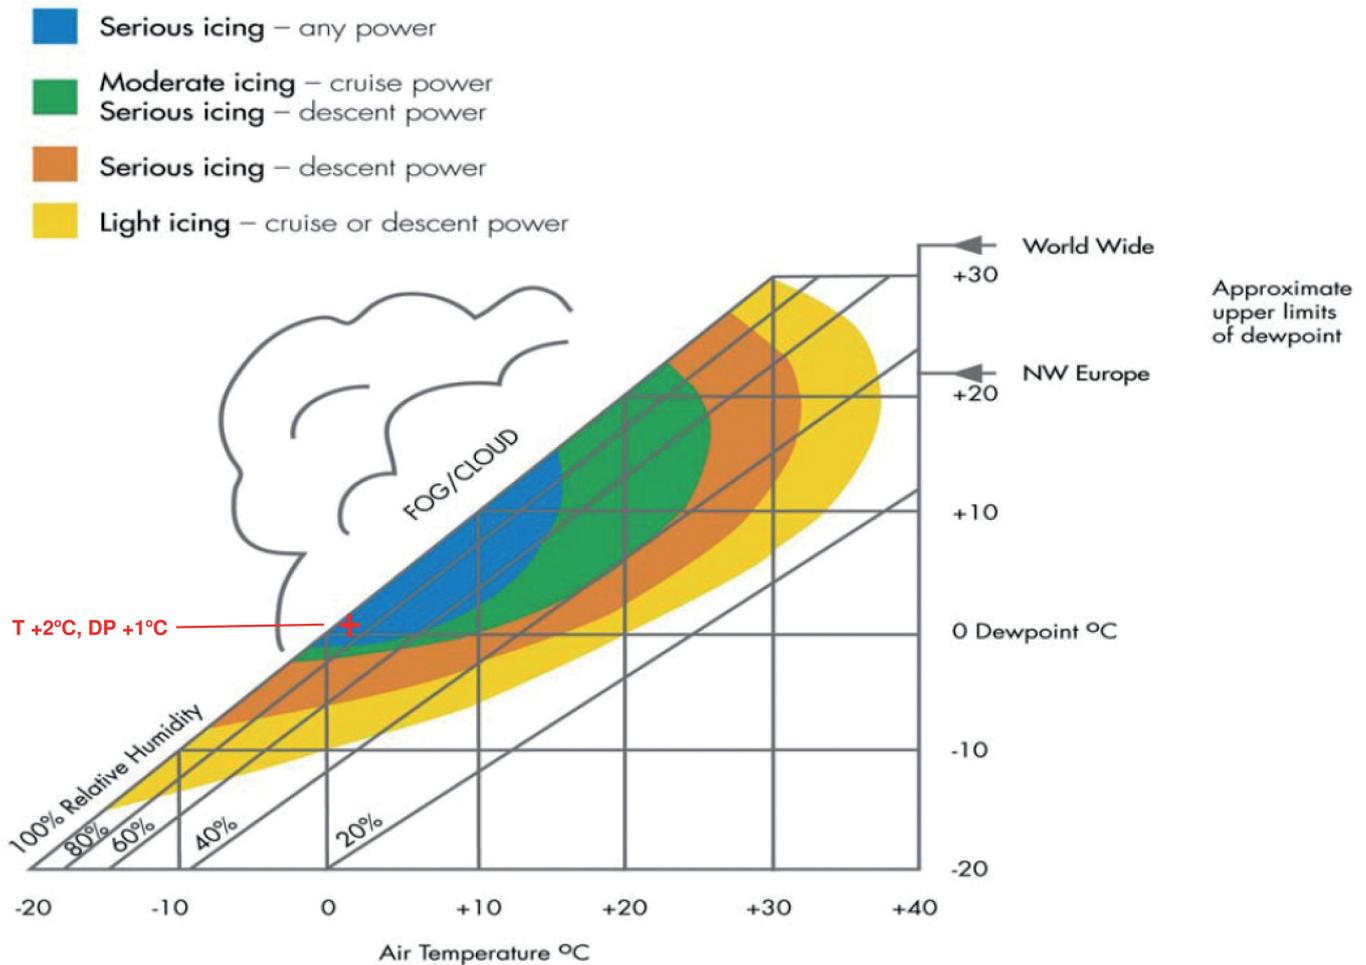
Figure 2
Carburettor icing chart

An aftercast was provided by the Met Office for the Compton Abbas area at the time the accident occurred. It estimated that, at 1,700 ft altitude, the air temperature was +2°C and the dewpoint was +1°C. These conditions were conducive to serious carburettor ice formation at any power setting (Figure 2).
