CONTENTS

SPECIAL BULLETINS

COMMERCIAL AIR TRANSPORT

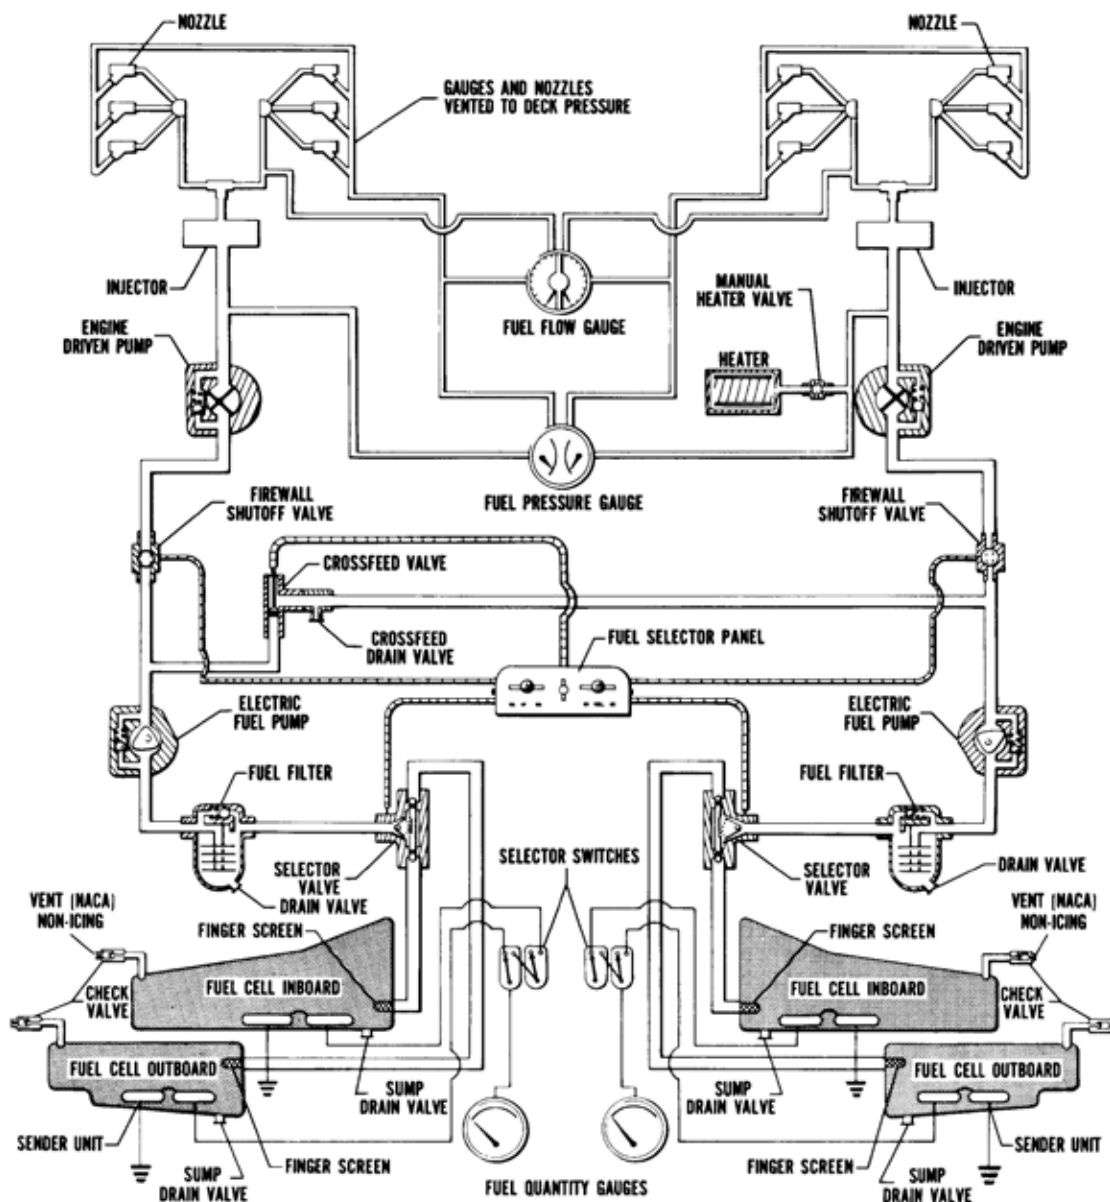
Figure 1

PA-31-310 Fuel System Schematic

An annual inspection had been performed on 3 November 2009, by an FAA approved aircraft maintenance technician, when the aircraft had flown 2,850.9 hours. No fuel system-related defects had been reported to the maintenance technician since this annual inspection and, at the time of the accident, the aircraft had flown 2,866.5 hours.

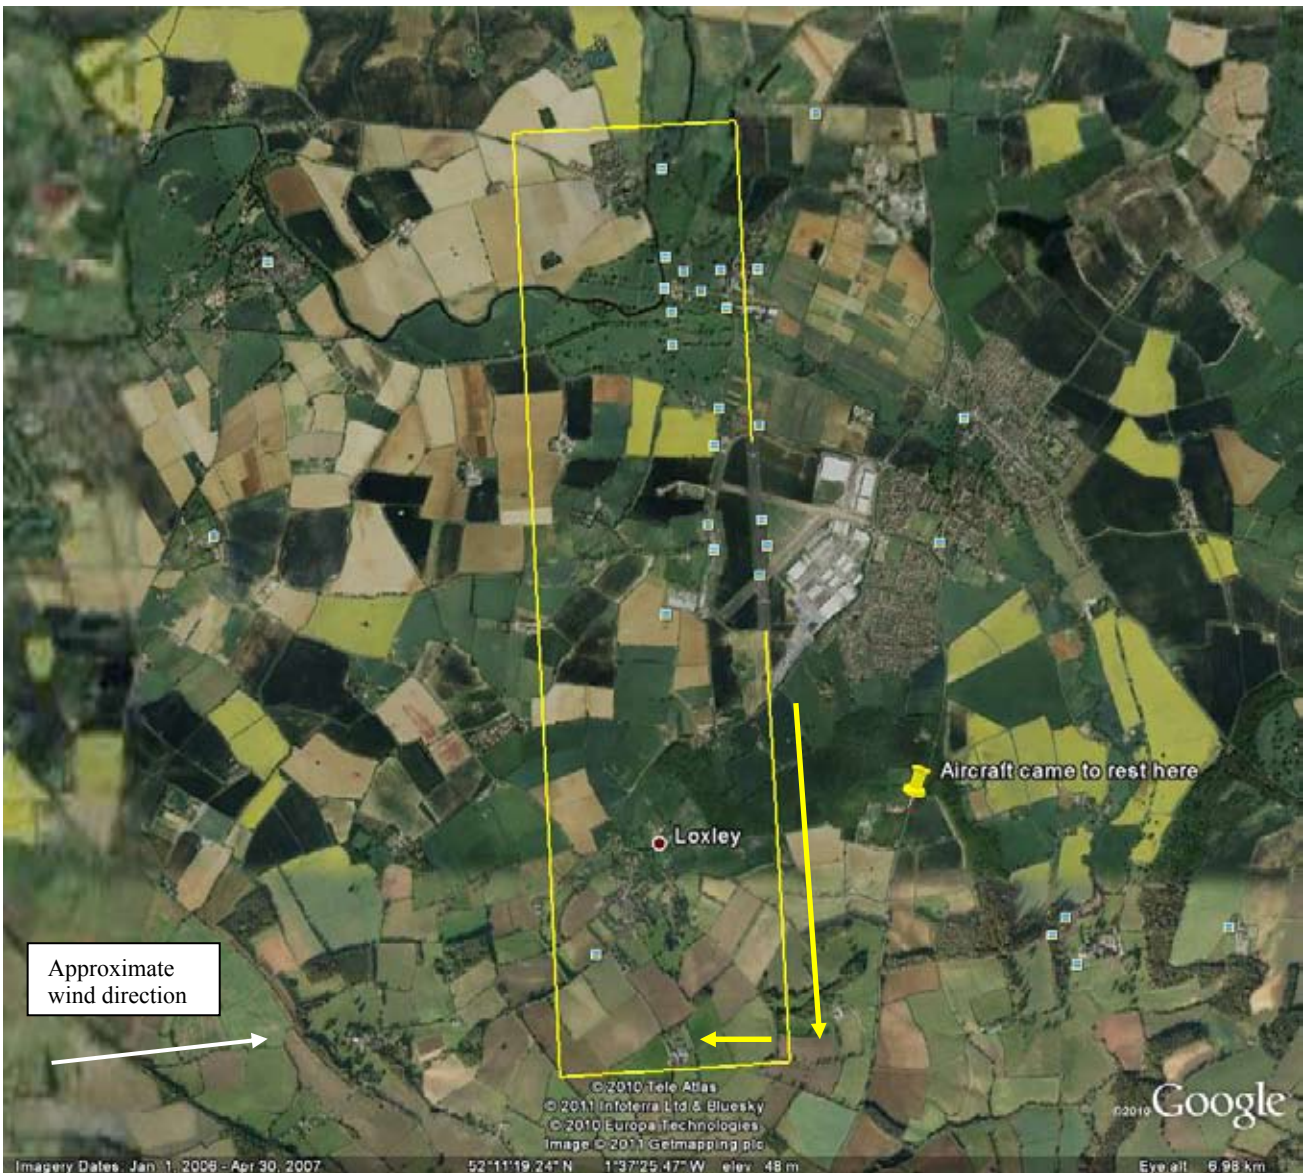
Figure 1
Circuit plan and accident site

The student pilot had flown a number of practice solo circuits without incident. The weather was fine, with a 10 kt breeze from the west, an air temperature of 7°C and a cloud base of 2,500 ft. During climb-out on the final circuit, the pilot noted that the engine noise changed subtly as the aircraft passed through 500 ft agl. The pilot continued the circuit, climbing to 1,000 ft agl and turning onto the crosswind leg, before levelling the

aircraft and throttling back the engine. Immediately the engine lost power and the rpm dropped to 1,200. The pilot applied carburettor heat and switched fuel tanks. Although the engine responded to throttle position, the changes were small and no significant increase in power was evident. The pilot selected a field to the north-east of his position (Figure 1) and attempted a forced landing. However, the aircraft touched down at the far end of the field, hitting the boundary hedge at over 20 kt and came to rest on the road behind. The landing caused extensive damage to the aircraft and the hedge, but the pilot was uninjured and exited the aircraft without assistance through the door. Traffic using the road was brought safely to a halt without collision.
