CONTENTS

SPECIAL BULLETINS

SERIOUS INCIDENT

Aircraft Type and Registration:	ATR 72-202, EI-SLG	
No & Type of Engines:	2 x Pratt and Whitney PW124B turboprop engines	
Year of Manufacture:	1990	
Date & Time (UTC):	15 March 2011 at 2130 hrs	
Location:	Near Edinburgh Airport	
Type of Flight:	Commercial Air Transport (Non-Revenue)	
Persons on Board:	Crew - 2	Passengers - None
Injuries:	Crew - None	Passengers - N/A
Nature of Damage:	None	
Commander's Licence:	Air Transport Pilot's Licence	
Commander's Age:	45 years	
Commander's Flying Experience:	TBA	
Information Source:	AAIB Field Investigation

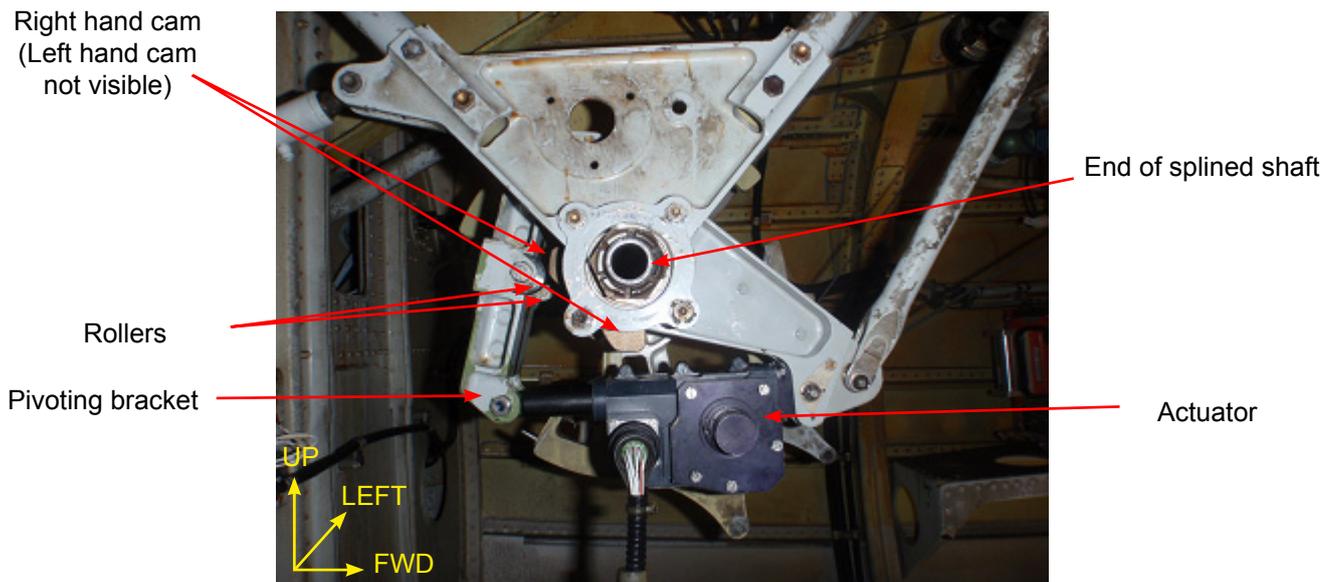
Figure 2

The TLU comprises an electrical actuator with two output shafts, two vee-shaped cams mounted on the rudder rear quadrant shaft and a pivoting bracket on which are mounted two rollers. The position of the pivoting bracket and hence the rollers is a function of the actuator extension. When the actuator is retracted, each roller is positioned into the vee groove of its corresponding cam (Figure 2).

In the reduced authority position the actuator retracts, rotating the bracket about its pivot, thereby engaging the rollers in the vee cams and thus mechanically limiting the rudder deflection. In the full authority position the actuator extends, disengaging the rollers from the vee cams such that rudder deflection is no longer limited. A green LO SPD indicator light illuminates in the cockpit when the TLU is in the full authority position.

Rudder Travel Limitation Unit

approximately 19° to one side, the incorrect installation of the right hand cam resulted in the right hand cam no longer being symmetrically aligned with the left hand cam (Figures 3 and 4).

engaging in the vee groove of the cams and caused an uncommanded rudder input and corresponding rudder deflection.

It is recommended that ATR immediately informs all operators of ATR aircraft equipped with a Travel Limitation Unit that it is possible to install the cams on the rear rudder quadrant shaft in the incorrect orientation.

It is recommended that ATR amends all relevant Aircraft Maintenance Manual tasks to include a warning to highlight that the cams on the rear rudder quadrant shaft can be installed incorrectly.

It is recommended that ATR amends the Aircraft Maintenance Manual task '*Operational Test of the Rudder Travel Limitation Unit*' to state that: (1) the test should be carried out for a minimum of 30 seconds and (2) should an asymmetric restriction of the rudder pedals be detected or if the FLT CTL light illuminates, further inspection of the TLU system should be conducted.

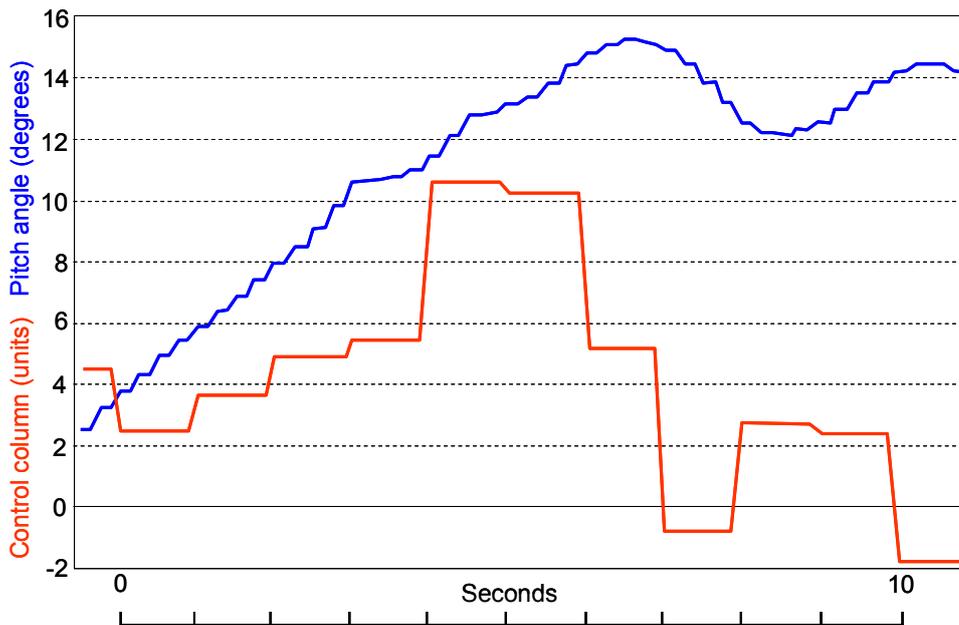
Data from the aircraft's flight data recorder (FDR) showed that rotation was initiated at 159 kt IAS, consistent with the planned 160 kt target. Figure 1 shows a graphical plot of the data for aft control column input and aircraft pitch attitude. The graph covers about 12 seconds, from just after the start of rotation through the early climb to about 100 ft agl (the nature of the two plots reflects the different update rates for each parameter).

Aircraft pitch attitude and control column position during rotation
