CONTENTS

COMMERCIAL AIR TRANSPORT

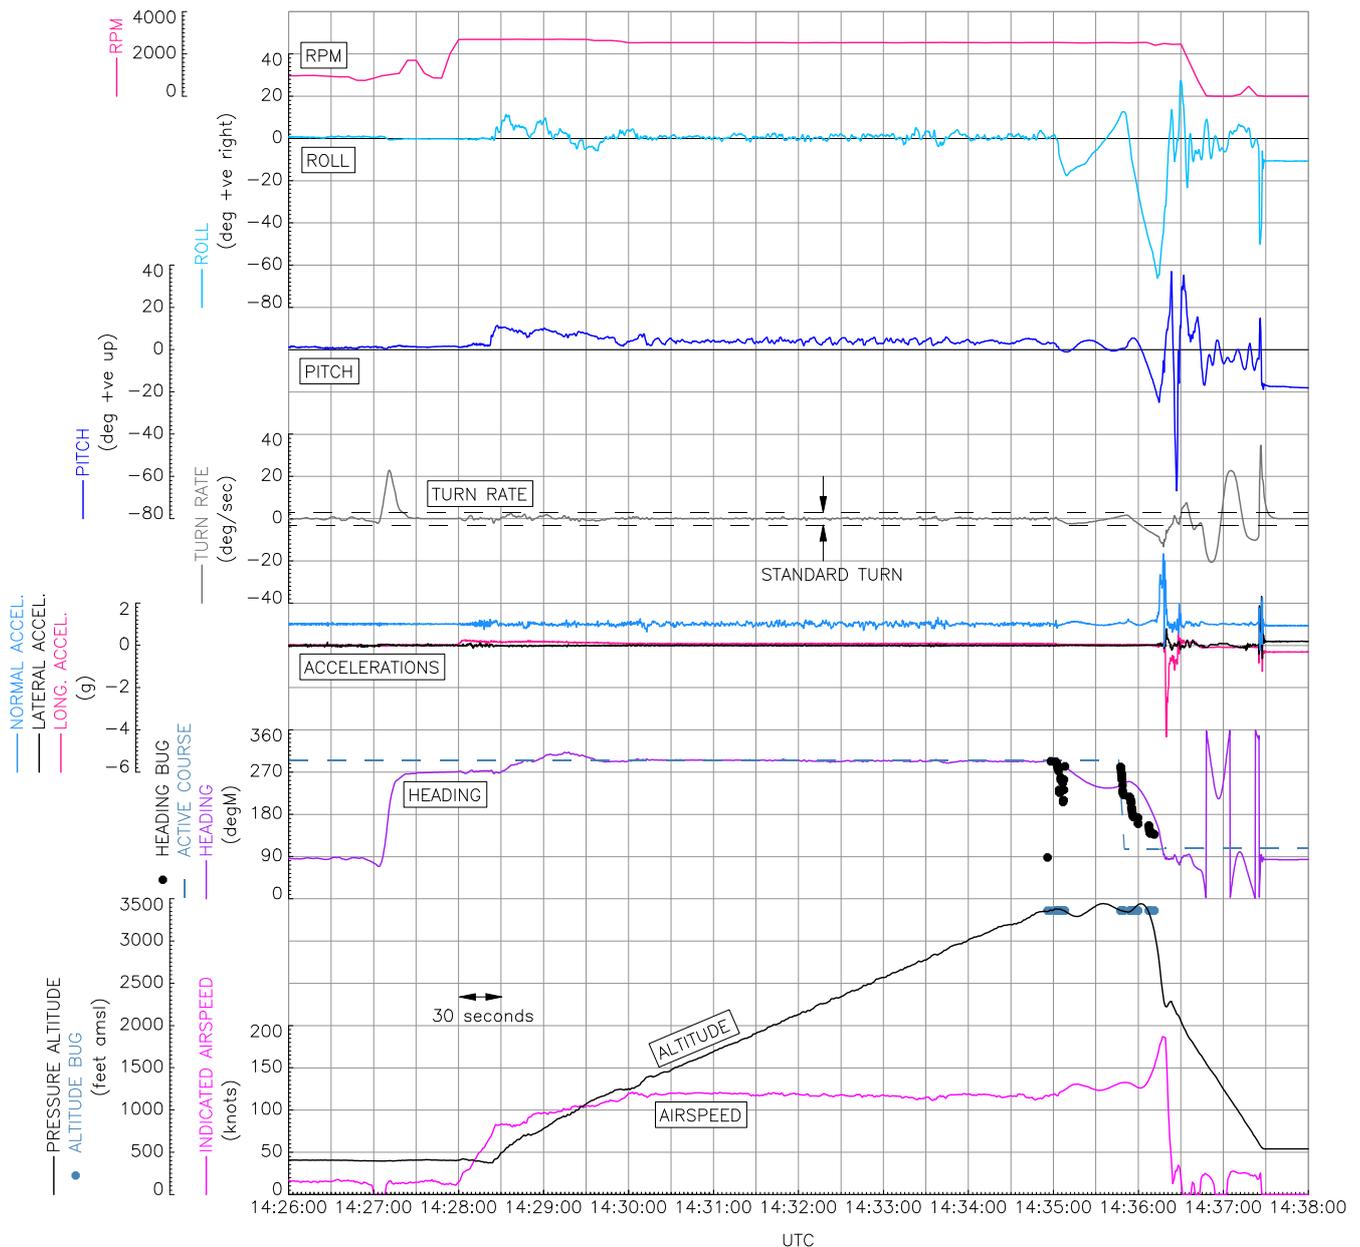
Figure 2 shows that between 1430:30 hrs and 1434:30 hrs, the aircraft was climbing at a constant 400 ft/min on a heading of 295°M. The recorded engine speed was 2,530 rpm and the indicated airspeed

120 kt, reducing to 115 kt. The aircraft then began to level off. 25 seconds later, at 1434:55 hrs, the aircraft reached 3,360 ft amsl and this altitude was selected on the altitude bug. During the next 75 seconds of flight the data is smoother than data recorded up to this point. The recorded data covering this portion of the flight is presented in more detail in Figure 3, which includes the

Salient recorded parameters from the PFD and MFD showing the whole flight

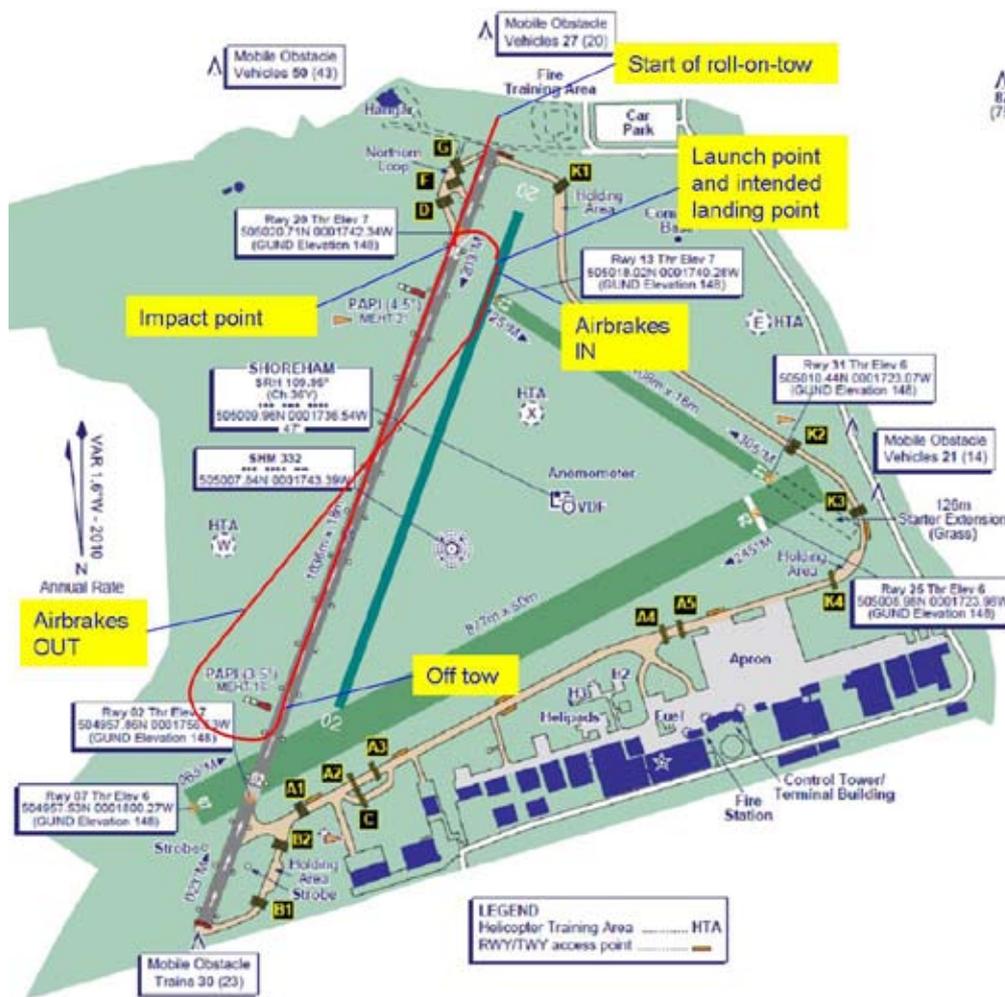
the asphalt Runway 20. He retracted the airbrakes and began a left turn. Figure 1 shows the ground track of the glider.

Ground track flown by G-IZII
