CONTENTS

AAIB FIELD INVESTIGATIONS

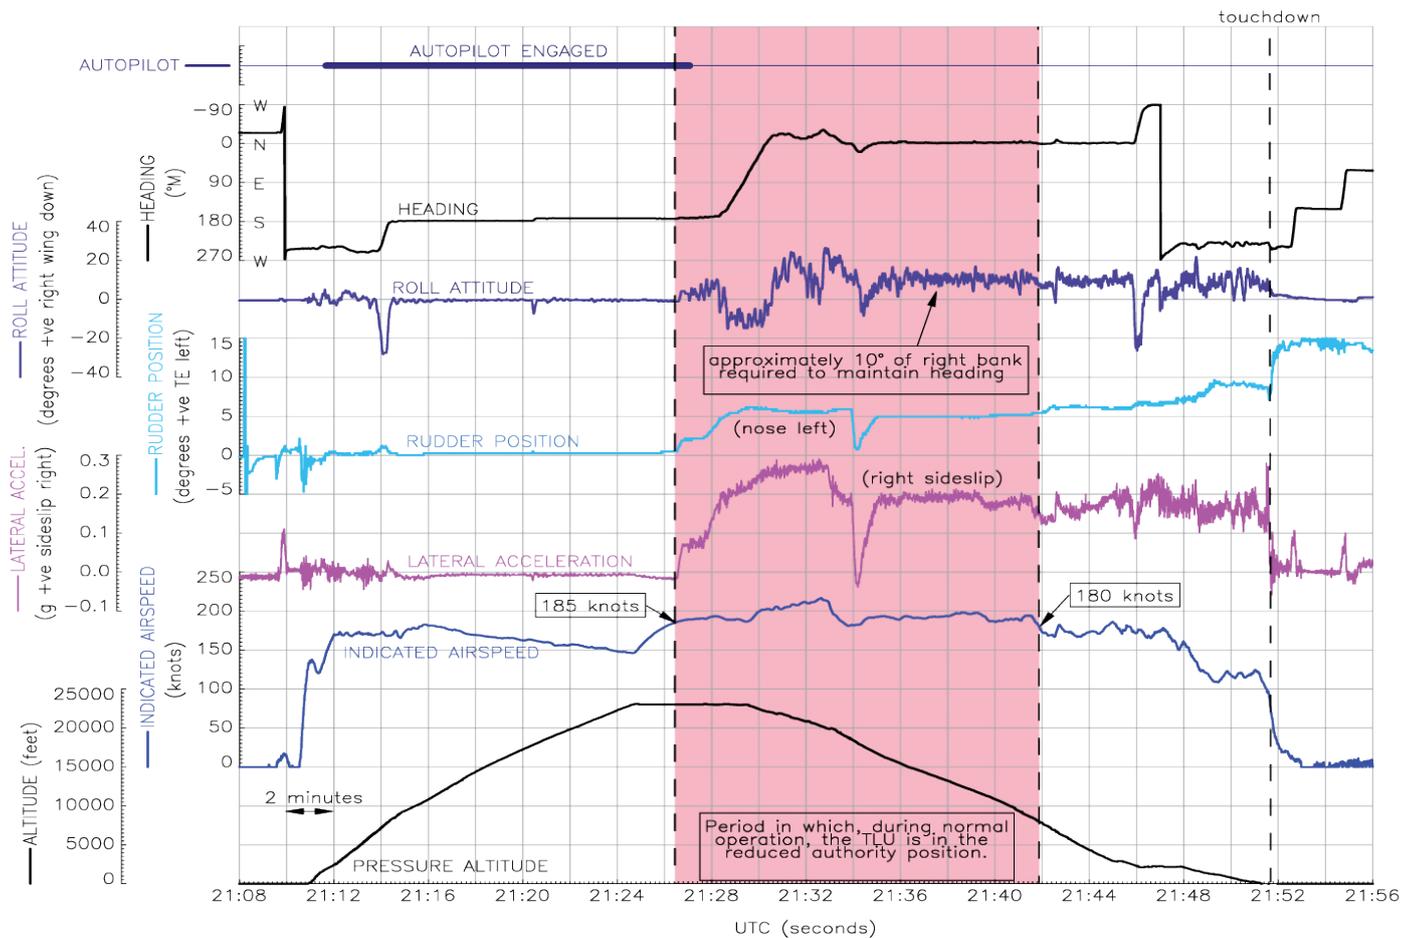
Figure 2

A history of salient (and available) parameters from the QAR for the incident flight is shown in Figure 2. Highlighted (in pink) is the portion of the flight during which the aircraft had accelerated through 185 kt (2126:25 hrs) and then decelerated to below 180 kt (2141:54 hrs). In normal operation, during this period, the TLU would have been in the reduced authority position.

Salient QAR parameters

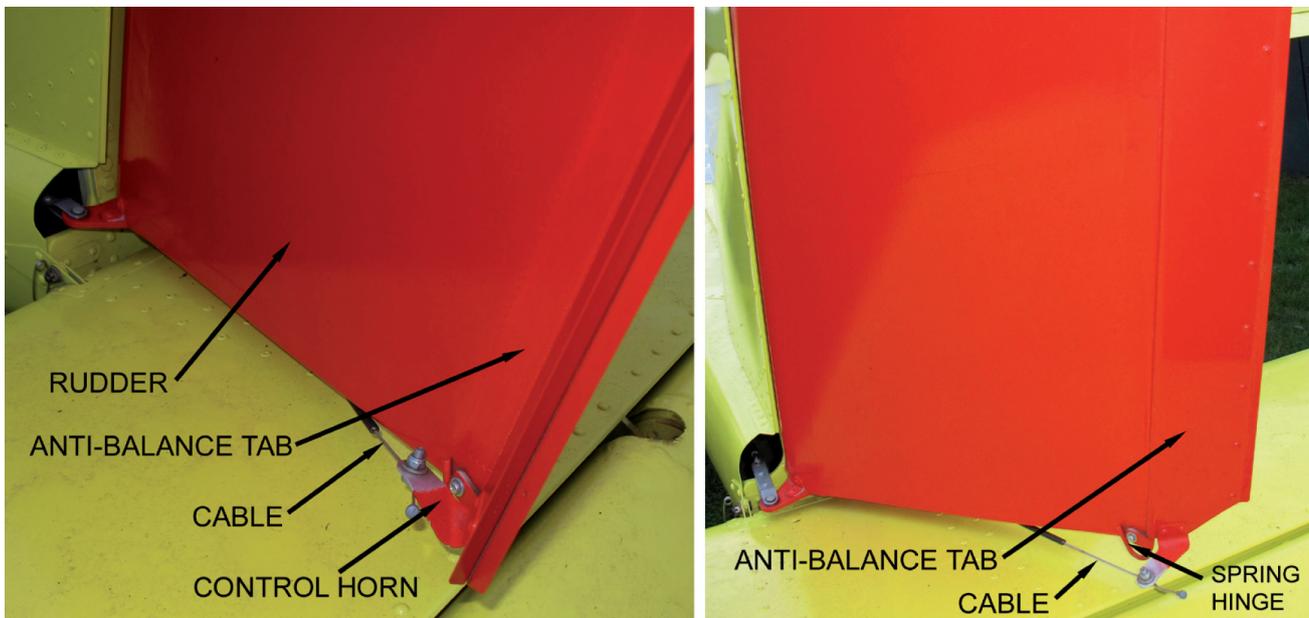
Figure 2

Rudder of a similar Foxbat A22L;
full left rudder deflection and full left anti-balance tab deflection (left image);
full right rudder deflection and full right anti-balance tab deflection (right image)

replaced and the bolt securing the cable was orientated 'head down' (as in Figure 2) which is how the bolt should have been attached to provide maximum clearance. The aircraft was then test-flown and the rudder anti-balance system worked normally.

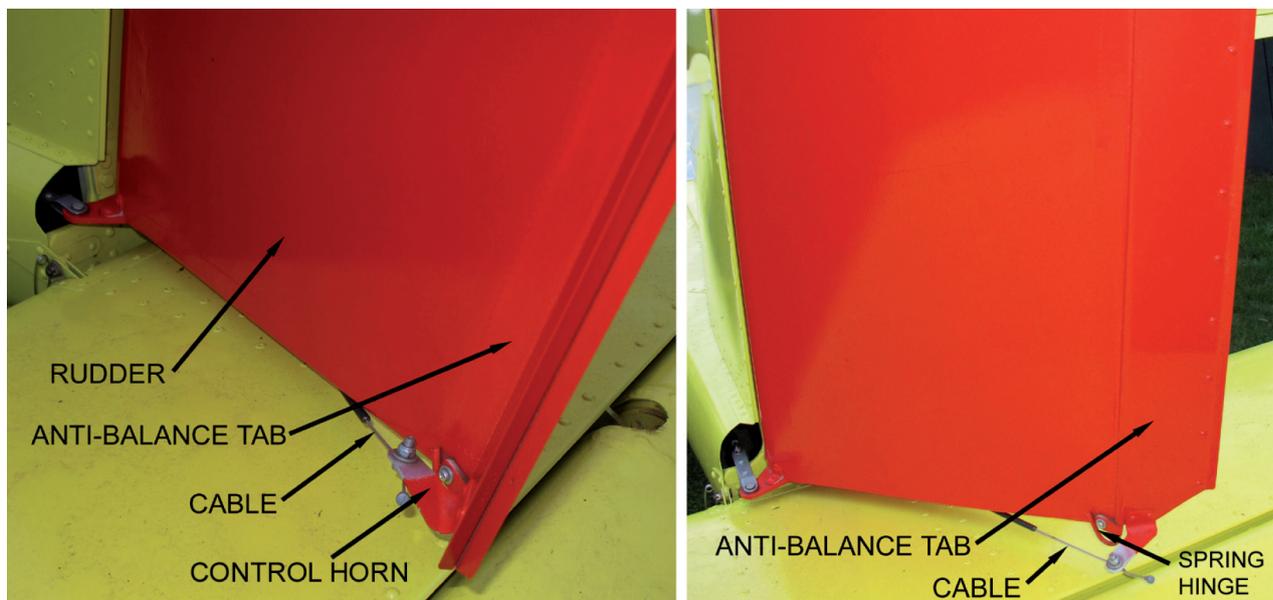
Figure 2

Rudder of a similar Foxbat A22L;
full left rudder deflection and full left anti-balance tab deflection (left image);
full right rudder deflection and full right anti-balance tab deflection (right image)
