CONTENTS

COMMERCIAL AIR TRANSPORT

| Boeing 757-28A | G-STRY | 25-Aug-10 | 1 |
| Bombardier DHC-8-102 | SX-BIO | 24-Apr-10 | 17 |

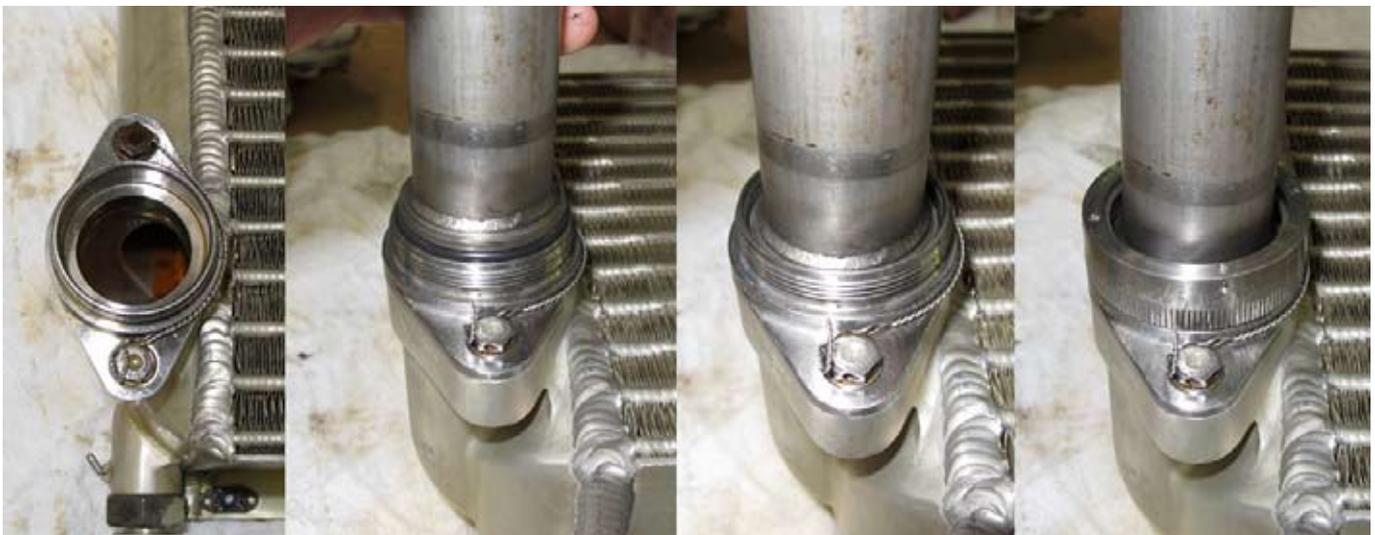
SX-BIO had mod 8/0642 embodied which changed the assembly and nut type, and only hand tightening of the nuts was required. The following sequence of photographs in Figure 14 helps to illustrate the installation.

When the knurled nut is fully wound down, as in (4) in Figure 14, the oil pipe is free to move and can be rotated and moved up and down. The O-ring is the only barrier against oil leakage from the cooler. If the nut cannot be tightened and fully wound down by hand then this is an indication that the pipe has not been installed correctly and/or the O-ring may have been damaged. The O-ring provides the seal and no additional clamping force is provided by over-tightening the nut.

From left to right: (1) oil cooler fitting; (2) oil pipe partially inserted – O-ring seal visible; (3) oil pipe fully inserted; (4) knurled nut fully wound down, hand tight

The upper section of the oil cooler fitting (image (1) in Figure 14) has a thin wall, 1.64 mm thick, and on its inner edge it has a 30 degree chamfer which further reduces the wall thickness at its top edge, making this edge feel moderately sharp to the touch. Trying to force the pipe into the oil cooler fitting when it is not perfectly aligned could result in the sharp edge of the fitting pressing up against the O-ring seal on the pipe.

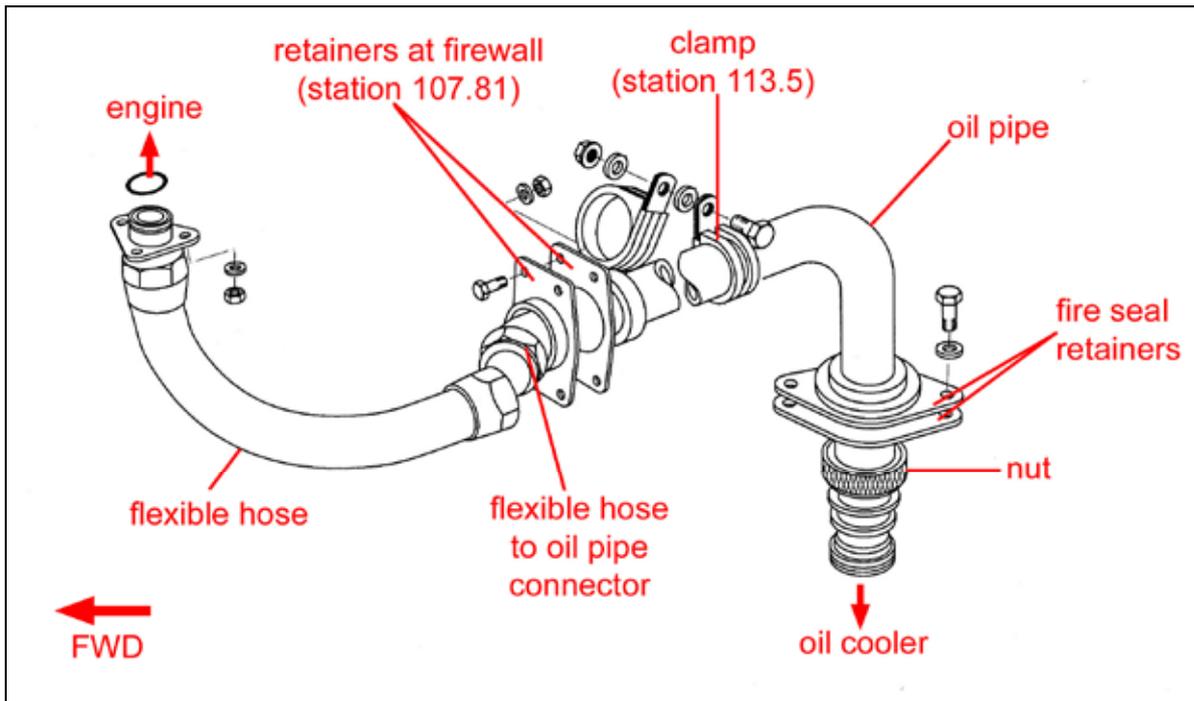
Figure 15

Above the oil cooler, the oil pipe passes through a pair of fire seal retainers and a clamp which serves to secure

the pipe to the nacelle structure. The pipe then passes through a pair of retainers in the firewall and is attached to a flexible hose (Figure 15). The AMM procedure for the oil cooler removal requires the fire seal retainers to be disconnected, but it makes no reference to the clamp, firewall retainers nor flexible hose. According to the engineer and technician who undertook to re-install the oil coolers following the incident, in order to be able to rotate the oil pipe to the vertical position and easily manoeuvre it into the oil cooler fitting, they needed to loosen the clamp and disconnect the pipe from the flexible hose. They reported that the flexible hose was not sufficiently flexible to permit the pipe to be rotated to, and stay in, the vertical position, without disconnecting it from the pipe. Figure 10 shows that the oil pipes were not in the vertical position on the right engine installation.

Oil cooler oil pipe installation on the DHC-8-100

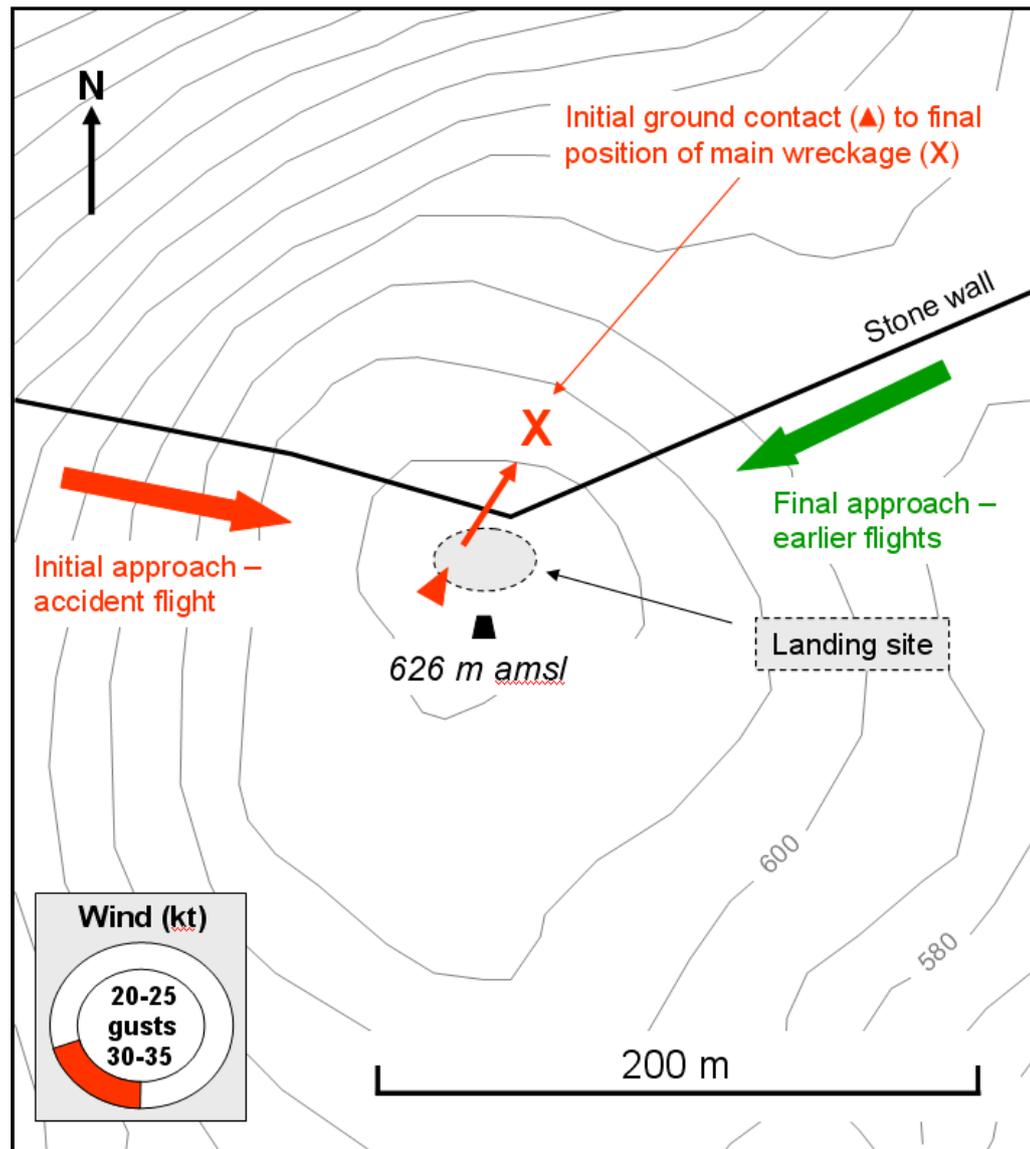
Figure 1

The four previous approaches had been made from the north-east, approximately into wind. Whilst at the summit on the previous flight the pilot thought that the wind had backed and reduced in strength. On the accident flight, because of the possible drop-off at the alternative site, the helicopter approached the hilltop from a westerly direction. It overflew the landing site and started a right turn back towards it (Figure 1).

With the helicopter descending rapidly and now with significant forward speed, the pilot flared the helicopter just before it struck the ground. He recalled that it struck the ground a short distance before the intended landing site. The occupants sensed that the rear of the helicopter

Sketch of accident location
