## CONTENTS

### SPECIAL BULLETINS

S2/2011 Britten-Norman BN2A-26 Islander	VP-MON	22-May-11	1
---	--------	-----------	---

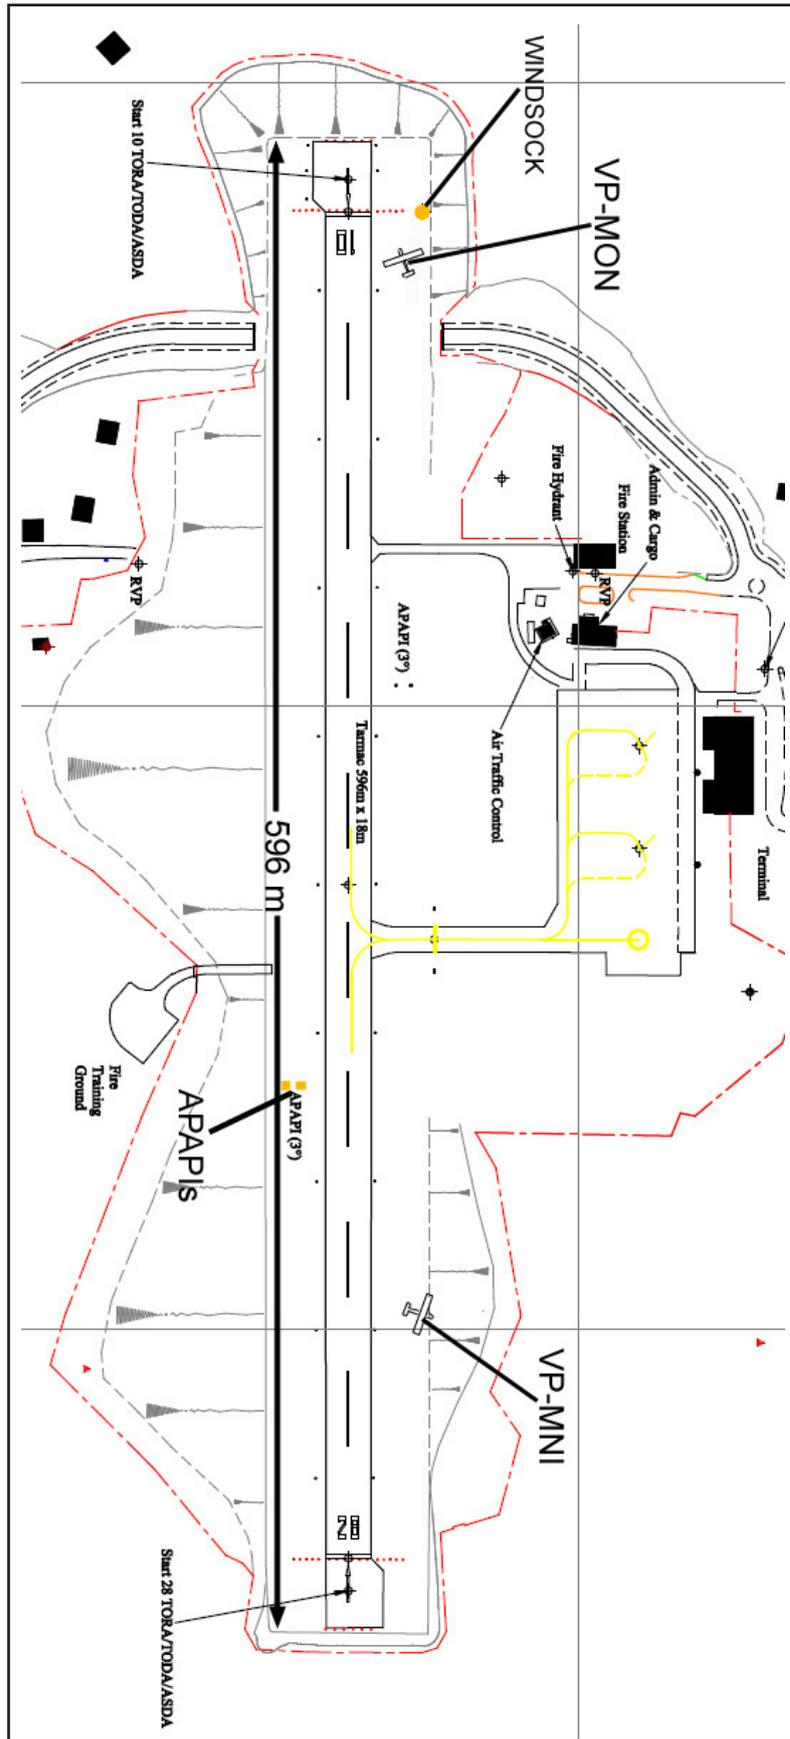
There are no overrun areas on either runway. At the end of each runway is a vertical drop in excess of 200 ft. See Figure 1 for a diagram of the airfield.
