CONTENTS

SPECIAL BULLETINS

COMMERCIAL AIR TRANSPORT

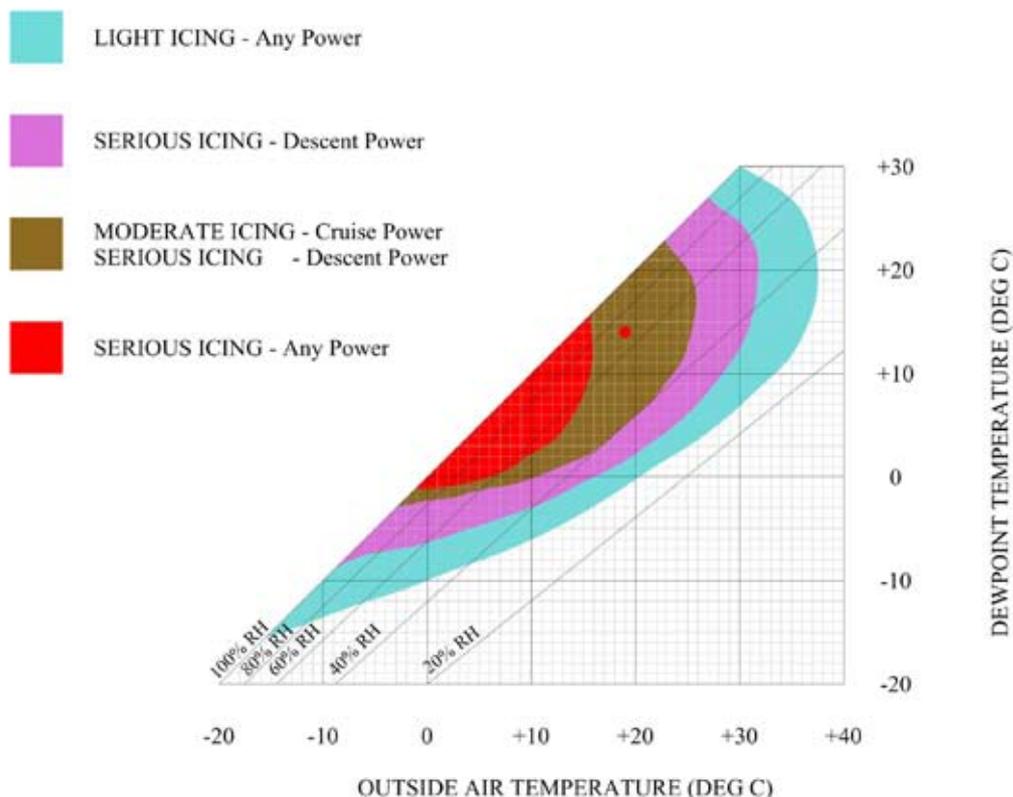
Figure 2
Carburettor icing prediction chart

The weather conditions at the time were such that carburettor icing could have been a possibility with moderate icing at cruise power and serious icing at descent power, Figure 2. The carburettor heat control was found in the COLD position.

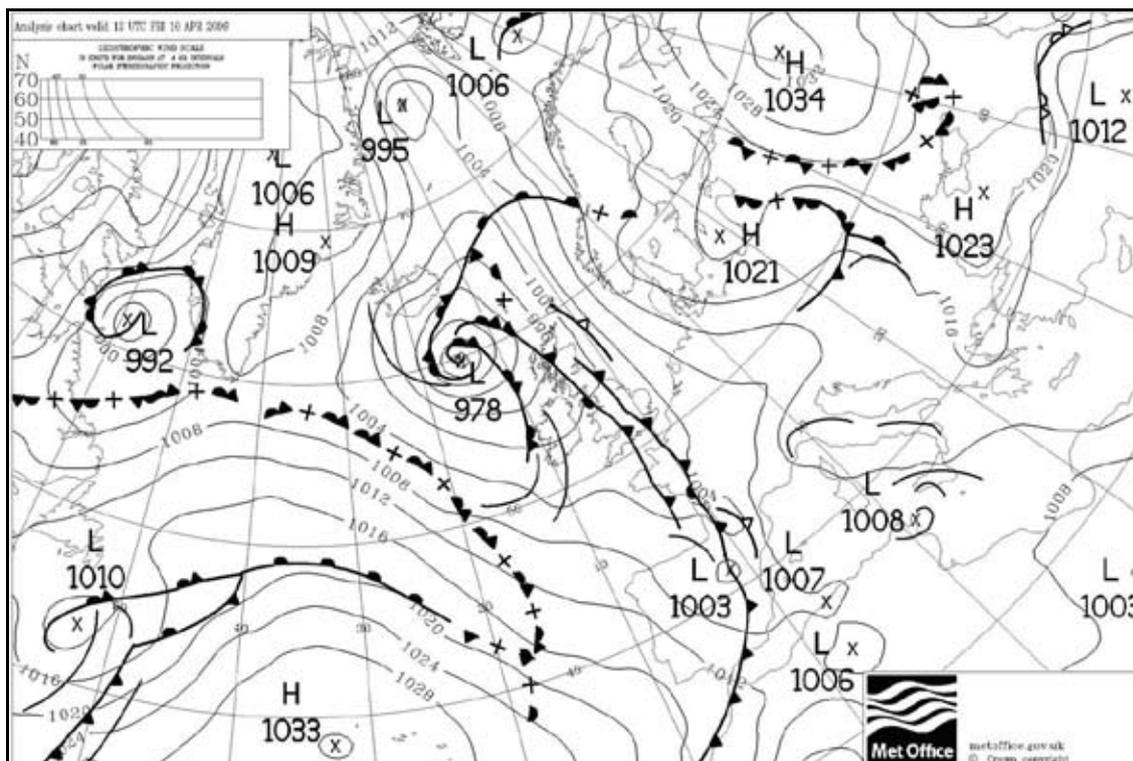
Figure 3

The Met Office produced an analysis of the weather at the time of the accident. The surface analysis for 1200 hrs is shown at Figure 3.

Synoptic situation at 1200 hr

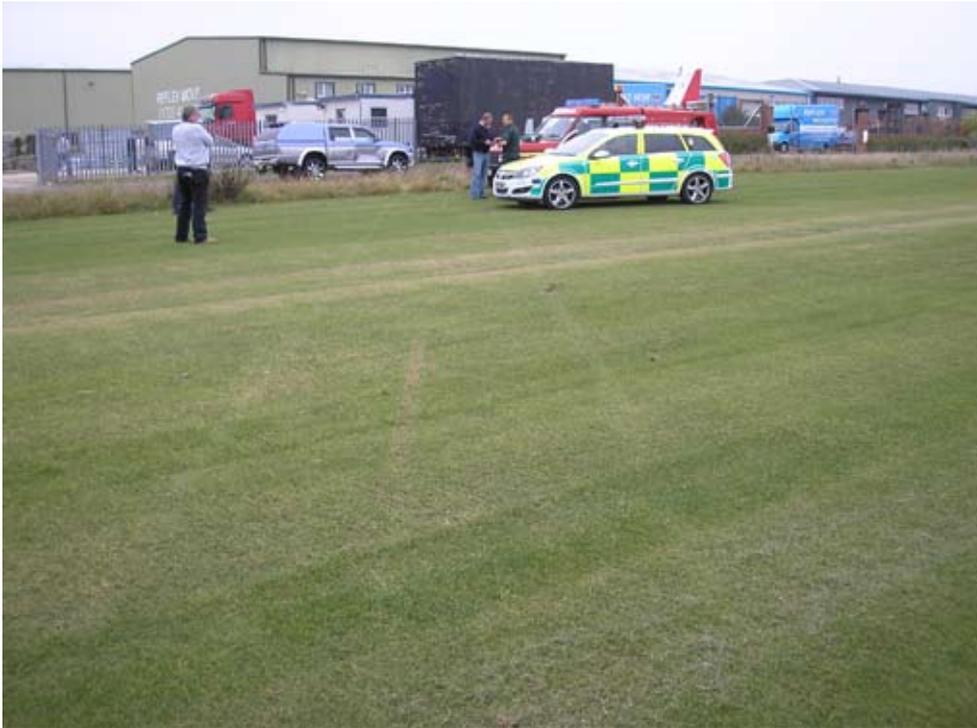
The pilot looked subsequently at markings left by the nose wheel just as the aircraft began its rapid swing and thought that they suggested the nose wheel was skidding. Figure 2 shows the tracks left later by the aircraft as it approached the road.

The tyre marks shown in Figure 2 were left by the aircraft shortly before the impact and, had the nose gear already collapsed, the marks would be consistent with the damage already done. The marks left by the
