CONTENTS

INCIDENT

Aircraft Type and Registration:	Airbus A320-232, G-EUUR
No & Type of Engines:	2 International Aero Engine V2527-A5 turbofan engines
Year of Manufacture:	2003
Date & Time (UTC):	26 November 2008 at 0820 hrs
Location:	Approx 10 miles north-east of Glasgow Airport
Type of Flight:	Commercial Air Transport (Passenger)
Persons on Board:	Crew - 4 Passengers - Not known
Injuries:	Crew - None Passengers - None
Nature of Damage:	None
Commander's Licence:	Airline Transport Pilot's Licence
Commander's Age:	49 years
Commander's Flying Experience:	14,750 hours (of which 5,400 were on type) Last 90 days - 150 hours Last 28 days - 82 hours
Controller's Experience	The controller had qualified in 1973, had been an approach radar controller since 1980 and employed at Glasgow since 1994
Information Source:	AAIB Field Investigation

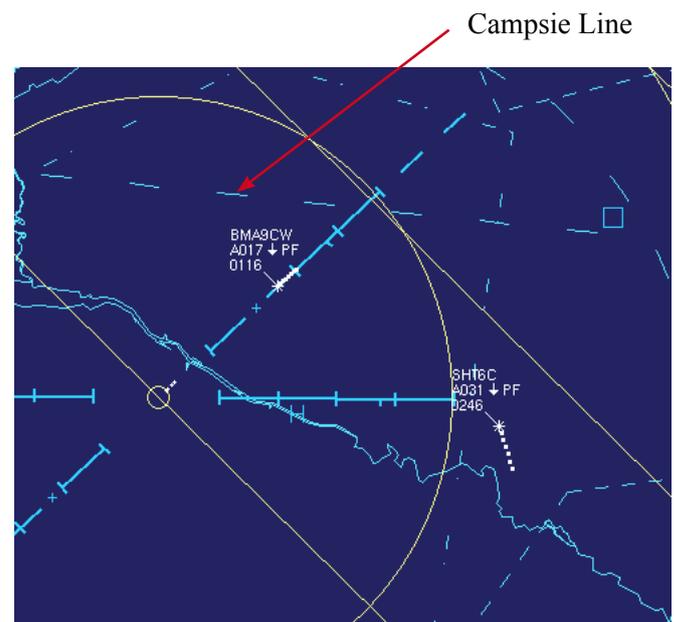
Figure 1

Radar 'screen grab' - Campsie Line & G-EUUR (SHT6C)

The ATCO had available two sources of terrain information however the radar overlays of certain features, including the Campsie Line (Figure 1), were his primary source of information. A laminated colour copy of the Glasgow Terrain Chart (Figure 3) was also available at his station. This chart is also contained in Glasgow's MATS Part 2 document. The track overlay in Figures 2 to 5 was generated using data overlays not available to the controller. Figure 5 is a summary, in side view, of data in Figures 2 to 4 (all in plan view).

The terrain at Glasgow causes difficulties in descent and approach planning for both ATC and pilots. The ATC procedures in place will keep aircraft 'terrain safe' if followed accurately but records show that at least three arrivals in nine years have breached the Campsie Line below MSA.

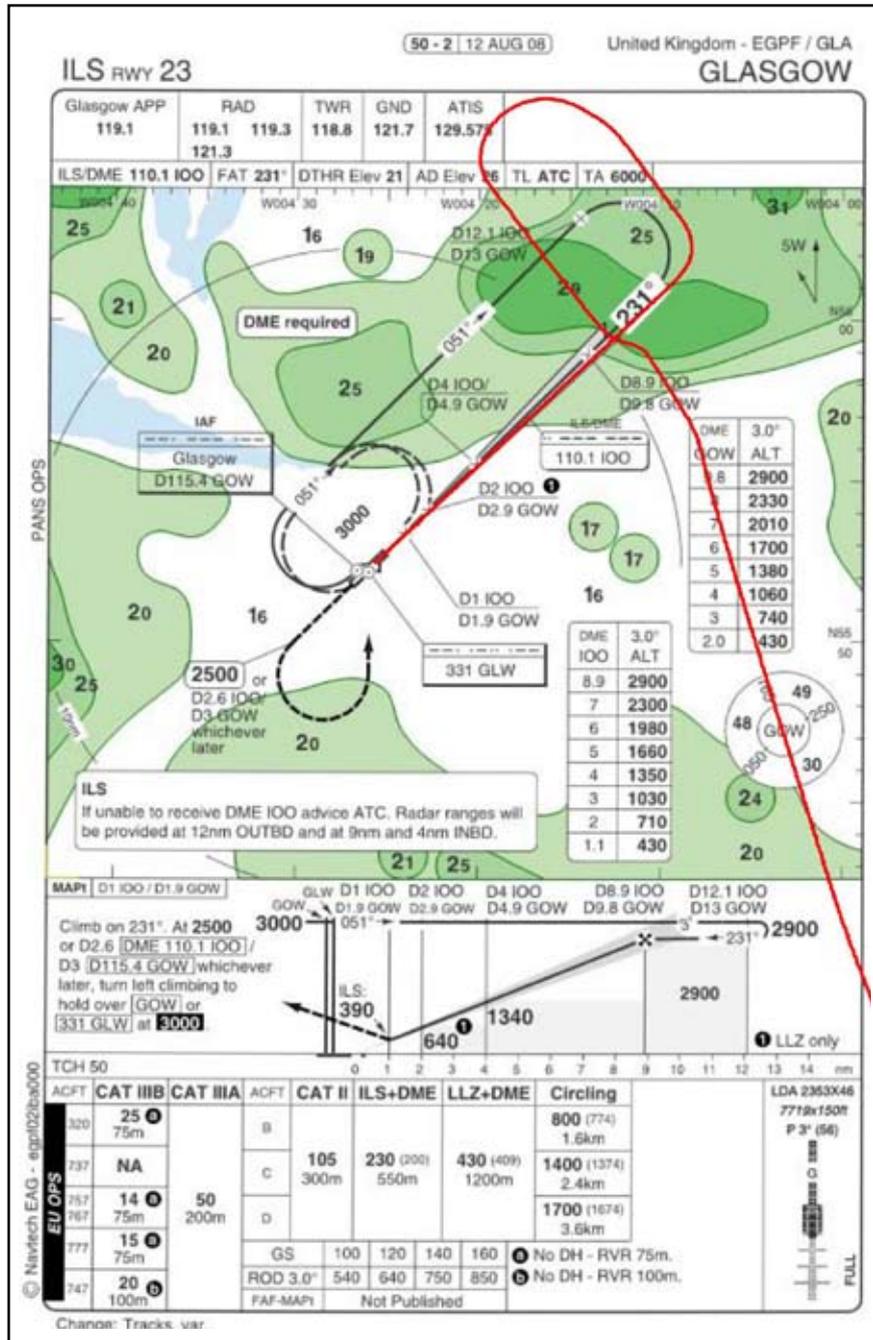
Figure 2

On receiving the GPWS warning the PF had climbed the aircraft to 5,000 ft, which was above the Minimum Safe Altitude (MSA) on the approach chart (Figure 2) of 4,900 ft. The crew levelled at 5,000 ft before being vectored for a second approach.

Approach chart - ILS RWY 23

The flight crew had access to three sources of terrain information. Two of these were paper charts (the radar minimum altitude chart (Figure 4) and the ILS Runway 23 approach chart (Figure 2)). These were included in

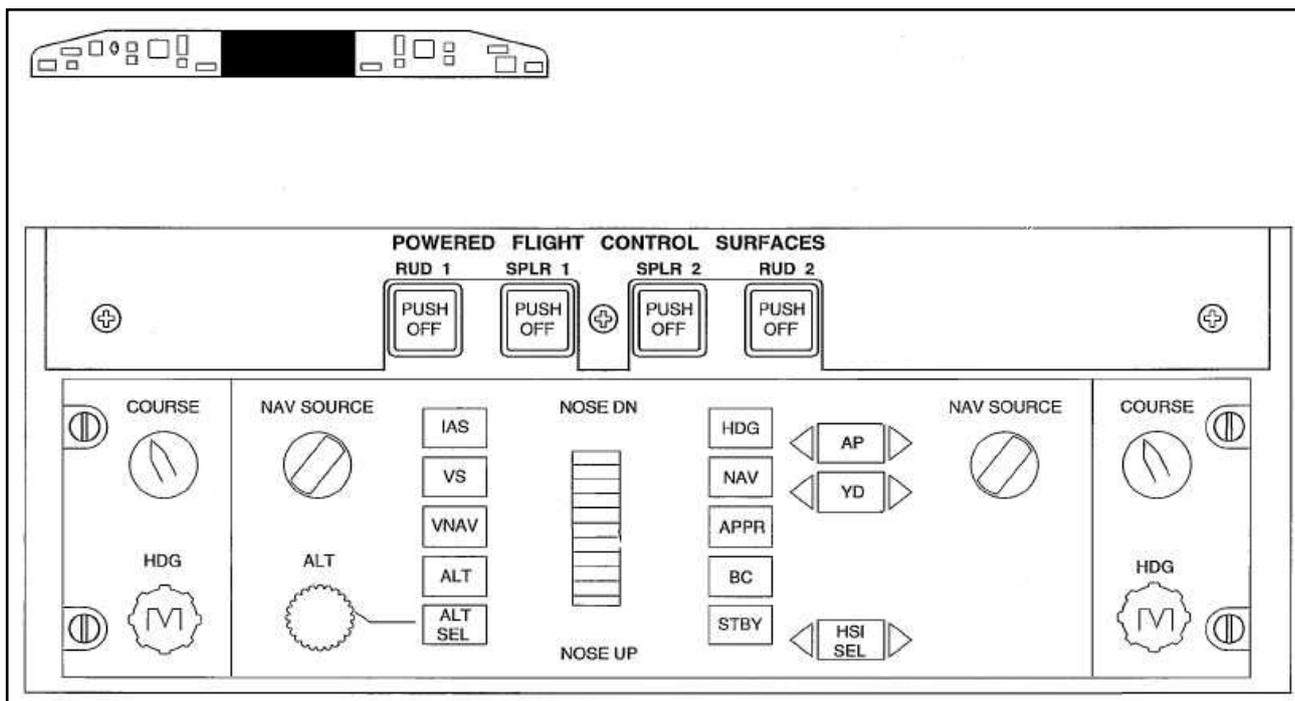
Figure 1

Flight guidance and control panel, location and functions

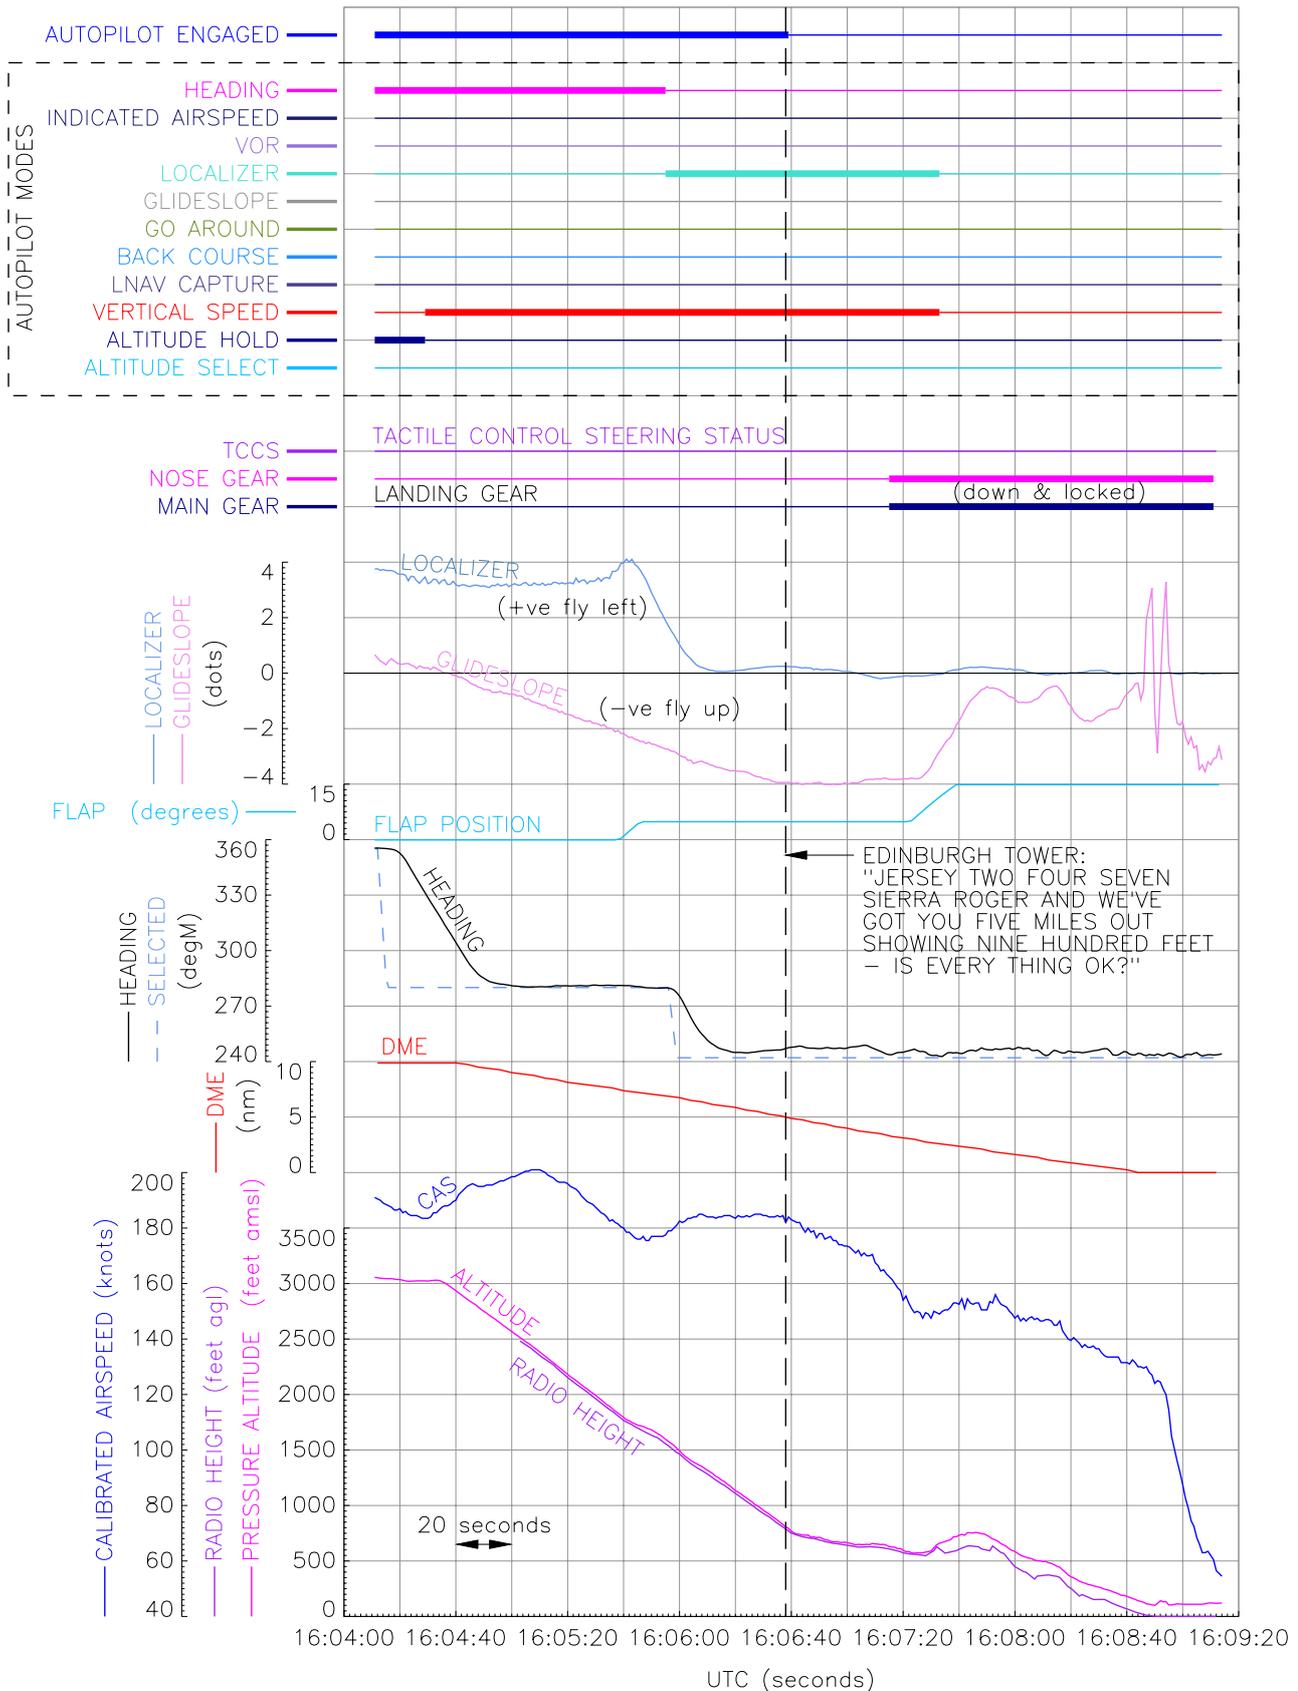
Salient parameters obtained from analysis of the data from G-JECI's Quick Access Recorder (QAR) for the incident are presented in Figure 2. The data starts just under four minutes before touchdown on Runway 24 at Edinburgh airport. At this point, the aircraft was flying straight and level at 3,000 ft amsl, with the landing gear and flaps retracted; the airspeed was 190 kt and decelerating. The autopilot was engaged with ALTITUDE HOLD mode and HEADING mode selected.

Figure 2
Salient FDR Parameters, G-JECI

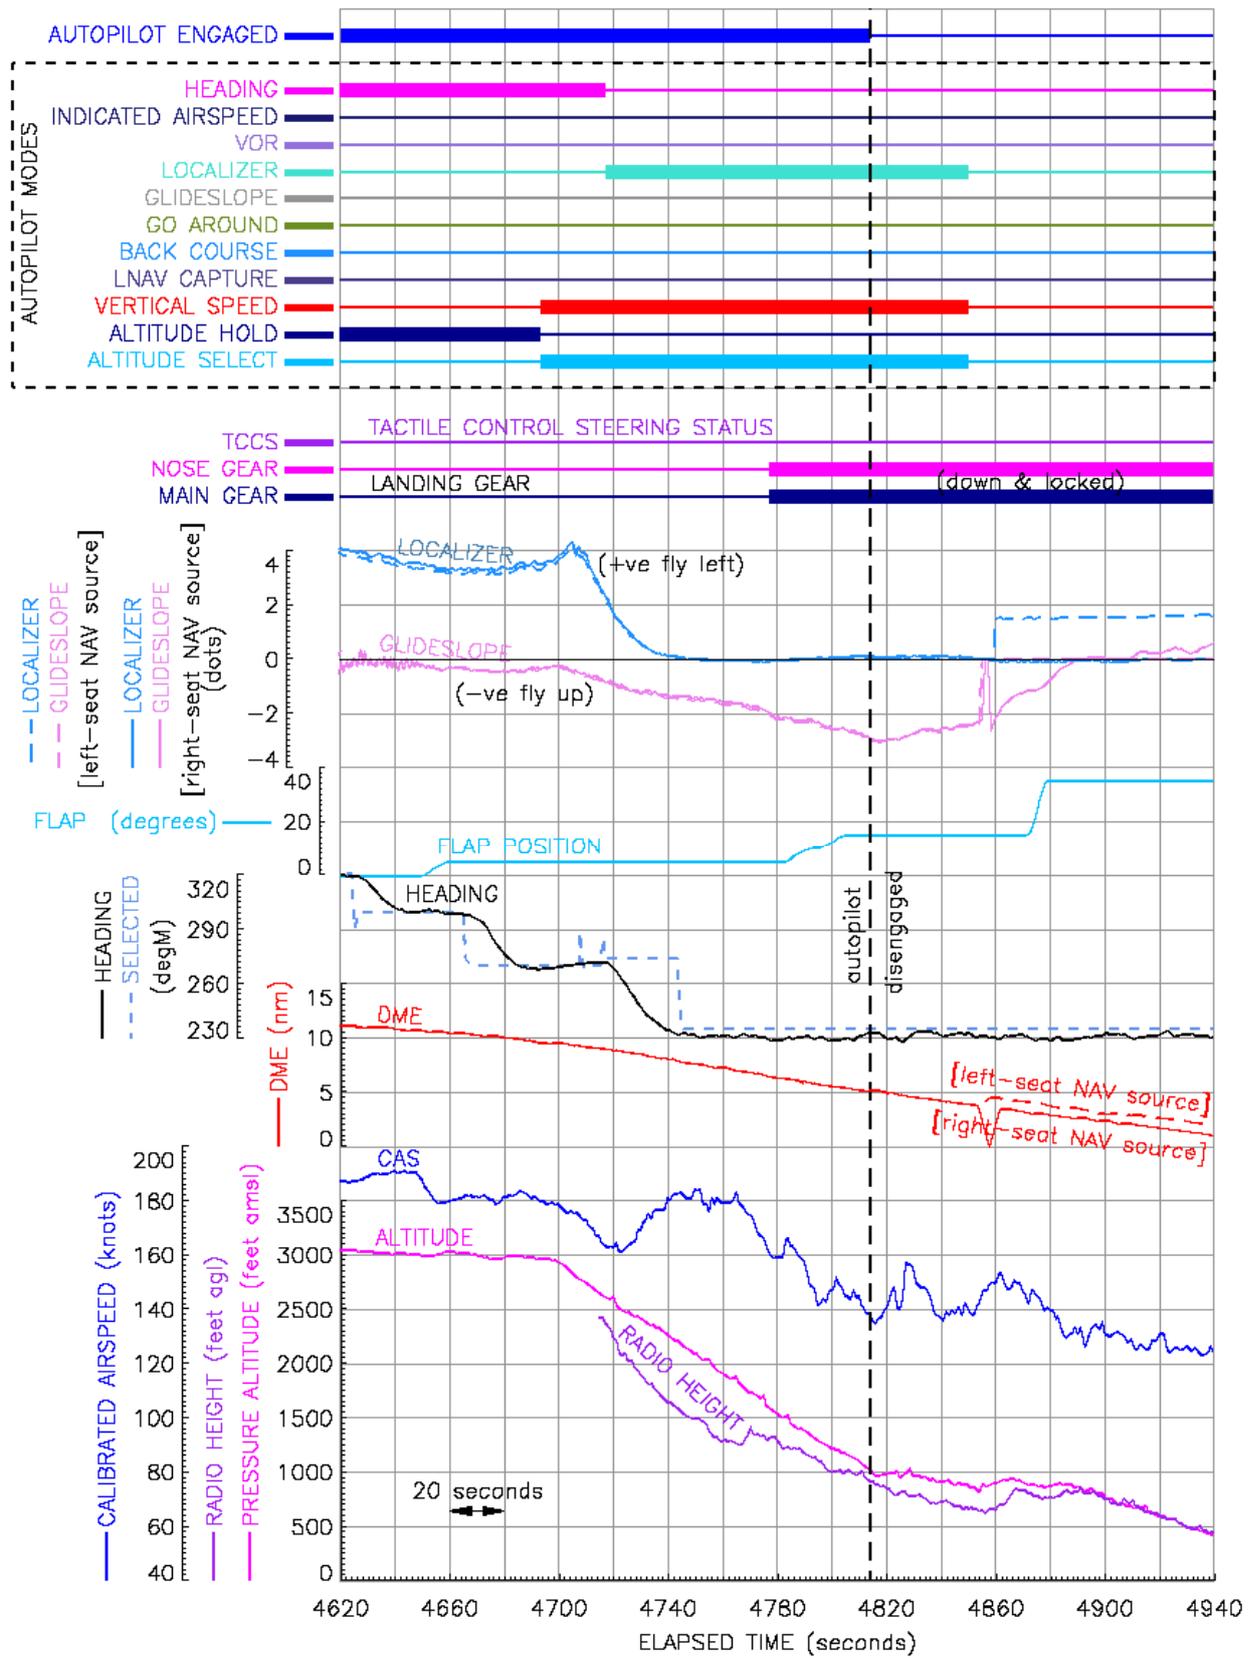
Salient parameters from the QAR for this flight are presented in Figure 3 which start about six minutes before touchdown on Runway 23 at Glasgow Airport. At this point, the aircraft had levelled at 3,000 ft amsl, the landing gear was up, the flaps retracted and the airspeed was 190 kt. The autopilot was also engaged with ALTITUDE HOLD mode and HEADING mode selected.

Salient FDR Parameters, G-JECK
