CONTENTS

AAIB Field Investigation reports

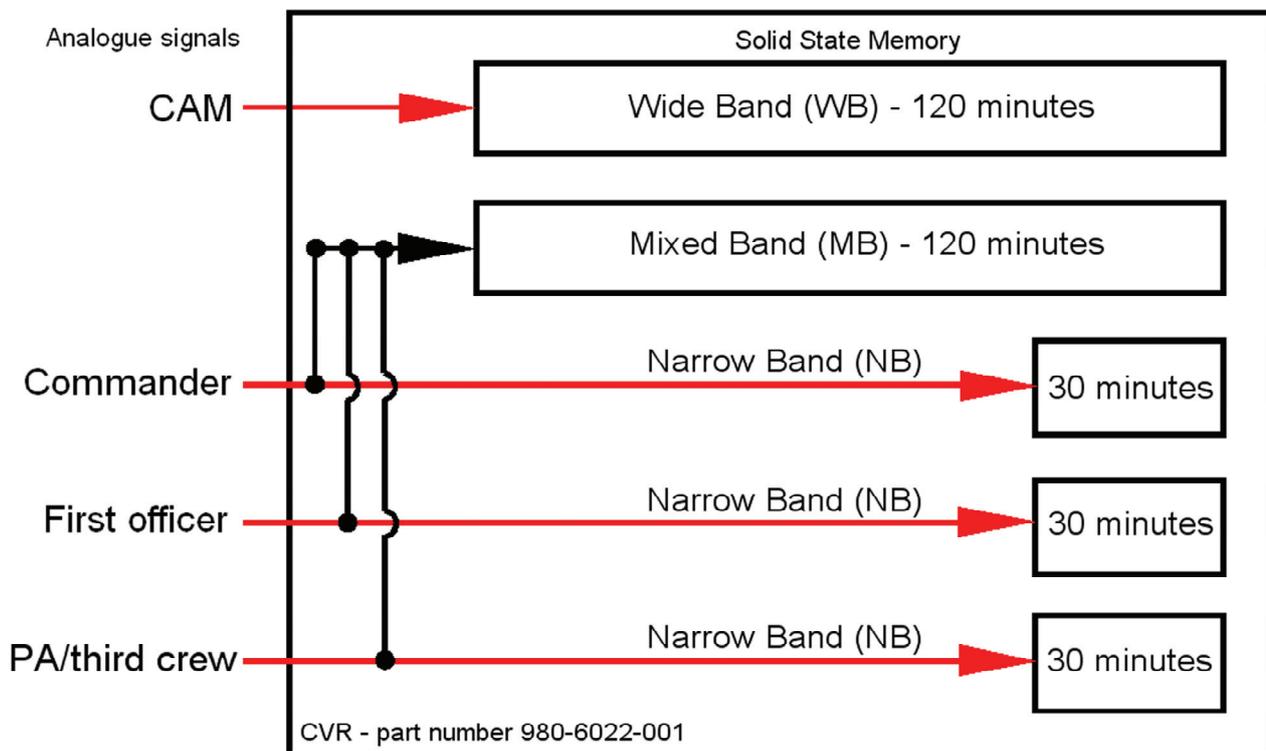
Figure 3

The initial recording process consists of the analogue-to-digital conversion of the four audio signals. The commander's, co-pilot's and PA/third crew member's communications channels are also combined at this stage to generate the MB channel. The digital data for each of the five channels is then passed to a single integrated circuit (IC), referred to as the 'data packer'². This component is central to the correct operation of the recorder. Under software control, the Data Packer component collects and packs the digital data into packets prior to it being written to the solid state memory. The data packer IC also forms part of the unit's Built-In Test (BIT) function.

CVR channel architecture

The CVR manufacturer stated that although the physical inspection had been inconclusive, its analysis of the data and test findings indicated that the multiplexer circuit within the data packer IC was intermittently failing. Further, it considered the failure to be an isolated case.

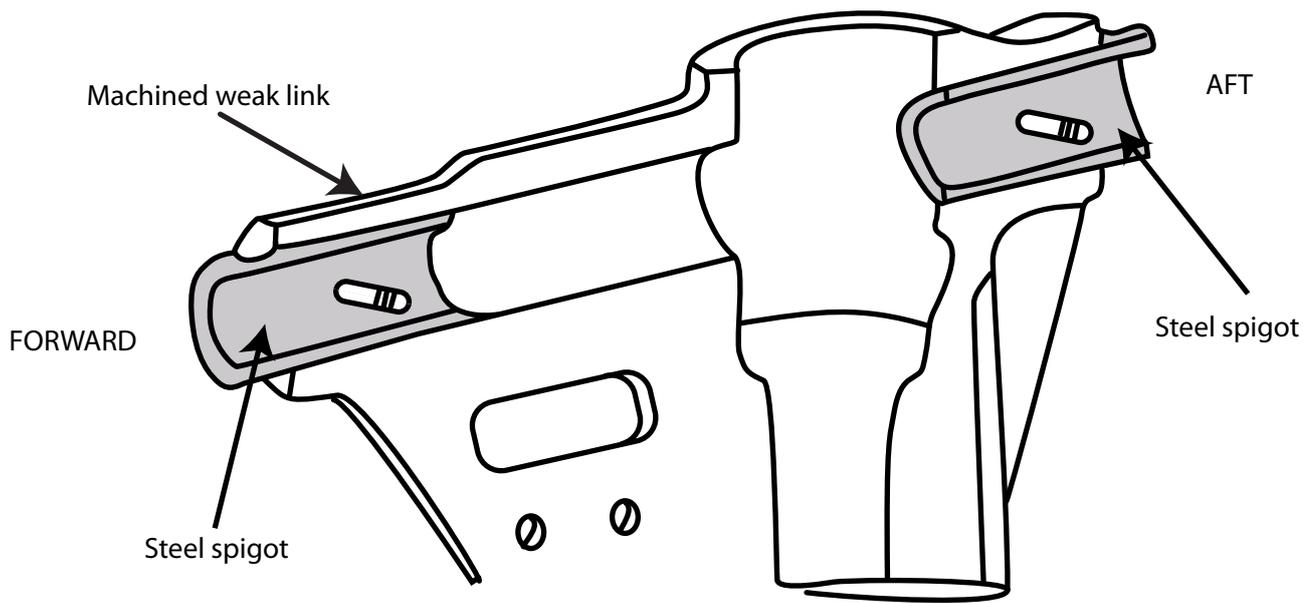
Figure 2

of the landing gear being subjected to a force outside its design limits, will fail and allow the landing gear to detach from the aircraft without damaging the fuel tanks. With the exception of the machined area, which is 9 mm thick, the wall thickness of the pintle is 17 mm. A sketch of the yoke pintle is shown in Figure 2.

Sketch of yoke pintle

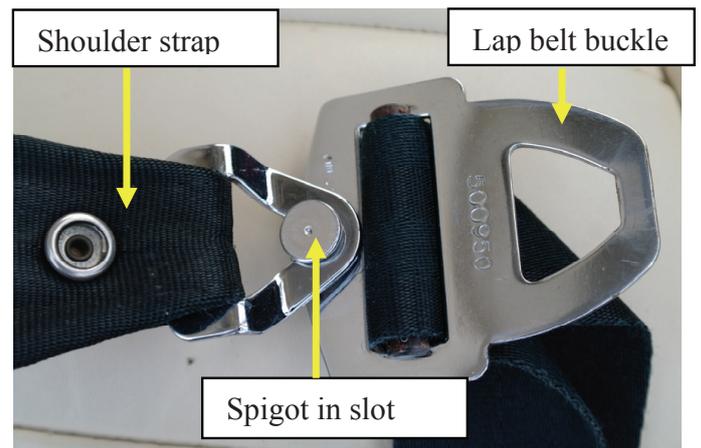
Figure 4
Seat belt buckle

Entry and exit from the cabin is through a door situated on the right side, secured by two latches. The front seats are adjustable fore and aft and are fitted with a three-point harness consisting of a lap belt and shoulder strap. The male portion of the lap belt buckle engages with the female portion of the buckle, which is mounted on a strap secured to the floor between the front seats. The shoulder strap incorporates an inertia reel which is connected to the aircraft structure, just above the side window. The shoulder strap is routed over the shoulder adjacent to the windows and attaches to the lap belt buckle, in the area of the occupant's inboard hip, by a spigot and slot arrangement (Figure 4).

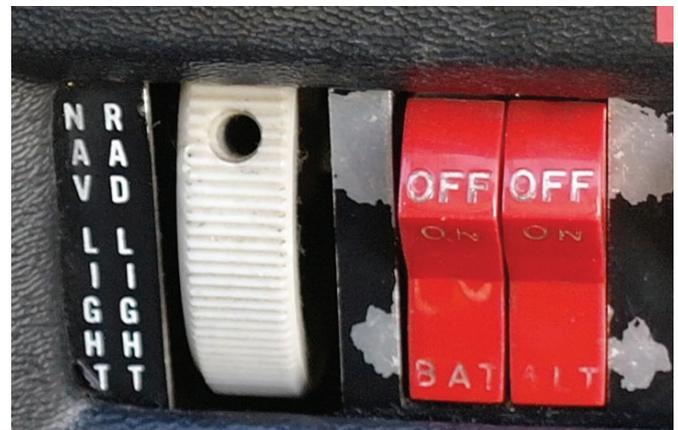
Figure 5
Battery master and alternator switches (red)

The electrical system in G-BXRG included a 14V 60-amp alternator, a 12V battery with a 1-hour rate of 23 amps, a voltage regulator, an over-voltage relay and a battery master switch relay. The battery and alternator are both connected to the aircraft busbar from which electrical power is provided, through circuit breakers (CBs), to the aircraft and avionic systems. The CBs are located at the bottom of the instrument panel in front of the passenger and the battery and alternator are controlled by red switches mounted on the centre instrument panel. Figure 5 shows the switches fitted to

another PA-28-181. The passenger believed that these switches had both been in the ON position during the accident flight.

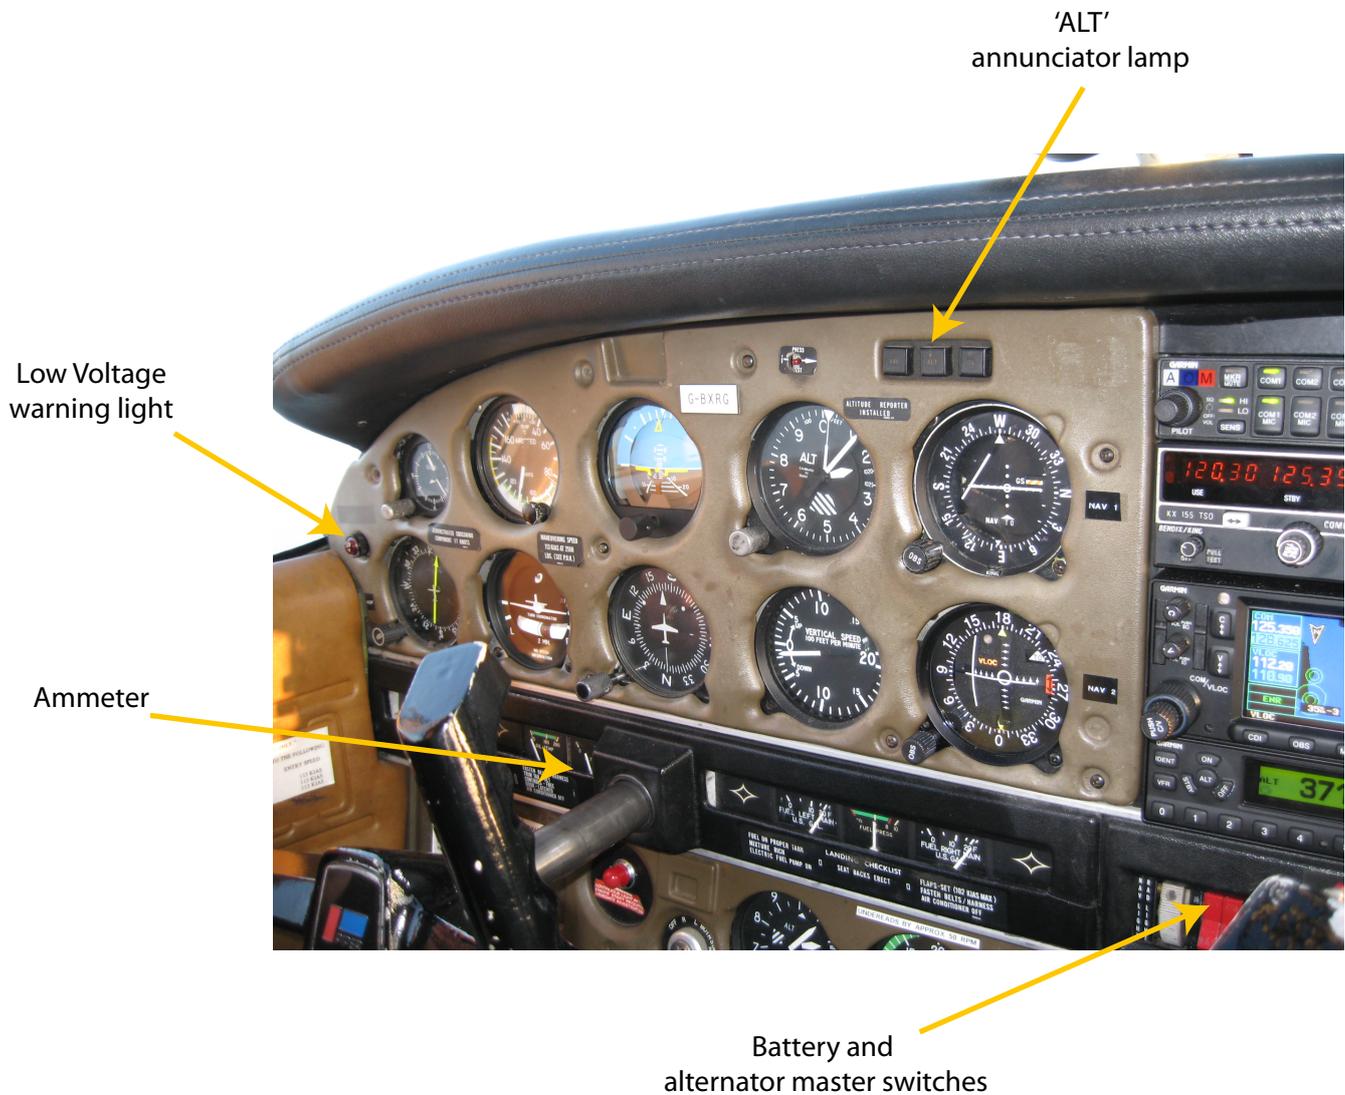
Figure 6
Pilot's instrument panel on G-BXRG

An ammeter, located at the bottom of the pilot's instrument panel, displays the load, in amps, placed on the alternator (Figure 6). An annunciator panel above the pilot's primary instruments contains an amber 'ALT' warning caption which illuminates when the current from the alternator falls to zero amps. A non-flashing red 'Low Voltage' warning lamp, located on the left side of the instrument panel, operates when the voltage of the aircraft electrical system falls below 12.5 to 13 volts.
