CONTENTS

SPECIAL BULLETINS

(ALL TIMES IN THIS BULLETIN ARE UTC)

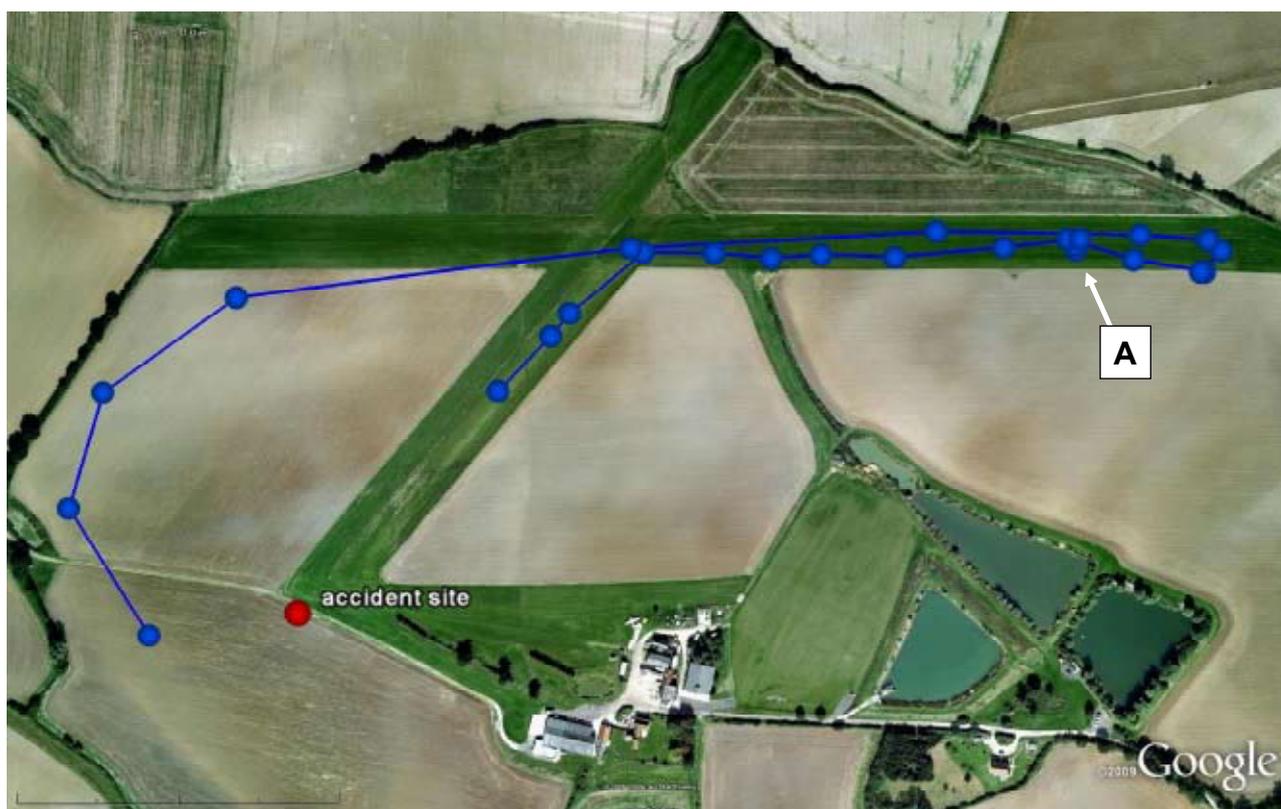
Figure 2

The track of the accident flight is shown at Figure 2. The recording starts at 10:37:20 hrs as the aircraft was taxiing prior to takeoff and ends at 10:42:43 hrs, near the accident site. The track shows that the aircraft entered Runway 09 and taxied part-way along it, before stopping for approximately one minute, presumably while the pilot carried out his before takeoff checks (position A of Figure 2). The aircraft then continued taxiing to the takeoff point. The average groundspeed between each GPS track point is presented in Figure 3.

GPS track of the accident flight.

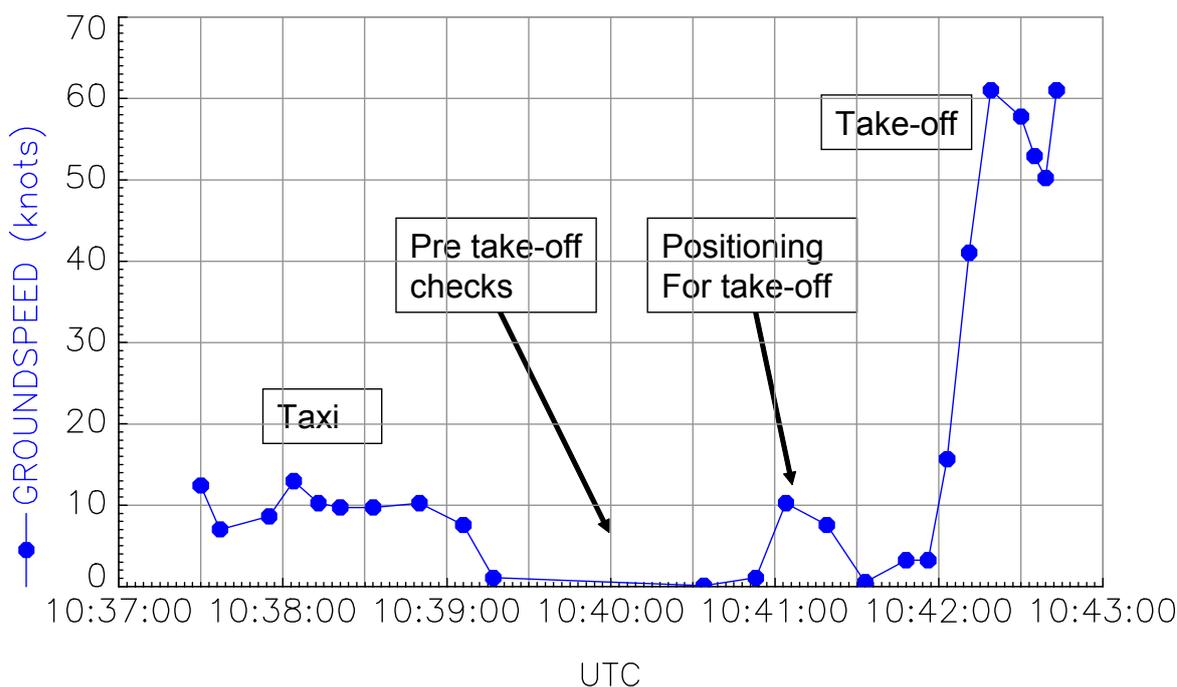
Figure 3

Accident flight calculated groundspeeds

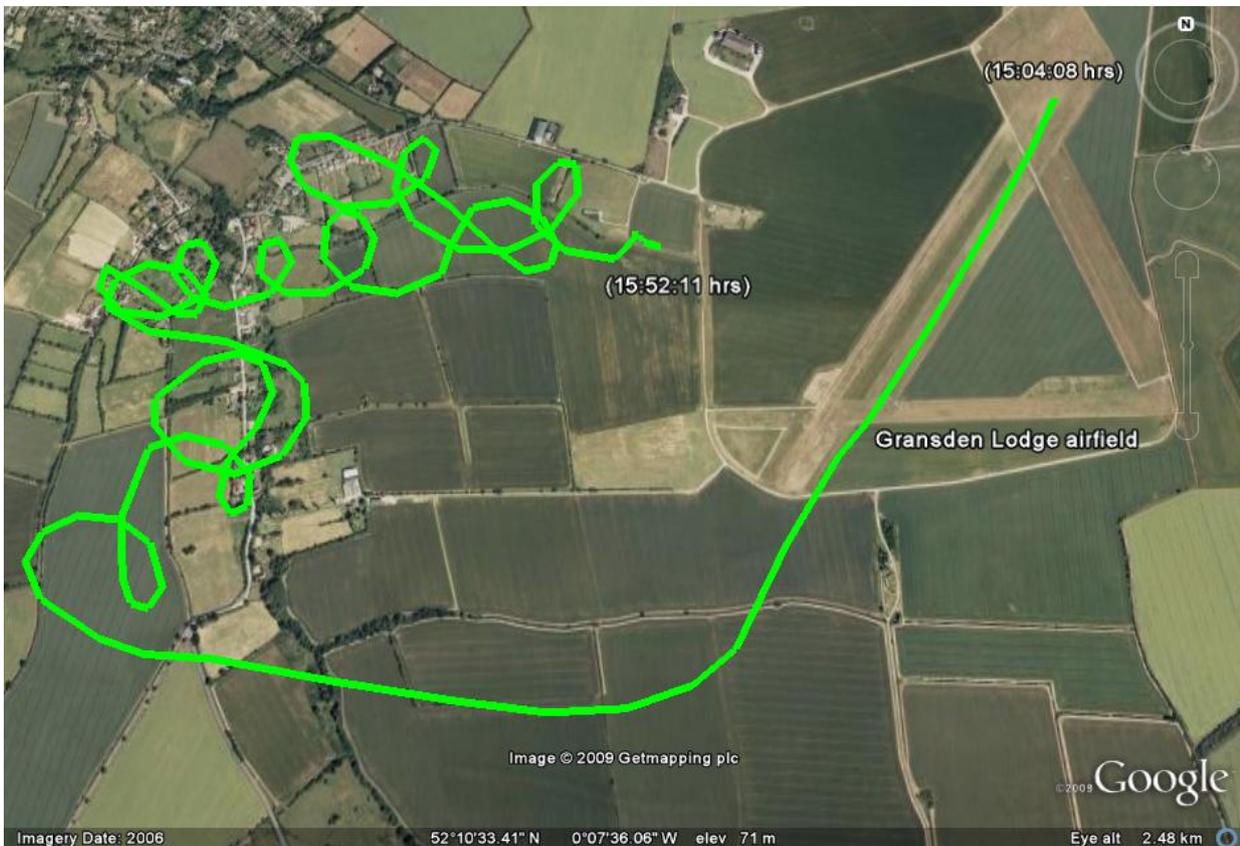
Figure 1 shows the GPS track for G-CHOM, which is consistent with the glider soaring. The accident site was very close to the last recorded GPS position. The indications were that the aircraft's track at the point of impact was approximately 170°M.

Figure 1
GPS track of G-CHOM

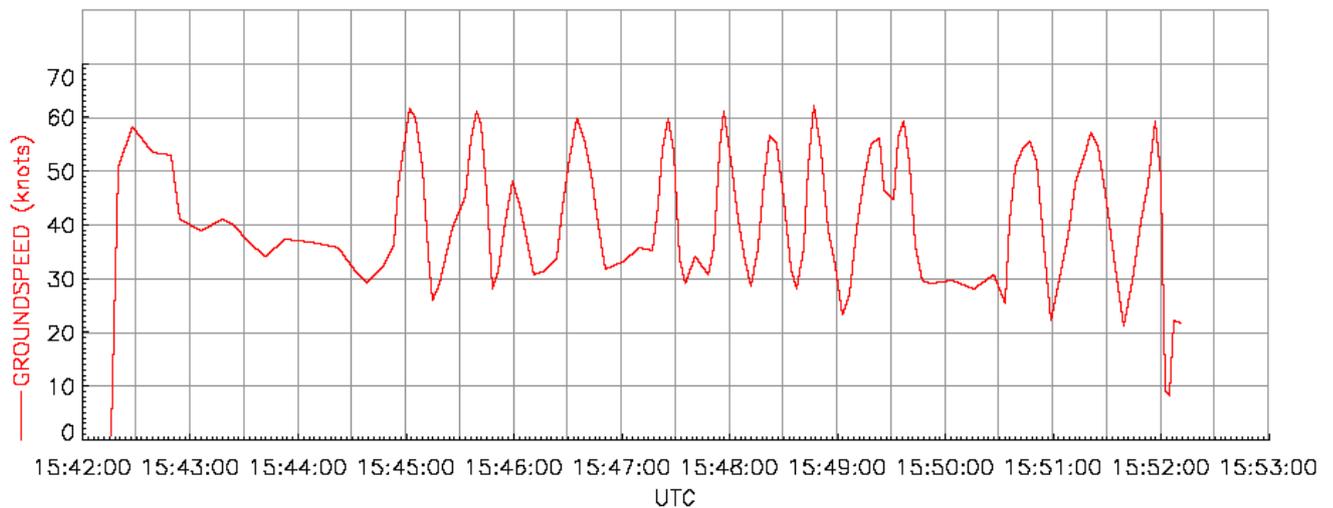
The average groundspeed between each GPS track point is presented in Figure 2 and shows that the groundspeed during the majority of the flight oscillated between 30 and 60 kt. The wind at 1552 hrs at 1,000 ft, 1,500 ft and 2,000 ft agl was estimated to

Speed of G-CHOM over the ground
