CONTENTS

(ALL TIMES IN THIS BULLETIN ARE UTC)

SERIOUS INCIDENT

Aircraft Type and Registration:	Airbus A340-642, G-VYOU	
No & Type of Engines:	4 Rolls-Royce RB211 Trent 556A2-61 turbofan engines	
Year of Manufacture:	2006	
Date & Time (UTC):	12 December 2009 at 1657 hrs	
Location:	London Heathrow Airport	
Type of Flight:	Commercial Air Transport (Passenger)	
Persons on Board:	Crew - 16	Passengers - 282
Injuries:	Crew - None	Passengers - None
Nature of Damage:	None	
Commander's Licence:	Airline Transport Pilot's Licence	
Commander's Age:	50 years	
Commander's Flying Experience:	16,432 hours (of which 10,833 hours were on type) Last 90 days - 164 hours Last 28 days - 38 hours	
Information Source:	Aircraft Accident Report Form submitted by the pilot and further enquiries by the AAIB

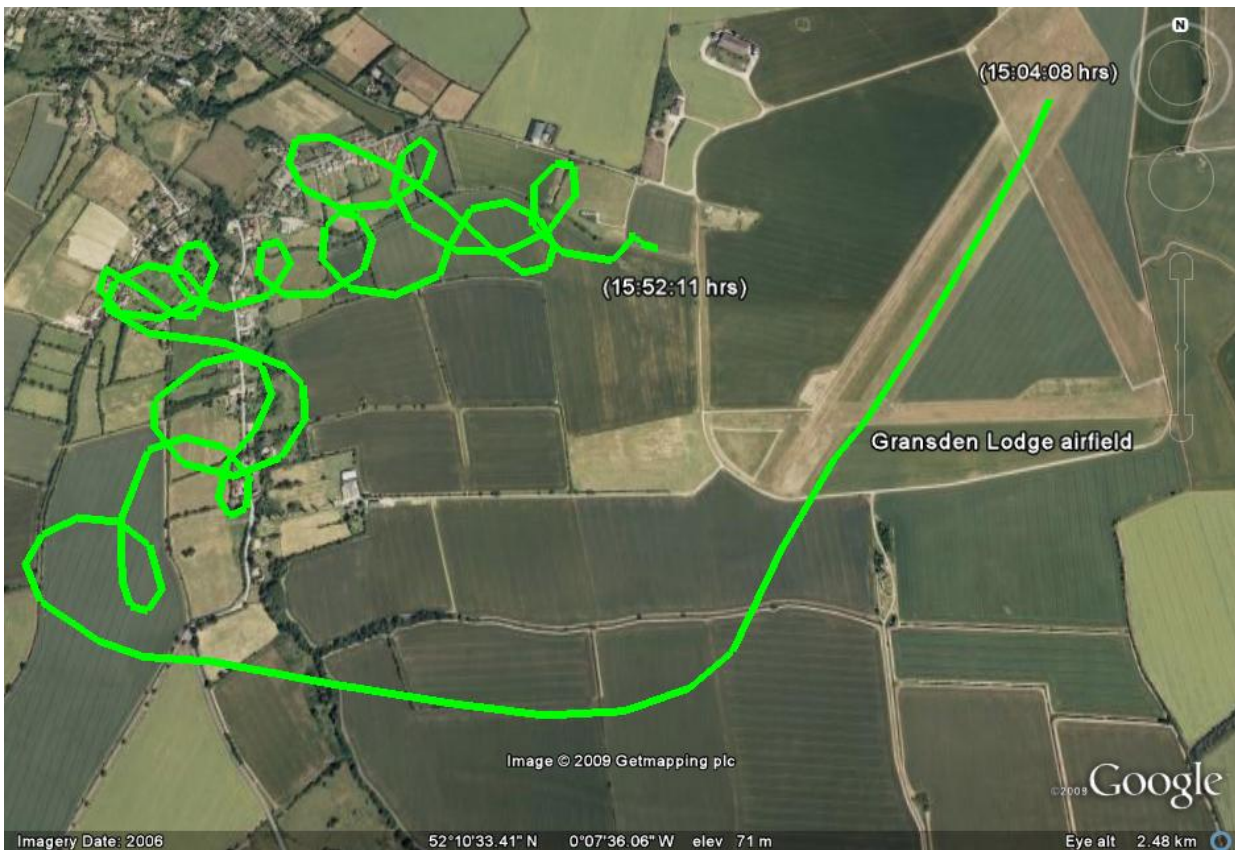
Figure 1
GPS track of G-CHOM

Figure 1 shows the GPS track for G-CHOM, which is consistent with the glider soaring. The accident site was very close to the last recorded GPS position. The indications were that the aircraft's track at the point of impact was approximately 170°M.

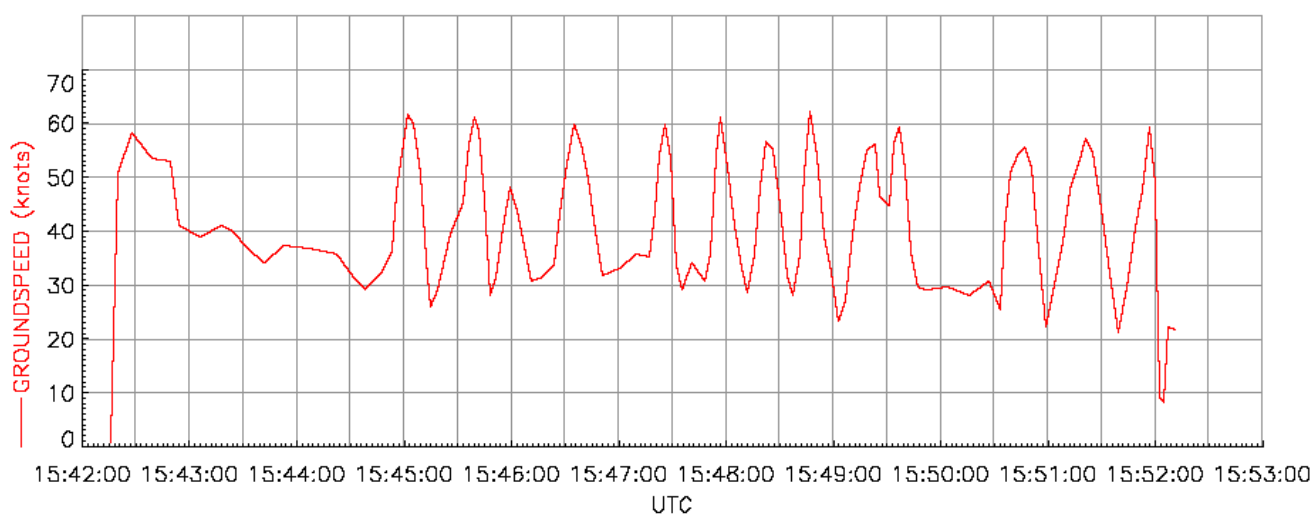
The average groundspeed between each GPS track point is presented in Figure 2 and shows that the groundspeed during the majority of the flight oscillated between 30 and 60 kt. The wind at 1552 hrs at 1,000 ft, 1,500 ft and 2,000 ft agl was estimated to

Speed of G-CHOM over the ground
