CONTENTS

INCIDENT

Aircraft Type and Registration:	DHC-8-402 Dash 8, G-JEDR
No & Type of Engines:	2 Pratt & Whitney Canada PW150A turboprop engines
Year of Manufacture:	2003
Date & Time (UTC):	3 March 2011 at 1255 hrs
Location:	Exeter Airport
Type of Flight:	Commercial Air Transport (Passenger)
Persons on Board:	Crew - 4 Passengers - 39
Injuries:	Crew - None Passengers - None
Nature of Damage:	Right main landing gear inboard wheel detached
Commander's Licence:	Airline Transport Pilot's Licence
Commander's Age:	58 years
Commander's Flying Experience:	6,778 hours (of which 3,417 were on type) Last 90 days - 103 hours Last 28 days - 24 hours
Information Source:	AAIB Field Investigation

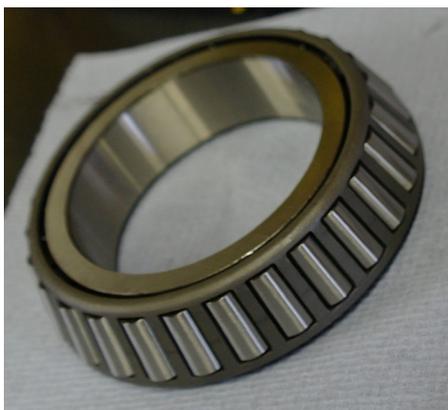
Figure 4

Each wheel bearing consists of a cup located in the wheel and an inner cone, roller and cage assembly which locates on the axle, Figure 4. The bore of the outer bearing cone is of a slightly smaller diameter than the inner bearing to prevent misassembly. The rollers and cups are common to both bearings. The bearings are lubricated on installation with specified high quality grease.

New wheel bearing cone assembly showing rollers located in the cage

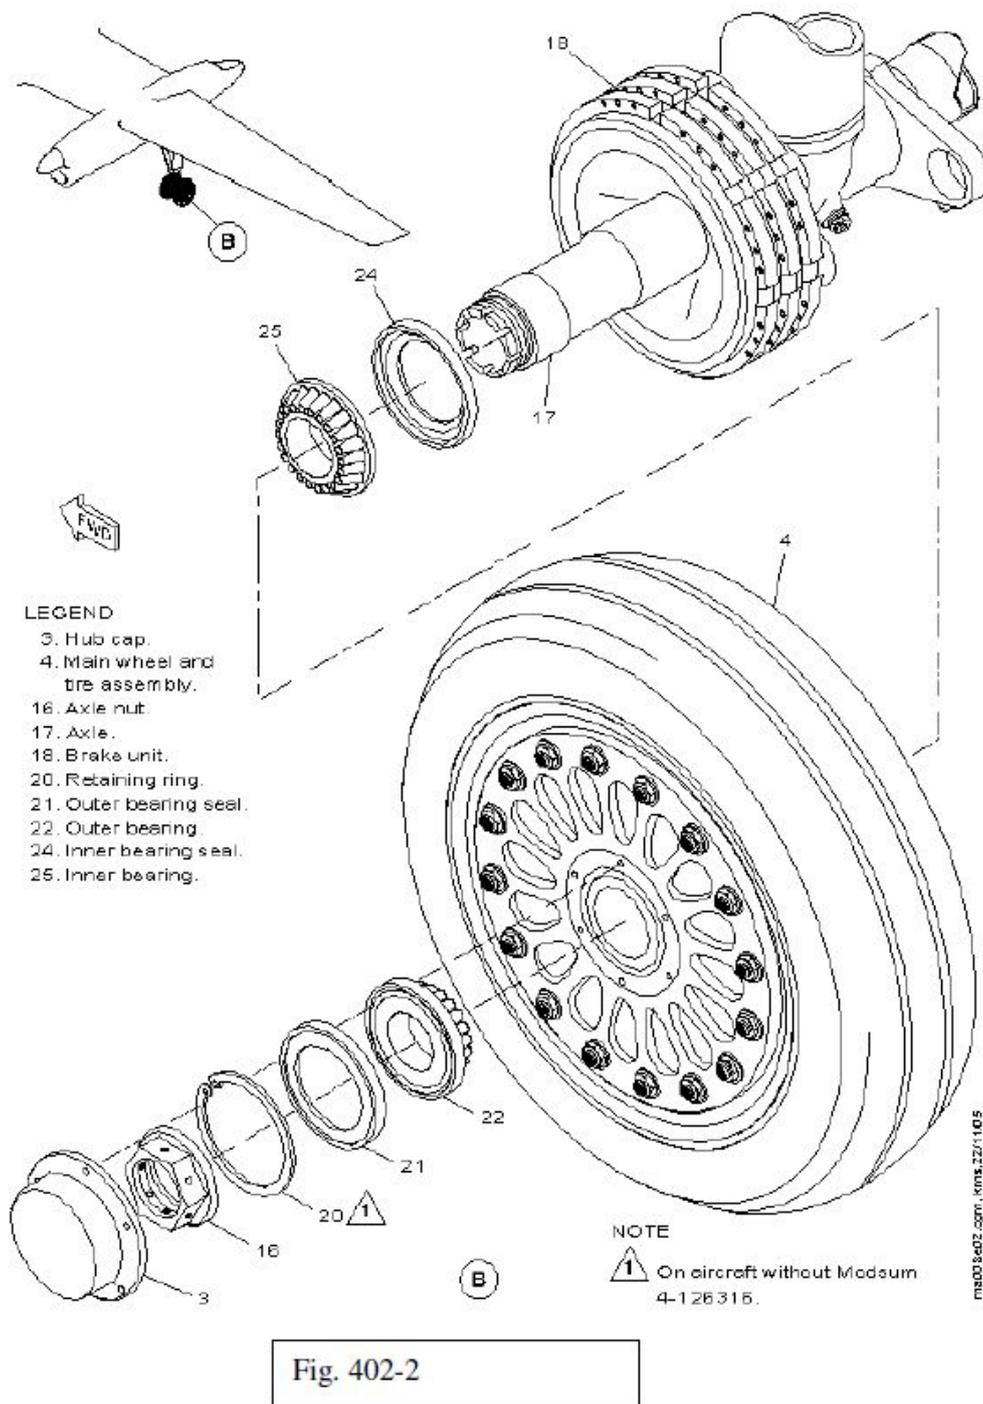
Each mainwheel is fitted with a pair of taper roller bearings arranged with their smaller rolling diameter towards the centre of the wheel. Figure 3 shows the general arrangement of the mainwheel, brake unit and bearings.

General arrangement of the mainwheel and bearings

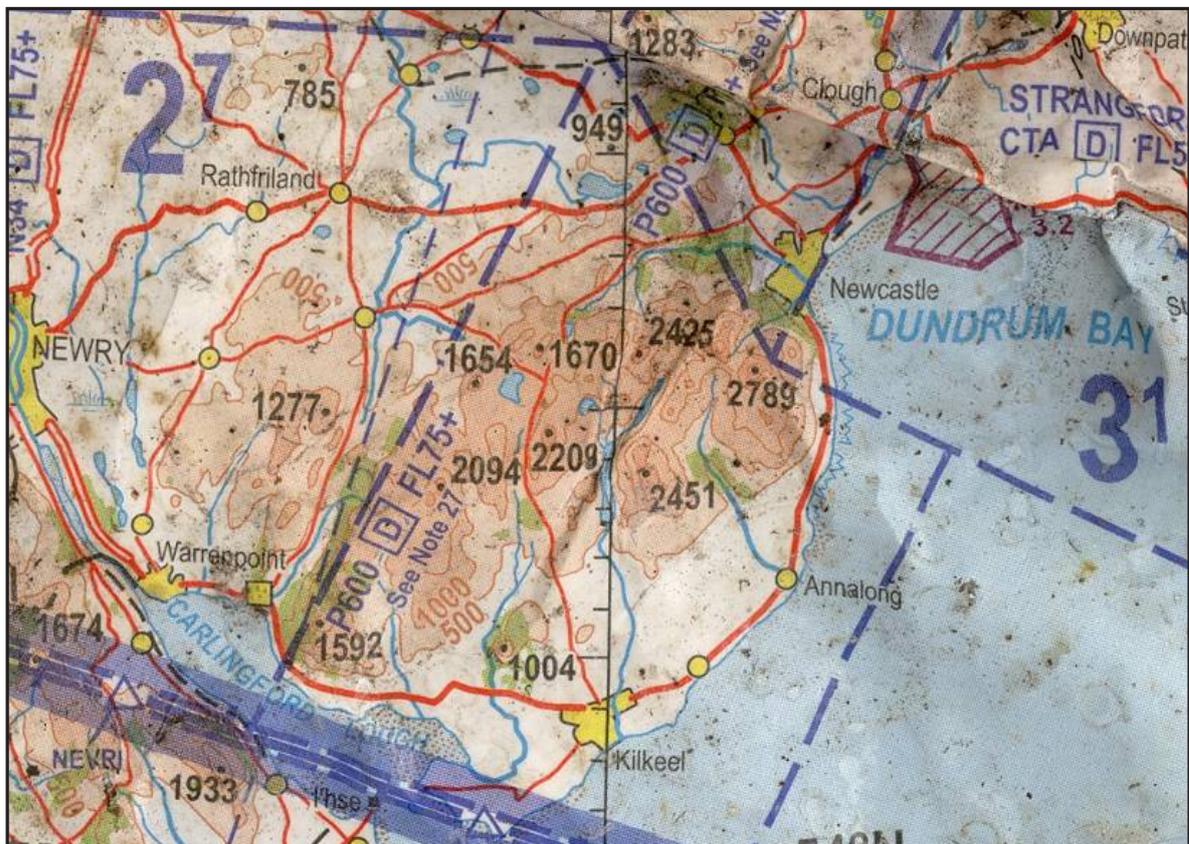
Figure 6

A CAA Northern England and Northern Ireland, ICAO air navigation chart scale 1:500 000, Edition 33, was also onboard the helicopter and was recovered from the accident site; the relevant area of the pilot's chart is shown at Figure 6. On this chart, the Maximum Elevation Figure (MEF) is shown in quadrangles bounded by graticule lines for every half-degree of latitude and longitude. They give the elevation of the highest known obstacle within that graticule square and are calculated using the highest figure from either:

The pilot's 1:500 000 map showing terrain colouring and spot heights with Maximum Elevation Figures

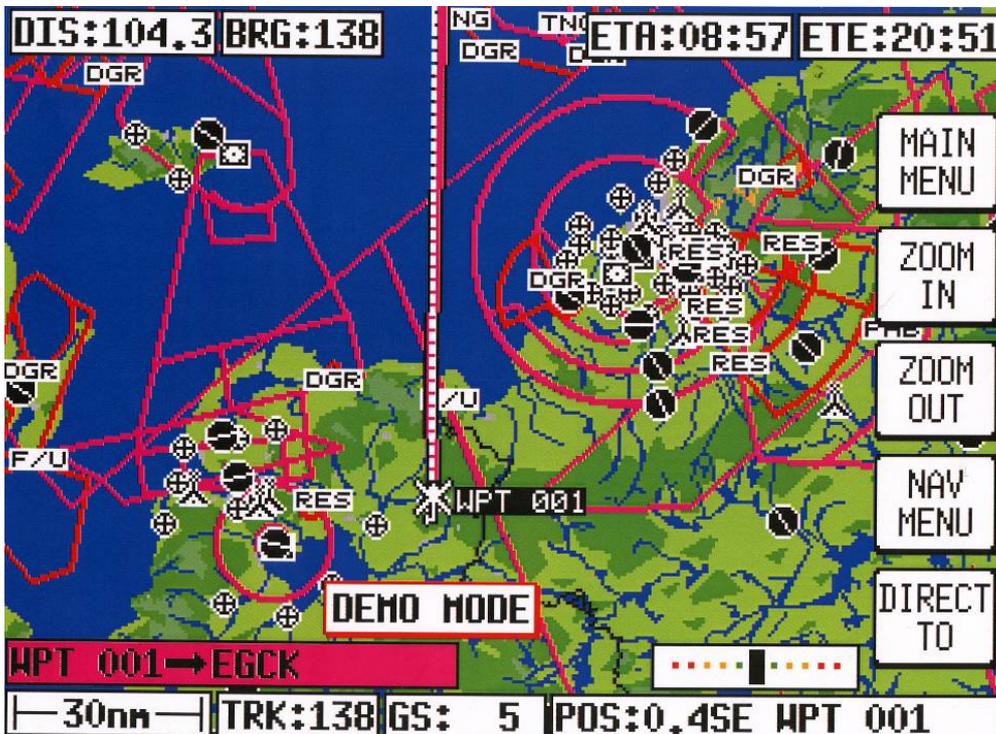
The screen print of the Skymap IIIC on 30 nm range, showing a projected track immediately prior to the left turn onto an easterly heading

The two 'screen prints', Figures 7 and 9, are examples of the information provided. Figure 7 shows the helicopter at the point of the first left turn with a 30 nm scale set and a direct track to Caernarfon selected. Figure 9 shows the position of the helicopter immediately prior to impact with an 8 nm scale selected. It should be noted from both screen prints that the area of the Mourne Mountains is depicted using two shades of green. The shaded areas do not contain any spot heights, or the brown colour representing the terrain between 2,000 ft

It is not known which scale or scales the pilot was using during the flight but Figure 7 shows that, had the helicopter continued on the direct track towards Caernarfon, it would have transited Irish airspace. In order to remain clear of Irish airspace, the pilot would have had to route to Newcastle, County Down, from where a direct track to Caernarfon would have remained in UK airspace.

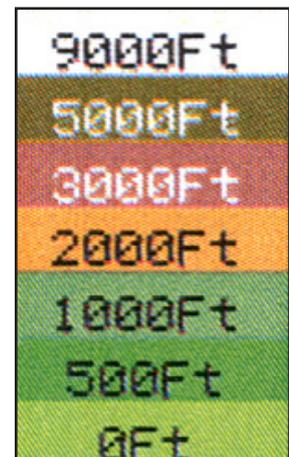
Figure 8

The Skymap IIIC colour coding for the terrain elevations

Spot heights were not displayed on the Skymap and the green colour coding would not have indicated that there was ground above 2,000 ft. If the spot heights on the projected track of the helicopter were not noted, and the Skymap were used for navigation, then with the upper slopes and Castle Bog obscured it could have been possible for the pilot to believe that he had overflown the high ground.

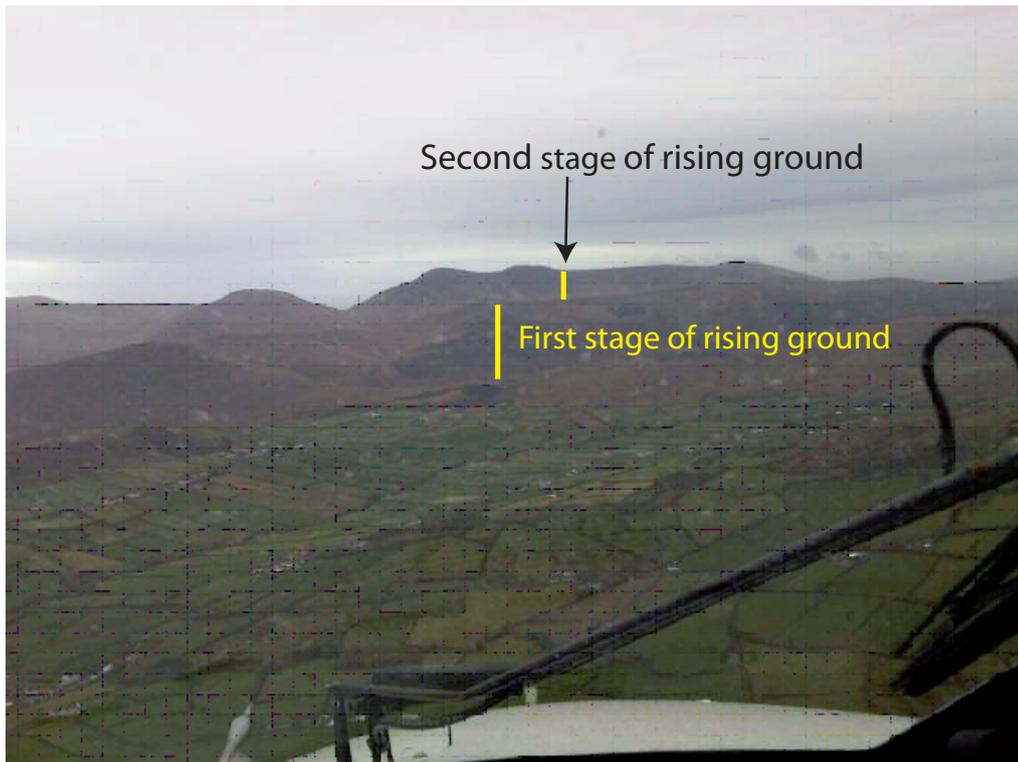
Figure 11

The hill walker witnesses were in cloud and it is not known how extensive the cloud cover was or whether any of the upper slopes or ridge were visible to the pilot; there may have been layers of cloud producing a false impression of the upper limits of the terrain. Whilst the terrain was clearly visible during the flight trial, if the upper slopes were obscured by cloud and the height of the terrain was known, it would have been apparent that it would not be possible to continue on the final

The first and second stages of rising ground, seen from a distance of 3 nm in the direction of flight

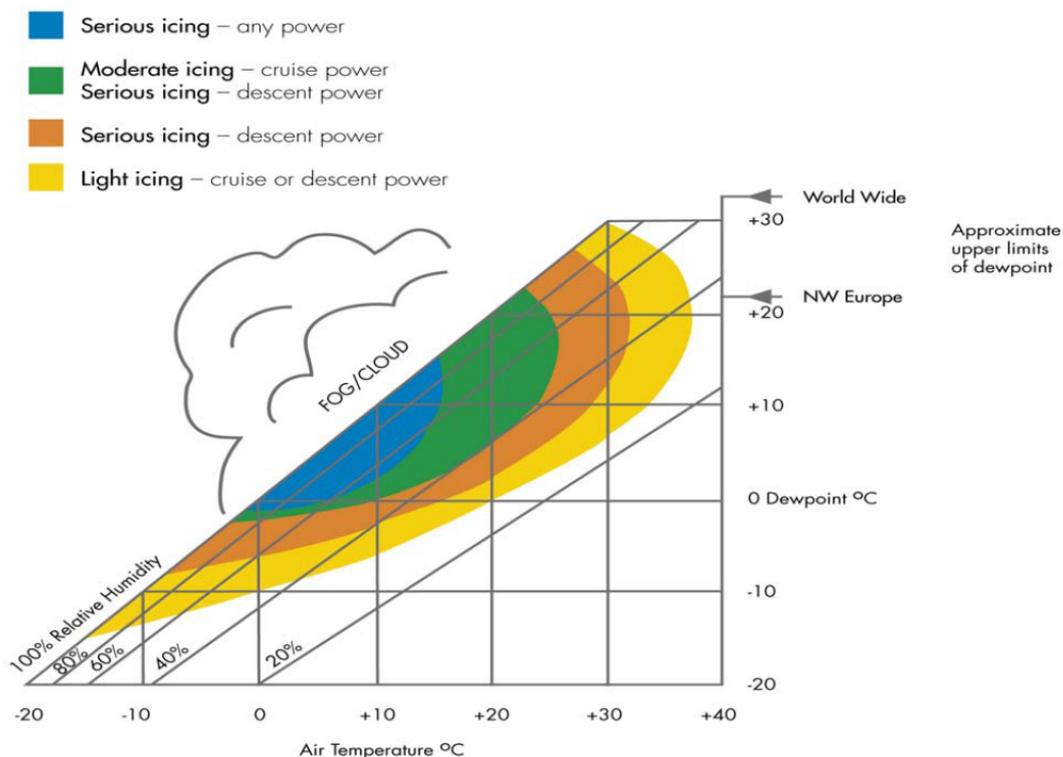
CAA Safety Sense Leaflet 14 describes the causes of carburettor icing and notes that ‘Carb icing is more likely when MOGAS is used’. The graph from the Safety Sense Leaflet showing the likelihood of carburettor icing is reproduced at Figure 1. From the graph it can be seen that the conditions at the time of the accident would have given a serious risk of carburettor icing at any power setting. However, the pilot’s report that there was a sudden reduction in engine rpm shortly after the aircraft

While carburettor icing can not be ruled out, the reported symptoms were also consistent with fuel starvation.

Figure 1
Carburettor icing chart
