List of recent aircraft accident reports issued by the AAIB 42
(ALL TIMES IN THIS BULLETIN ARE UTC)

ACCIDENT

Aircraft Type and Registration:	Brandli Cherry BX-2, G-BXUX	
No & Type of Engines:	1 Continental Motors Corp C90-12F piston engine	
Year of Manufacture:	1999	
Date & Time (UTC):	21 July 2008 at 1940 hrs	
Location:	Clipgate Farm Airstrip, Canterbury, Kent	
Type of Flight:	Private	
Persons on Board:	Crew - 1	Passengers - 1
Injuries:	Crew - None	Passengers - None
Nature of Damage:	Damage to the landing gear and associated mechanism, propeller and engine shock-loaded	
Commander's Licence:	Private Pilot's Licence	
Commander's Age:	61 years	
Commander's Flying Experience:	429 hours (of which 322 were on type) Last 90 days - 5 hours Last 28 days - 2 hours	
Information Source:	Aircraft Accident Report Form submitted by the pilot and AAIB examination of the aircraft

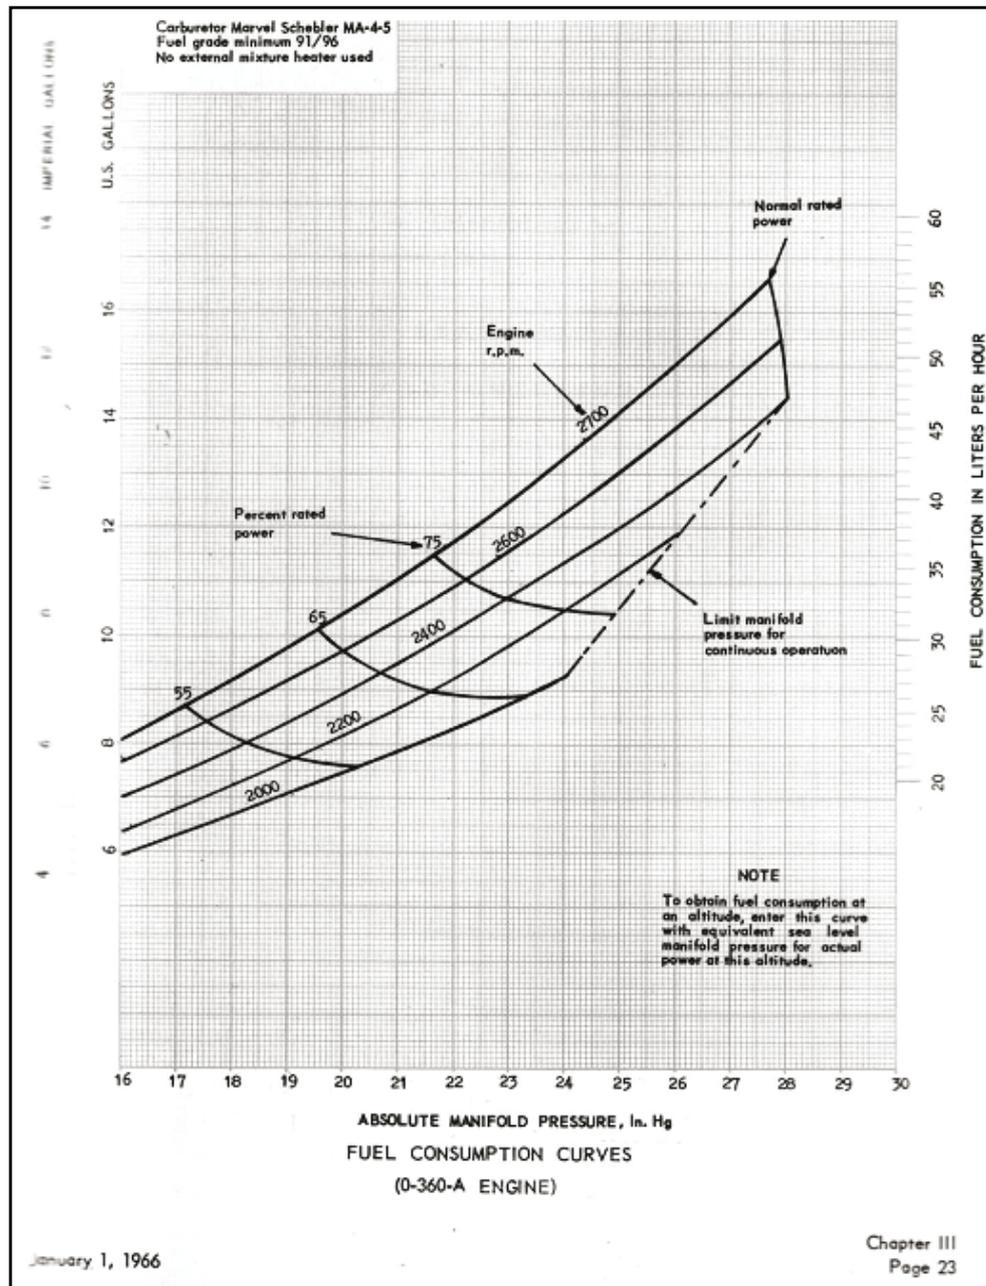
Figure 1

The pilot used the fuel consumption curves from the Operating Manual (Figure 1) to calculate the fuel

In an honest report the pilot acknowledged that his poor fuel planning caused the accident, although he was not helped by the incorrect conversion data that were published in the Operating Manual. In addition, had he selected the auxiliary tank when the engine started to falter, it is likely that the accident could have been averted.

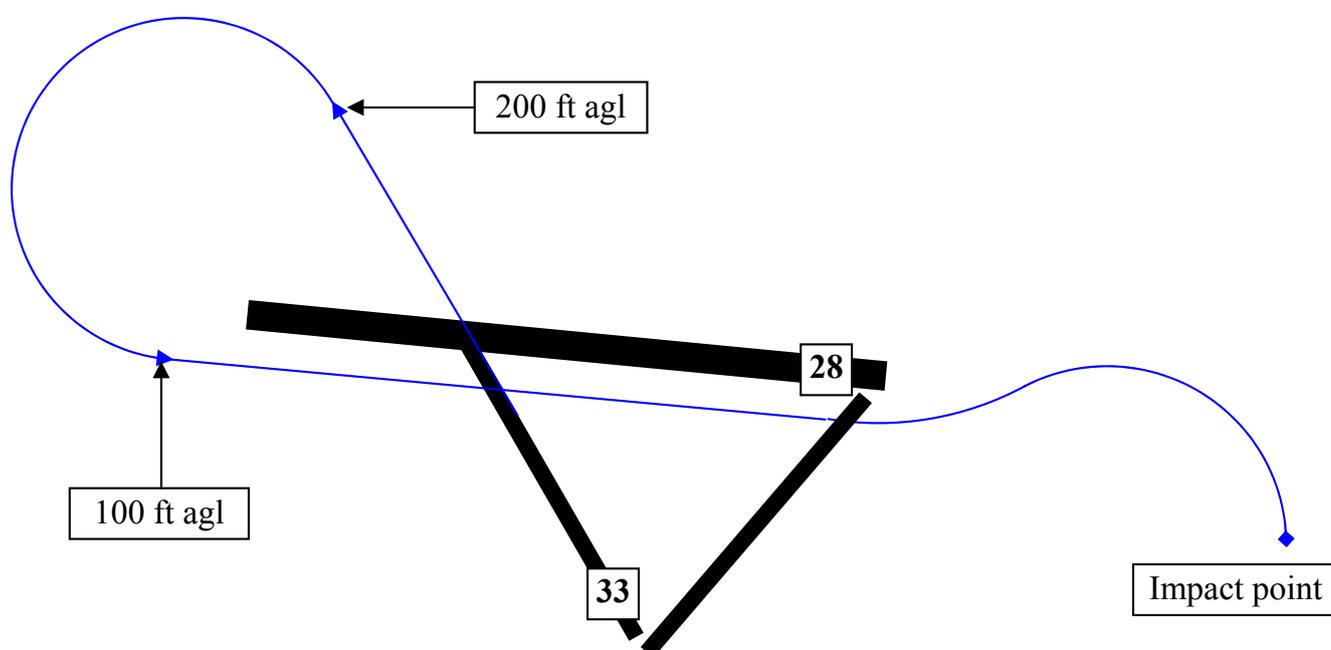
with its landing gear up, so the instructor called on the radio to advise the pilot, who immediately lowered the landing gear. The engine continued to run intermittently and make noises, which another witness on the ground described as “like shotgun fire”. This witness saw the aircraft flying in an easterly direction at a speed and height that he considered too great for a landing on Runway 10. At a point south of the Runway 28 threshold, with the aircraft descending to within 50 ft of the ground, the pilot attempted to position the aircraft onto a right hand base leg for Runway 33. The aircraft was seen to climb very slowly then adopt a nose-down attitude and roll to the right. The pilot reported that at this point the engine had ceased to produce power. He responded by applying nose-up elevator control, which resulted in a nose-up attitude but no decrease in the rate of descent. This was followed almost immediately by the aircraft impacting the ground. Figure 1 depicts the aircraft’s track following the go-around.

Leicester Aerodrome layout showing aircraft’s track after go-around

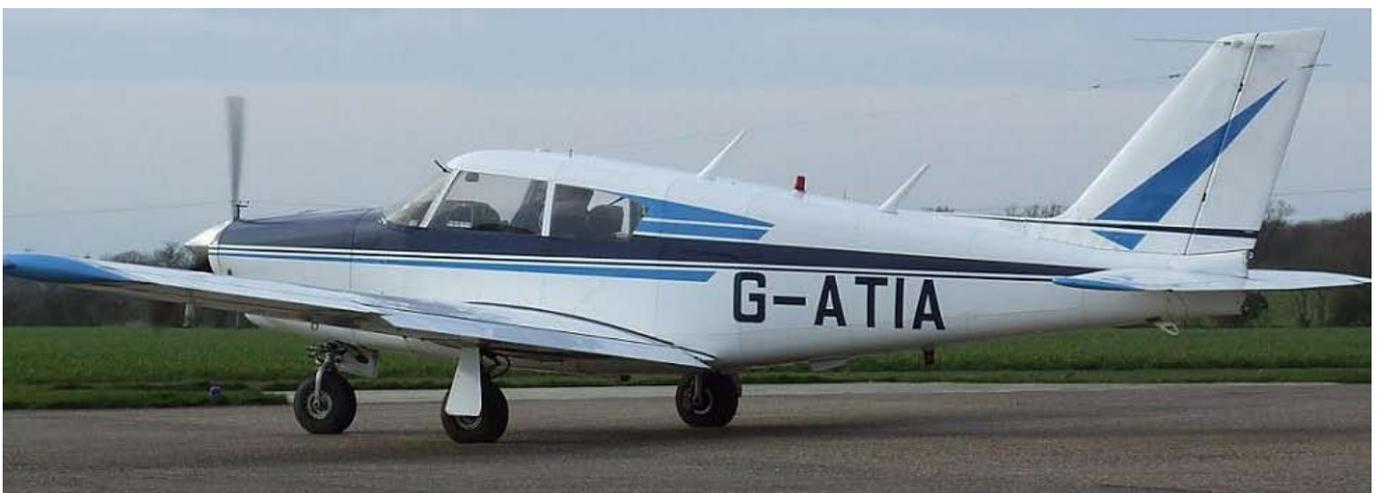
Figure 2

The aircraft, G-ATIA, before the accident
