## ACCIDENT

<b>Aircraft Type and Registration:</b>	Brandli Cherry BX-2, G-BXUX	
<b>No &amp; Type of Engines:</b>	1 Continental Motors Corp C90-12F piston engine	
<b>Year of Manufacture:</b>	1999	
<b>Date &amp; Time (UTC):</b>	21 July 2008 at 1940 hrs	
<b>Location:</b>	Clipgate Farm Airstrip, Canterbury, Kent	
<b>Type of Flight:</b>	Private	
<b>Persons on Board:</b>	Crew - 1	Passengers - 1
<b>Injuries:</b>	Crew - None	Passengers - None
<b>Nature of Damage:</b>	Damage to the landing gear and associated mechanism, propeller and engine shock-loaded	
<b>Commander's Licence:</b>	Private Pilot's Licence	
<b>Commander's Age:</b>	61 years	
<b>Commander's Flying Experience:</b>	429 hours (of which 322 were on type) Last 90 days - 5 hours Last 28 days - 2 hours	
<b>Information Source:</b>	Aircraft Accident Report Form submitted by the pilot and AAIB examination of the aircraft

## Synopsis

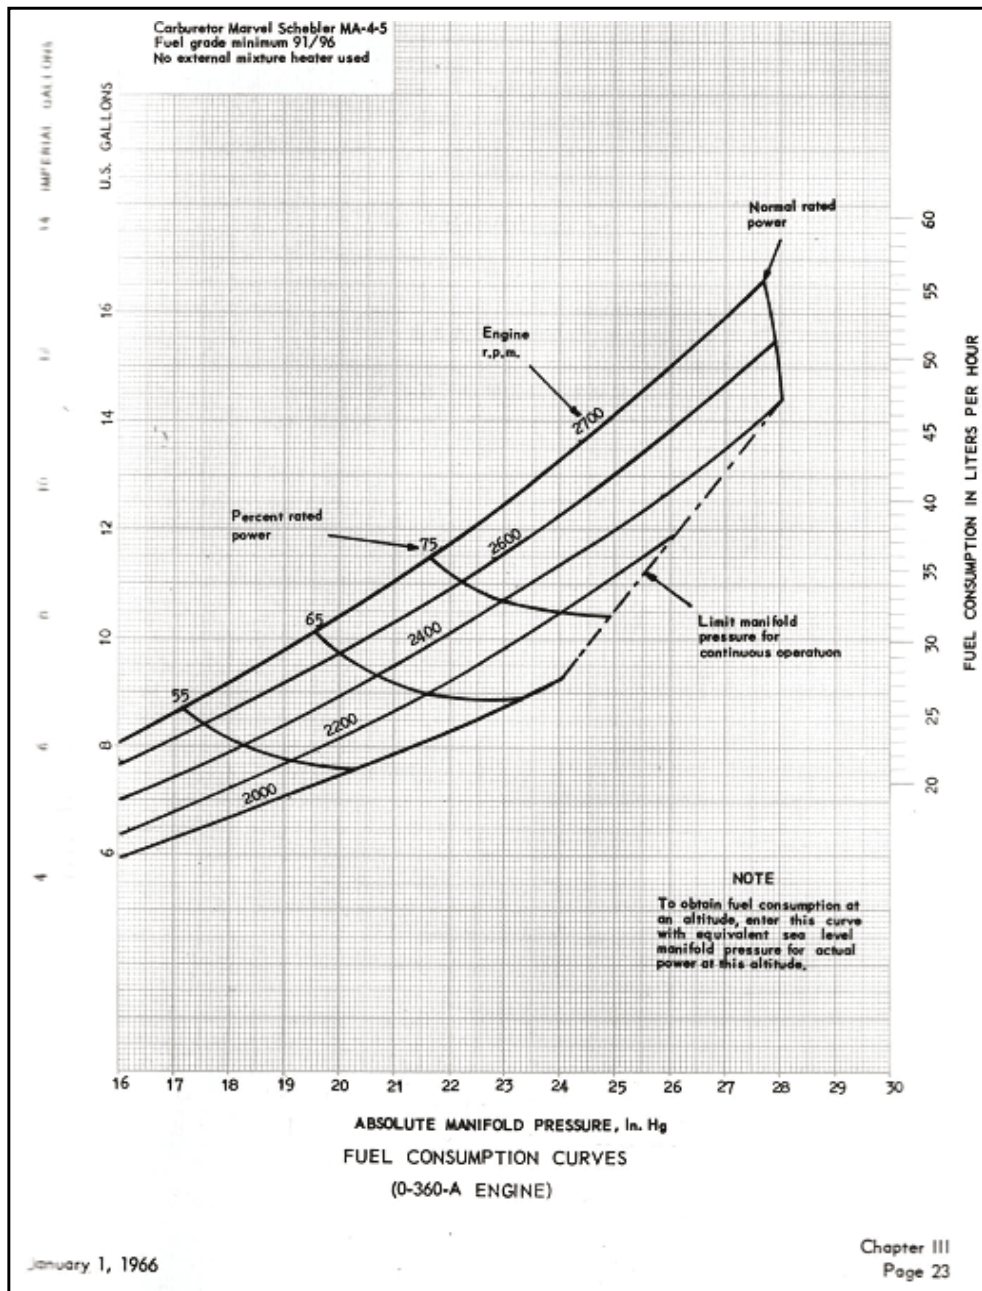
Figure 1

The pilot used the fuel consumption curves from the Operating Manual (Figure 1) to calculate the fuel

As the fuel tanks were at ¼ tank prior to refuelling a pilot following the CAA's advice would have added the 3 hours trip fuel to the tanks, or planned to pick up fuel from Panshangar.

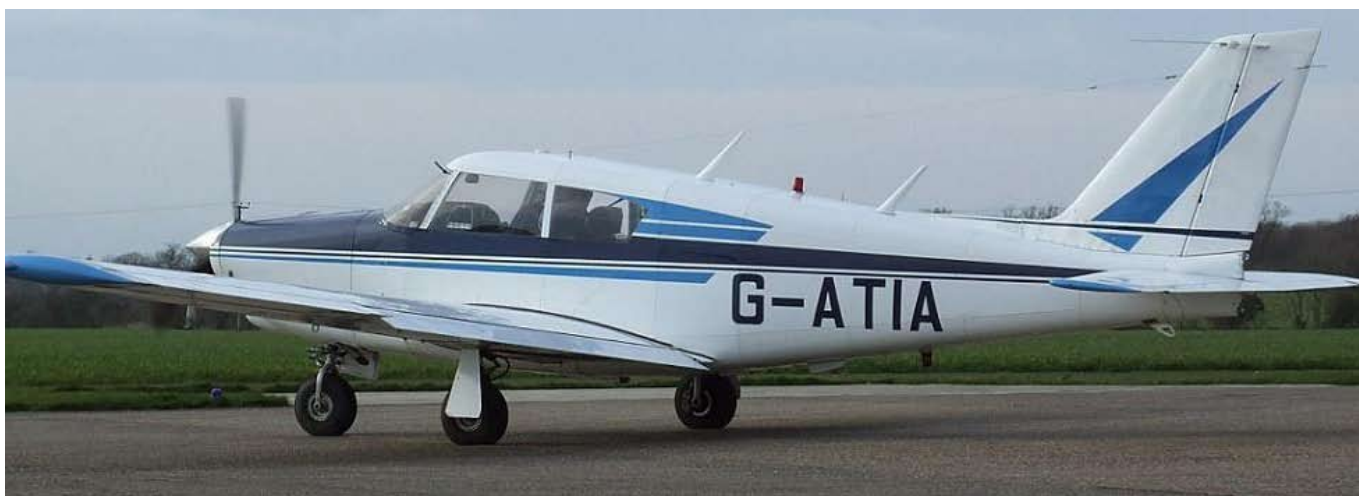
**Figure 2**

The aircraft, G-ATIA, before the accident
