## CONTENTS

## ACCIDENT

<b>Aircraft Type and Registration:</b>	Brandli Cherry BX-2, G-BXUX	
<b>No &amp; Type of Engines:</b>	1 Continental Motors Corp C90-12F piston engine	
<b>Year of Manufacture:</b>	1999	
<b>Date &amp; Time (UTC):</b>	21 July 2008 at 1940 hrs	
<b>Location:</b>	Clipgate Farm Airstrip, Canterbury, Kent	
<b>Type of Flight:</b>	Private	
<b>Persons on Board:</b>	Crew - 1	Passengers - 1
<b>Injuries:</b>	Crew - None	Passengers - None
<b>Nature of Damage:</b>	Damage to the landing gear and associated mechanism, propeller and engine shock-loaded	
<b>Commander's Licence:</b>	Private Pilot's Licence	
<b>Commander's Age:</b>	61 years	
<b>Commander's Flying Experience:</b>	429 hours (of which 322 were on type) Last 90 days - 5 hours Last 28 days - 2 hours	
<b>Information Source:</b>	Aircraft Accident Report Form submitted by the pilot and AAIB examination of the aircraft

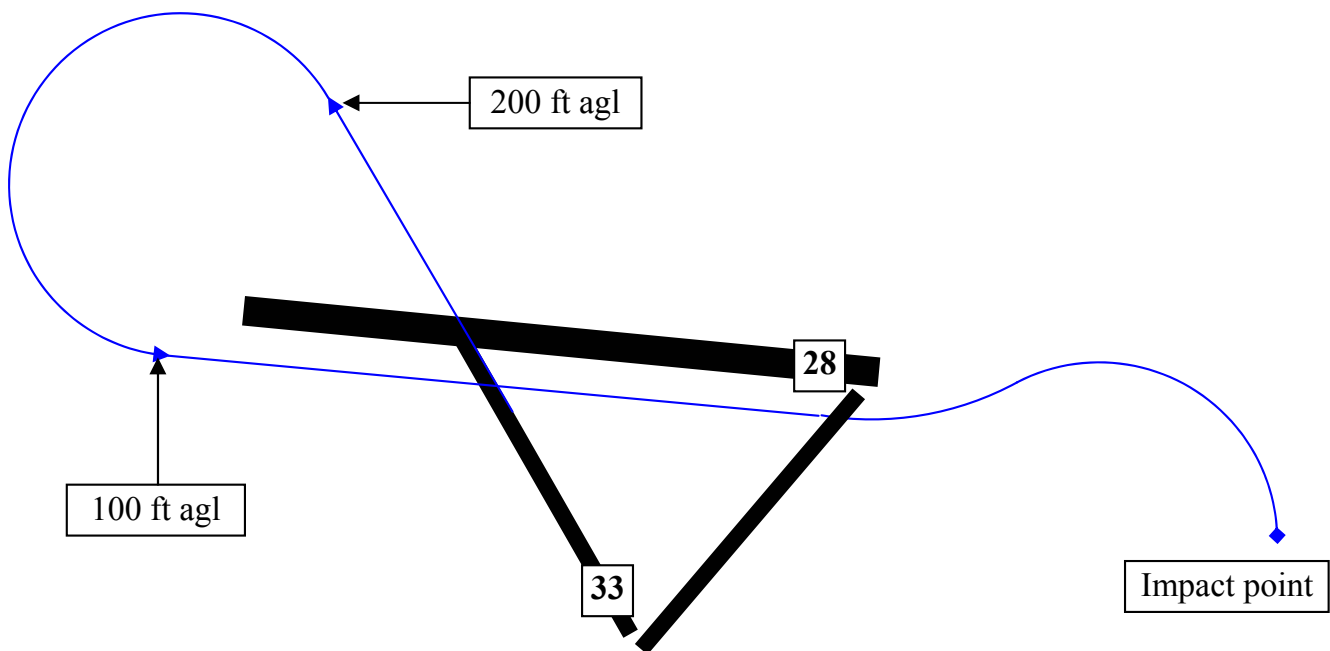
with its landing gear up, so the instructor called on the radio to advise the pilot, who immediately lowered the landing gear. The engine continued to run intermittently and make noises, which another witness on the ground described as “like shotgun fire”. This witness saw the aircraft flying in an easterly direction at a speed and height that he considered too great for a landing on Runway 10. At a point south of the Runway 28 threshold, with the aircraft descending to within 50 ft of the ground, the pilot attempted to position the aircraft onto a right hand base leg for Runway 33. The aircraft was seen to climb very slowly then adopt a nose-down attitude and roll to the right. The pilot reported that at this point the engine had ceased to produce power. He responded by applying nose-up elevator control, which resulted in a nose-up attitude but no decrease in the rate of descent. This was followed almost immediately by the aircraft impacting the ground. Figure 1 depicts the aircraft’s track following the go-around.

**Figure 1**  
Leicester Aerodrome layout showing aircraft’s track after go-around
