CONTENTS

COMMERCIAL AIR TRANSPORT

(ALL TIMES IN THIS BULLETIN ARE UTC)

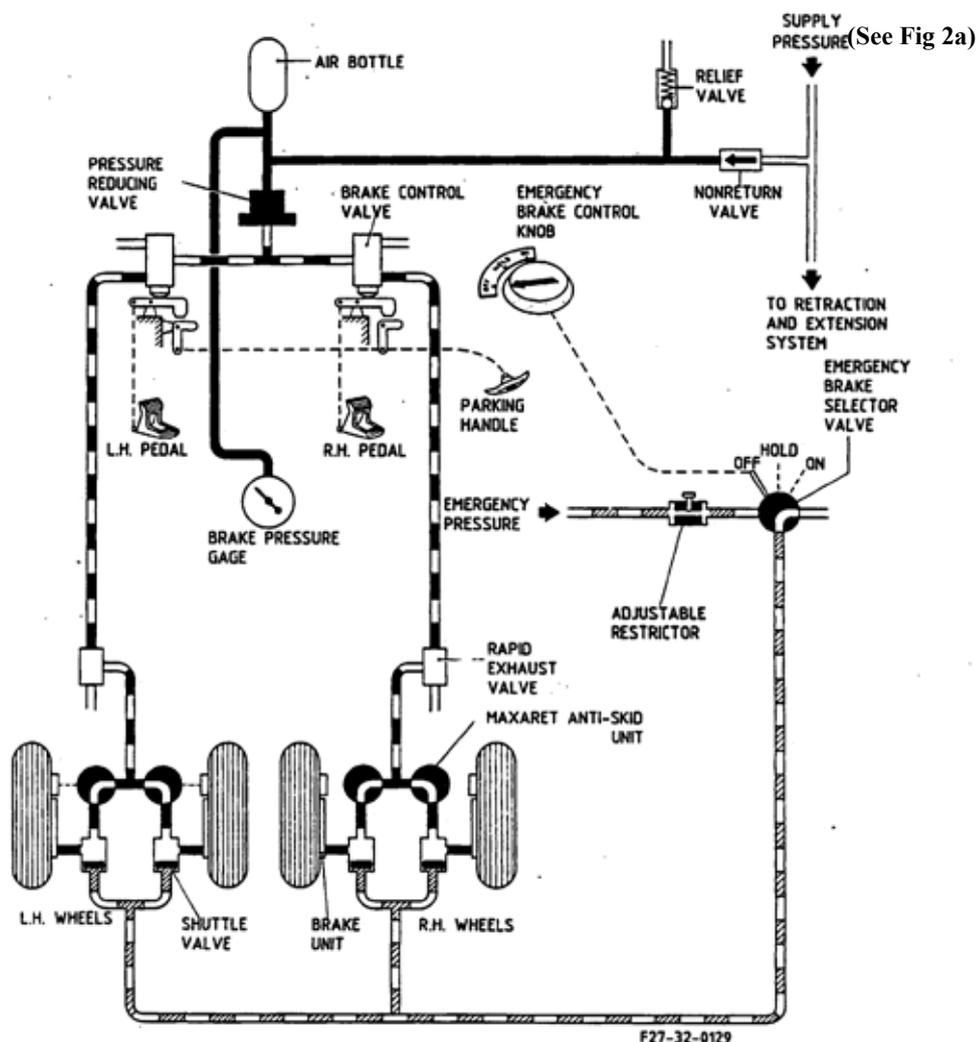
Figure 2b

Brake system schematic diagram

The third issue concerns the amount of leakage in the aircraft pneumatic system and the likely brake pressure available immediately prior to the accident. Subsequent tests showed that the leak rates for the brake and main systems were respectively 450 and 200 psi/hr. These values clearly exceeded the Maintenance Manual limit of 100 psi/hr, although it is possible that the pneumatic pipes within the right engine nacelle were subjected to a series of shocks and vibrations during the accident, resulting in the exacerbation of existing leaks or the generation of new ones.

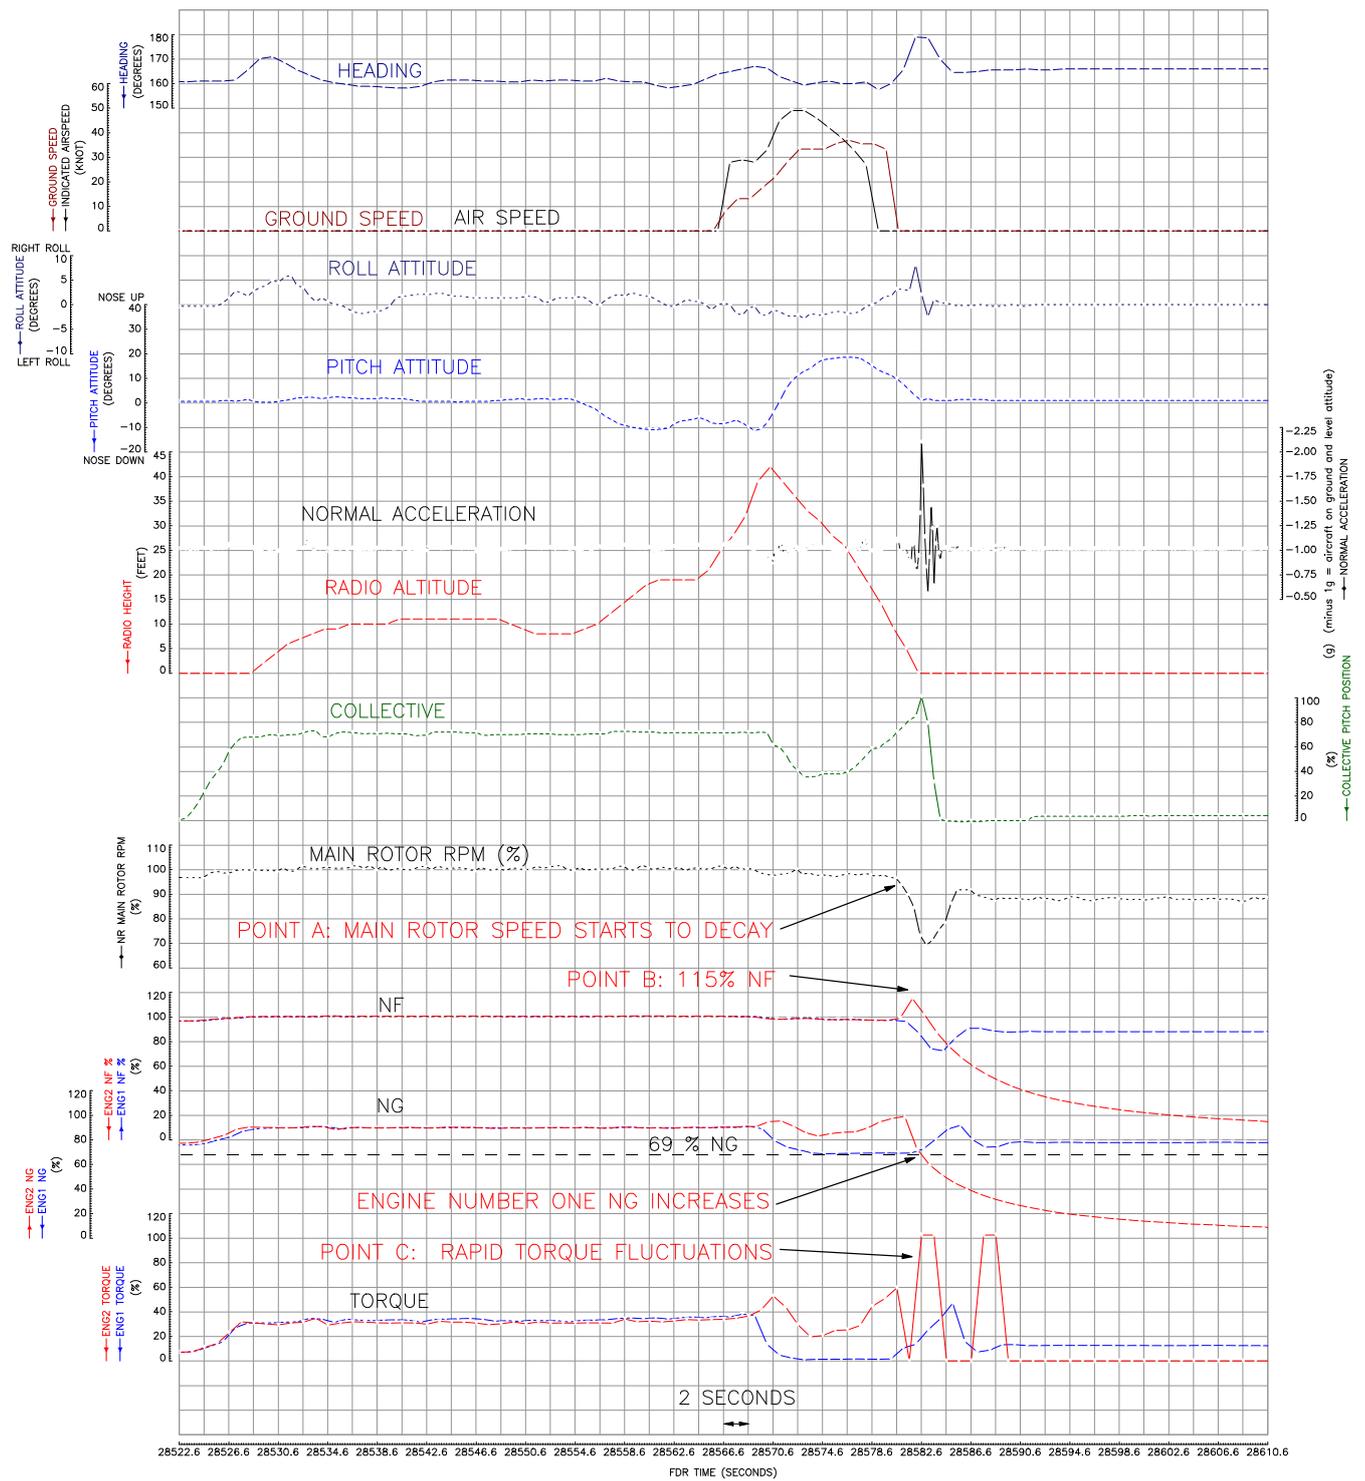
Figure 2
Salient FDR Parameters

the FDR systems mandatory tri-axial accelerometer². The defect did not affect the operation of the HUMS or any other helicopter system. It was found that rather than the normal acceleration parameter quiescent value indicating +1g, it indicated -1g. A check by the operator on 27 November 2007 found that the tri-axial accelerometer had been incorrectly installed. Maintenance records indicated that the accelerometer had last been removed and replaced during July 2007. A fleet-wide check was carried out and no further helicopters were affected. The incorrect installation of the sensor had the effect of inverting the sense of the normal acceleration parameter and also reversing the operation of the lateral acceleration parameter. The operating range of the lateral acceleration parameter was not affected; however, that of the normal acceleration parameter was no longer compliant with the legislative requirement. Instead of having an operating range of between +9g to -3g, this was reversed to +3g to -9g. Although the Aircraft Maintenance Manual (AMM) installation procedure provided a diagram of the correct orientation of the sensor, there was no requirement to carry out a post-installation test. On this occasion, the incorrect installation of the tri-axial accelerometer did not result in a loss of information, although under different circumstances, information from a mandatory parameter could have been compromised. The helicopter manufacturer has responded to the installation error by confirming that it will be carrying out a review of the AMM procedure.

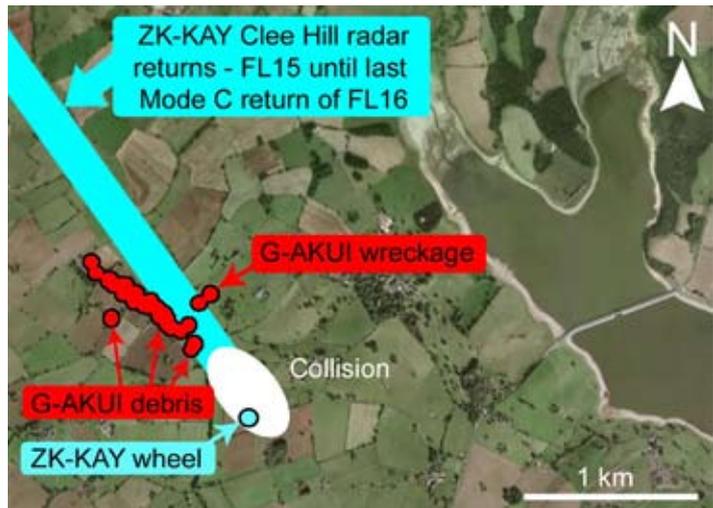
Figure 2

The Birmingham radar recording showed all three aircraft involved, until the time of the collision. At the moment of collision the radar returns of ZK-KAY and G-AKUI merged, and after this moment only the primary return of ZK-KAY was recorded (the SSR antenna on ZK-KAY was broken off in the collision, and SSR transmissions from the aircraft ceased).

Collision overview

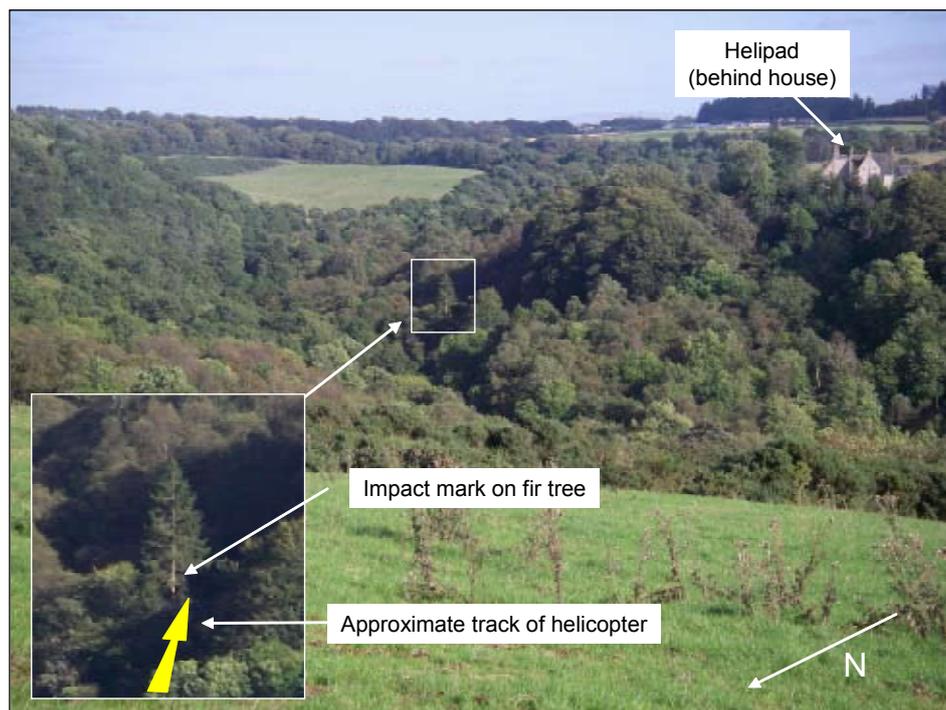
Figure 1

A closer examination of the fir tree at the initial impact revealed that the trunk bore evidence of a broad, horizontal, scar with a number of small branches that had surrounded

Accident location, looking along approximate track at impact

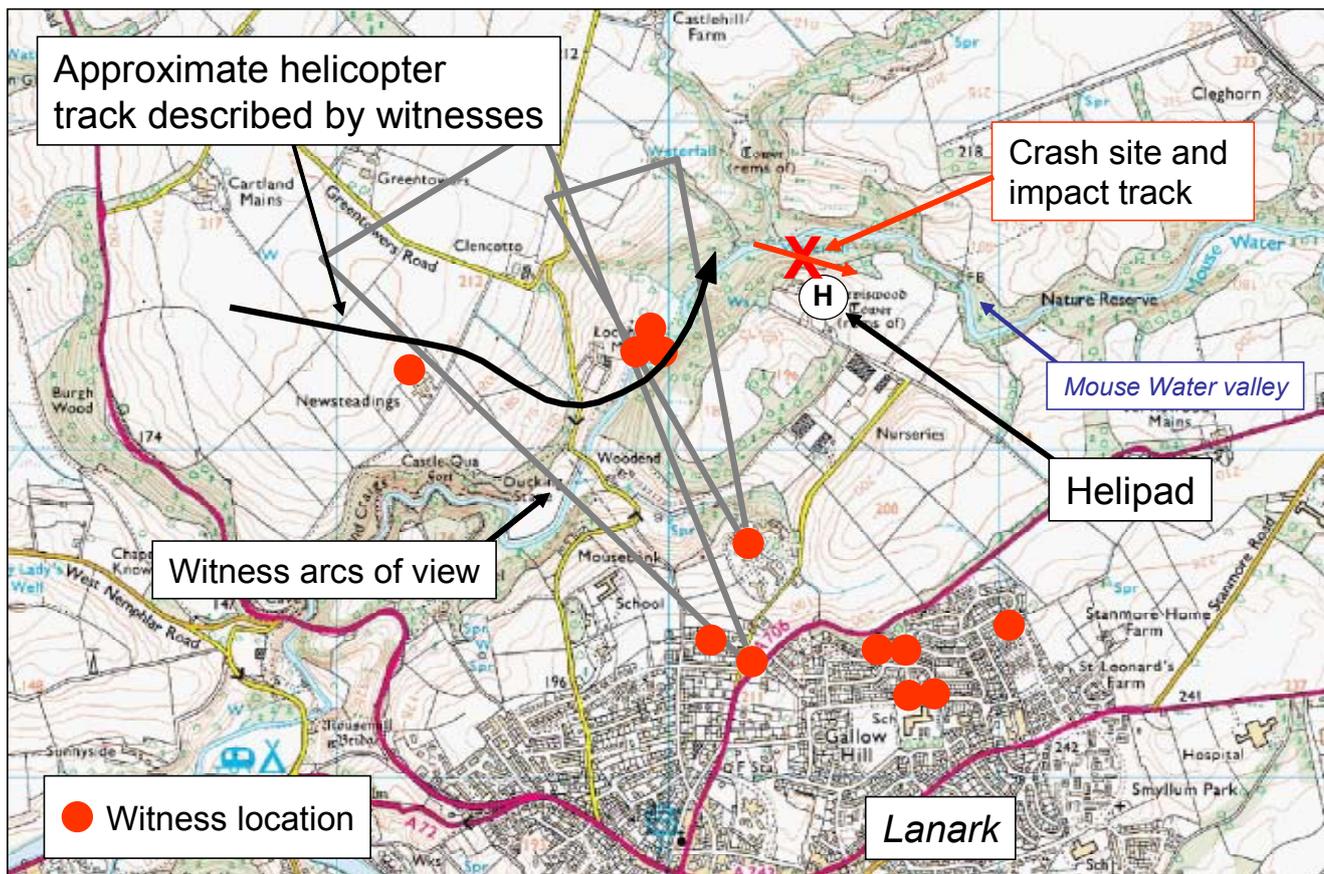
Figure 2
Witness information

airborne main rotor blade that was released in the initial impact. The locations of these witnesses are shown at Figure 2, together with an indication of the flight path they described. From their combined accounts, the helicopter approached the area from the west, initially flying across the Mouse Water valley in the general direction of the helipad. It then made a brief right turn before banking steeply to the left and descending into the valley. It adopted a marked nose-low, banked attitude as it descended, and was generally described as flying much faster than normal. The arcs of view shown in Figure 2 are of two witnesses who described seeing the helicopter in the steep left bank when it went out of view.

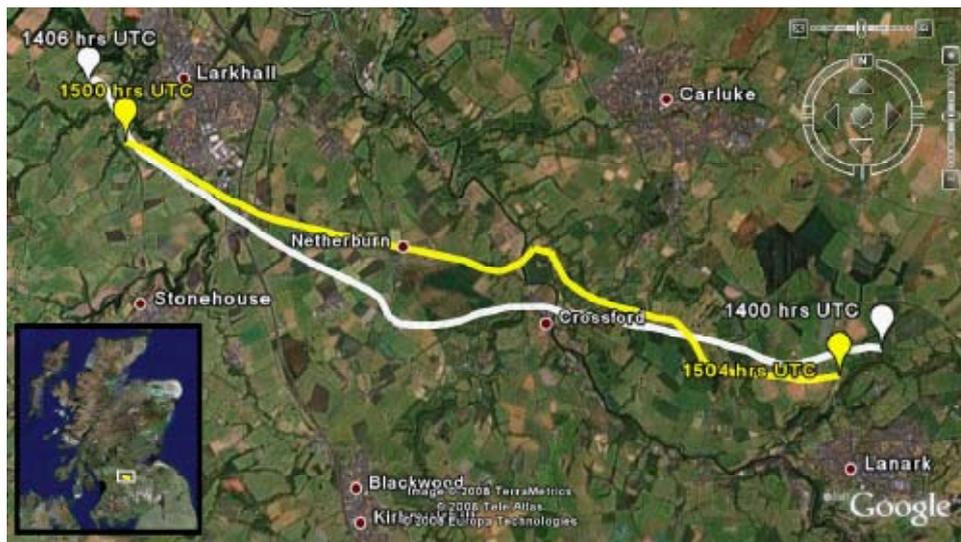
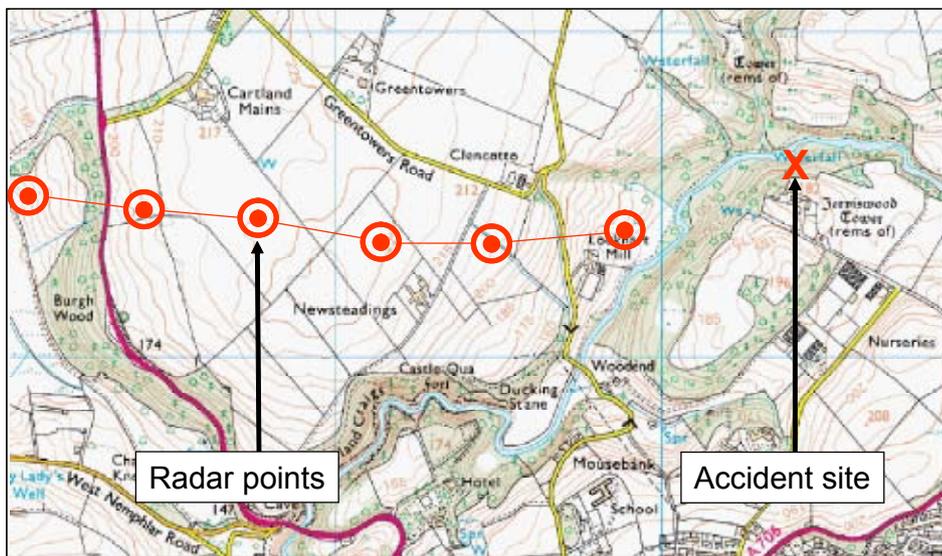
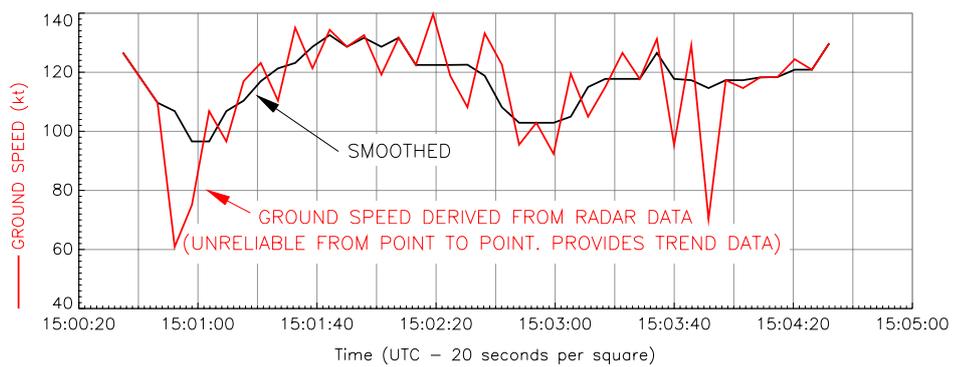
Figure 3 shows an overview of the outbound flight (white track) and the inbound accident flight (yellow track). It also shows the last six recorded radar points, together with a graph of the derived speed data of the whole accident flight. The coverage from Lowther Hill radar was good, and recorded positional data for the whole flight until less than 20 seconds before the accident.

Radar derived parameters

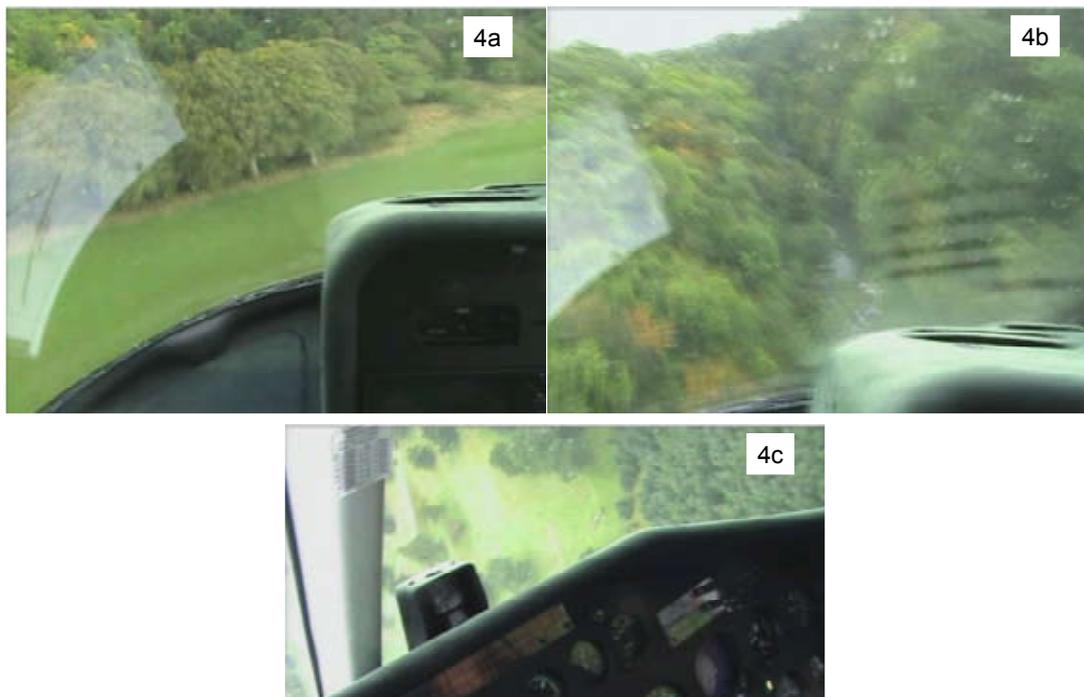
Figure 4

The final recorded segment lasted 8 seconds, the first frame of which is shown at Figure 4c. The helicopter was flying at 110 kt in a steep (about 60° angle of bank) turn to the right, at about 440 ft above a shallow valley floor. It appears to have just started a climb, with a pitch attitude at 10° and greater than normal cruise power applied. The helicopter then rolled left, reaching an approximately upright attitude as the recording ended. Again, the video and accompanying audio appeared to show that the passengers were enjoying the experience.

Still images from the recorded video

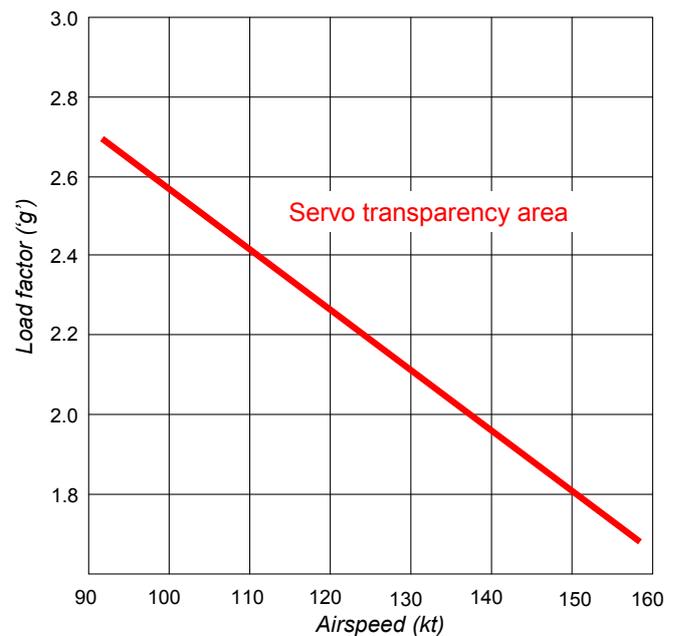
Figure 9

As part of the investigation, Eurocopter were asked to predict at what point G-CBHL would have encountered servo transparency, given the helicopter's known mass and the atmospheric conditions. The predictions, in terms of airspeed and load factor, are shown in graphical form at Figure 9. They assume

that maximum continuous power is applied; flight tests have shown that servo transparency does not occur under any circumstances with the collective pitch lever less than 50% raised. At 130 kt, the onset of servo transparency was predicted to occur at a load factor of 2.1 g.

Predicted conditions for the onset of servo transparency

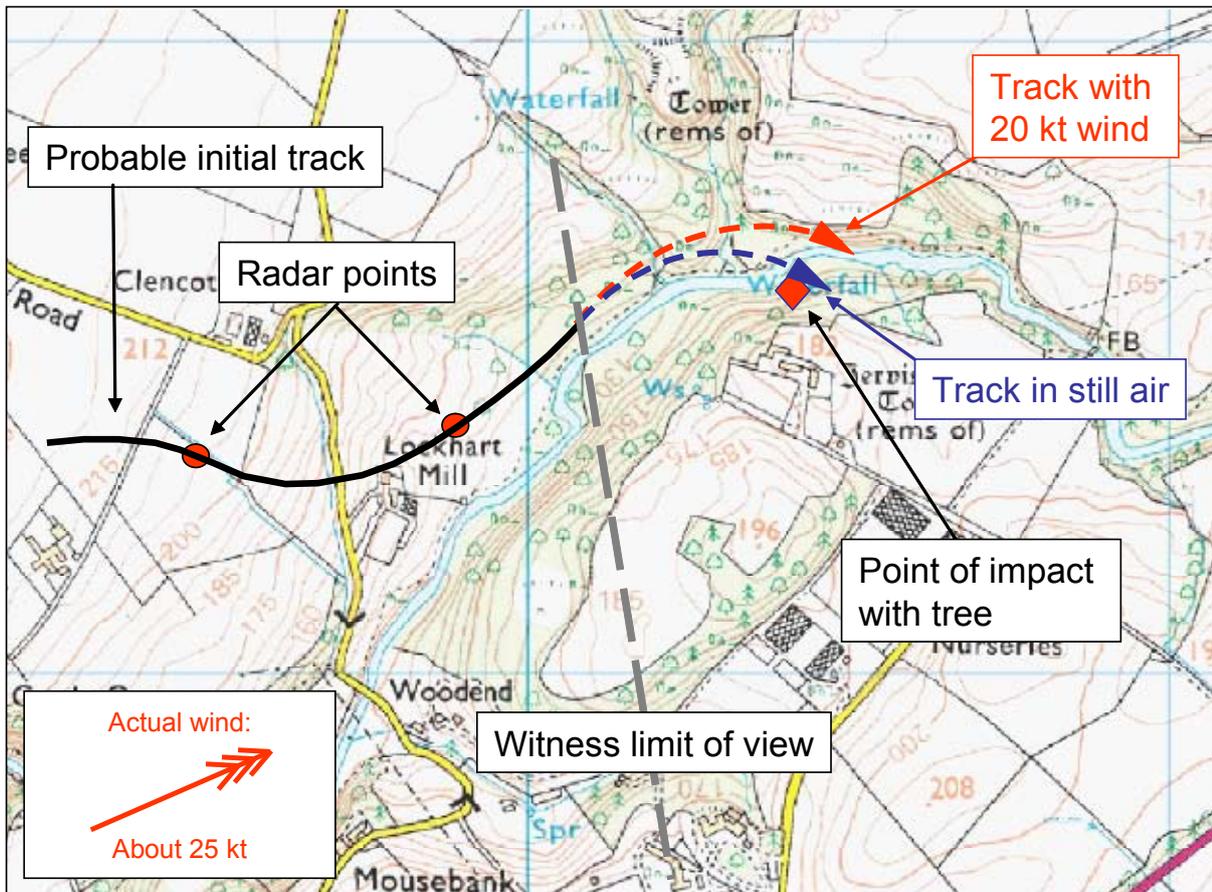
The helicopter was apparently in normal flight as it approached the Mouse Water valley from the west. Its probable initial track is shown at Figure 10, based on radar data and witness information, the latter indicating that the flight path was not a direct line between radar points. Although this was an uncommon route for the helicopter to take, two witnesses had seen something similar on previous occasions. The track shown is consistent with an initial right turn, followed by a brisk left roll to a high bank angle, as described by witnesses. The helicopter maintained the left bank as it descended, until it went out of view. At this point it would have been approximately along the line marked 'witness limit of view'. Although the helicopter was banked left as it

Probable initial flight path, shown with turns at 130 kt IAS and 60° bank angle

Figure 10 also shows two turn scenarios, illustrating turn performance and wind effect. Each turn is through a heading change of 90°, commencing from the witness limit of view line. Each of the paths is for a helicopter

flying at 130 kt IAS with a 60° bank angle. One shows a turn in still air, the other with a 20 kt wind blowing along the initial line of travel. In the latter case, the helicopter would drift just over 200 ft downwind during the turn. Flown under ideal conditions, in calm air and in level flight, the turns would require a steady loading of 2g. Figure 10 shows that such a turn would not have been sufficient to keep the helicopter within the narrowest part of the valley in the prevailing wind conditions.

With the onset of servo transparency in this case predicted to have been at 2.1 g (with maximum continuous power set), even a modest increase in turn rate over that shown at Figure 10, if accompanied by a power increase, would have caused the helicopter to encounter the phenomenon. Any turbulence in the valley could have caused transient additional loading of the rotor disc, which would further increase the likelihood of an encounter. At the height the pilot chose to fly, there would have been very little time to recognise and deal with such an encounter, and the helicopter could rapidly have adopted an attitude from which recovery was not possible.

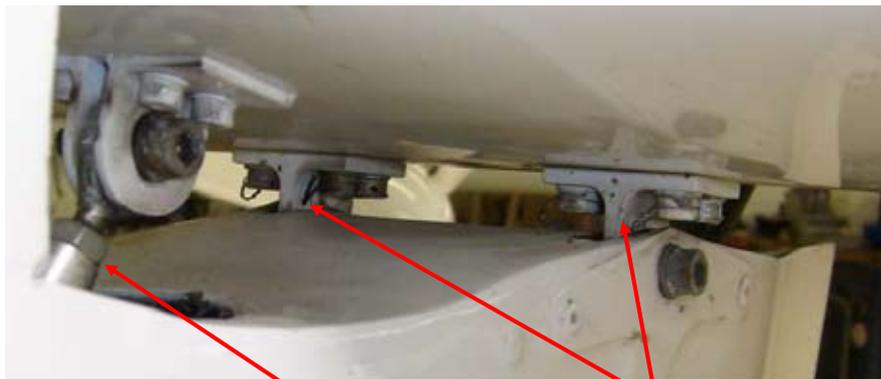
Figure 1

Tailplane attachment
(Photograph from Dyn'Aero BS 08 B 0034)

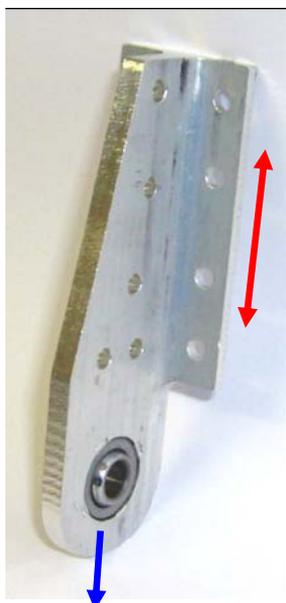
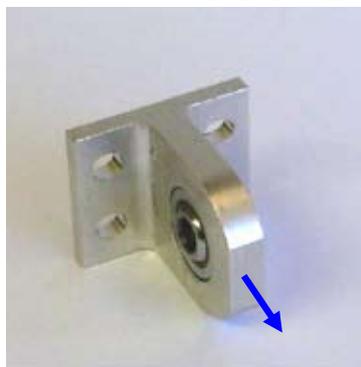
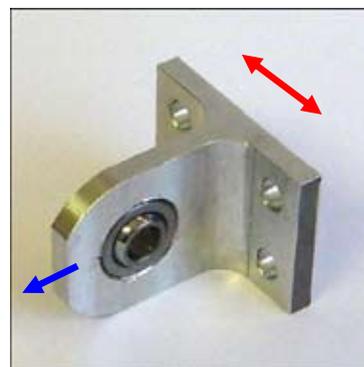
Figure 2

Early MCR-01 models, prior to 2001, have 4 mm thick aluminium lugs ('Type 1') which are integral to the tailplane and are riveted and glued to the vertical web of the spar during tailplane manufacture (Figure 2). This was superseded by the 'Type 2'

fixing, with 7 mm thick aluminium lugs and external attachments, which was introduced for the MCR4S, a four seat model, and extended to all models from 2001. A 'Type 3' lug was introduced subsequently. This is similar to the Type 2, but has a 4 mm thick lug, to fit the fin mountings on early models.

Type 1 - 4mm lug riveted and glued to tailplane spar vertical web

Type 2 - 7mm lug mounted on the tailplane with screw fixings

Type 3 - 4mm lug mounted on the tailplane with screw fixings

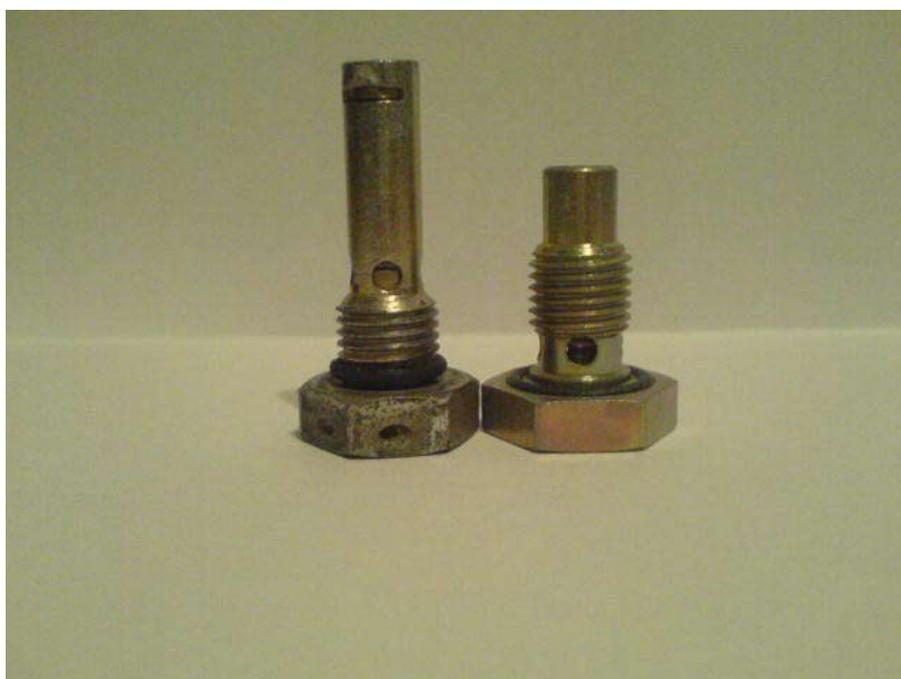
Figure 1

system after the accident which were not detected in samples taken during preflight checks.

Image showing difference between the fuel drains
