SPECIAL BULLETINS

INTERIM REPORTS

(ALL TIMES IN THIS BULLETIN ARE UTC)

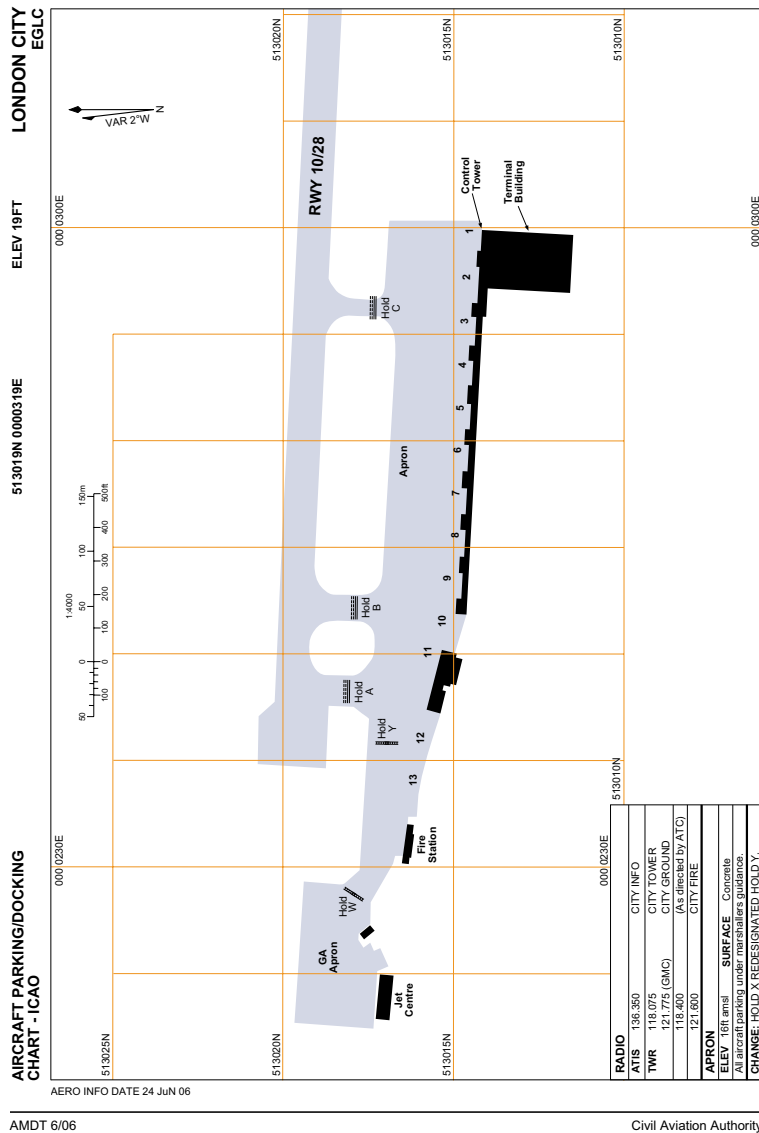
At the time of the incident there were 13 stands at London City (Figure 3). Stands 10 and 11 are smaller and non-uniform in shape when compared with Stands 1 to 9.

Figure 3
 ICAO Parking/Docking Chart for London City Airport
 (current at time of accident)
 as published in UK AIP

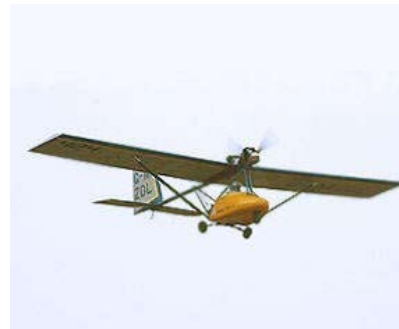
The MW6-S is a conventional three axis aircraft fitted with ailerons, rudder and an elevator with an anti-balance/trim tab. It has a rigid structure with fabric-covered flying surfaces.

The pilot considered that the accident was probably caused by a dislodged control cable. However, during the recovery of the aircraft from the field it received further significant damage and it was not possible to establish whether the control cables had been correctly connected at the time of the accident.
