CONTENTS

SPECIAL BULLETINS

INTERIM REPORTS

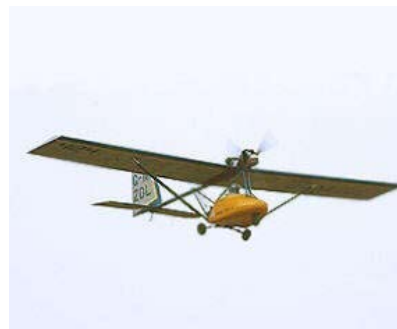
The MW6-S is a conventional three axis aircraft fitted with ailerons, rudder and an elevator with an anti-balance/trim tab. It has a rigid structure with fabric-covered flying surfaces.

The pilot considered that the accident was probably caused by a dislodged control cable. However, during the recovery of the aircraft from the field it received further significant damage and it was not possible to establish whether the control cables had been correctly connected at the time of the accident.
